ON  
**GEOTECHNICAL INVESTIGATION AND SLOPE  
STABILITY RISK ASSESSMENT**

FOR  
**PROPOSED ALTERATIONS AND ADDITIONS**

AT  
**88 BOWER STREET, MANLY, NSW**

Ref: 33662BMrpt

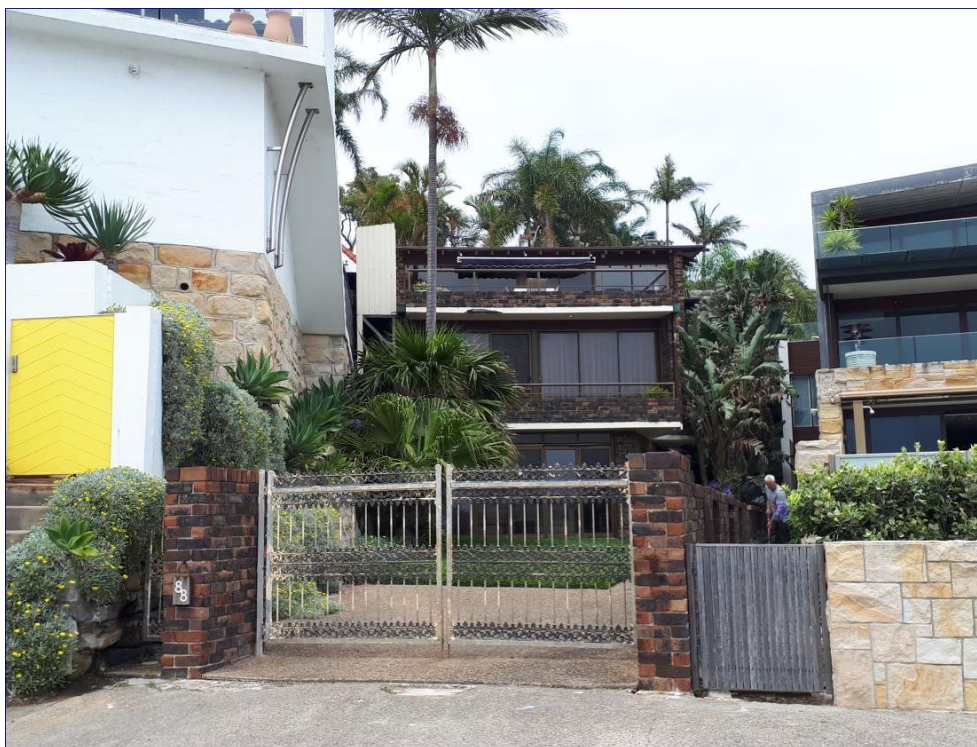
**Plate 1: looking southwards from Marine Parade**

The house appeared to be in good condition with no cracks observed during our cursory viewing. The lower ground floor level is at a similar level to the northern garden and the promenade of Marine Parade. (Refer to

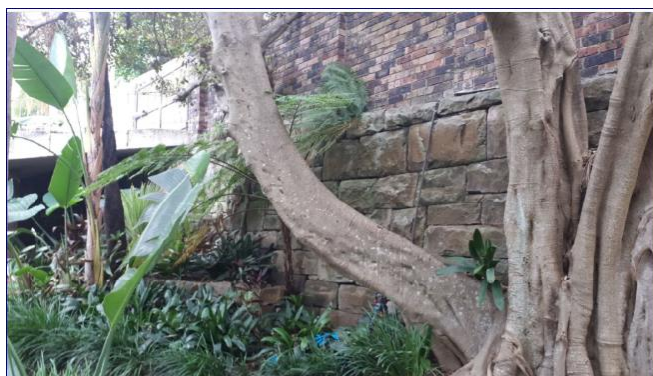
**Plate 2**

The stone retaining wall along Bower Street is inclined about 75° back into the slope and appeared in good condition, although fig trees are growing out of the wall. Refer to Plates 2 and 3.

- The fig tree growing in the stone retaining wall supporting Bower Street (Hazard C) must be monitored in the future for potential destabilising actions on the stone retaining wall, although it should be noted it has already compromised the integrity of the brick boundary fence above it.

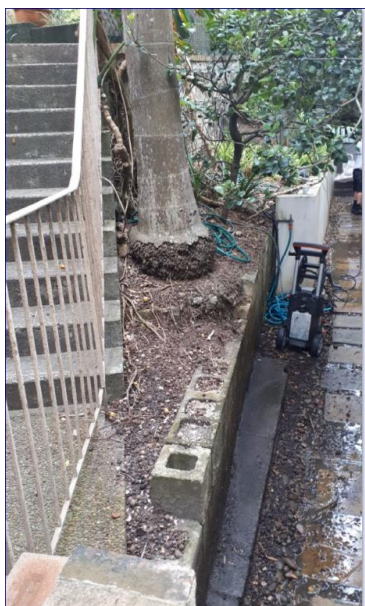
**Plate 5**

Along the top of the Bower Street stone wall is a 'single skin' brick fence, approximately 1.8m in height, for the full length of the wall. The brick fence has been lifted about 10mm off its base, and has other cracking in the vicinity of the fig tree(s). Within the property there is a concrete path adjacent to the base of the stone wall. The path leads up to a pedestrian gate at the western end where the path becomes suspended above gardens. The garden path links at its eastern end to the house at the 1<sup>st</sup> floor level. Close to the house the path appears to be supported by a 1.7m high timber retaining wall. The garden between the Bower Street frontage and the house steps down to the west where it is supported by masonry and rubble retaining walls of about 1.5m height, over sandstone bedrock outcrops, and a further masonry retaining wall along the apparent boundary with No 92 Bower Street. Refer to Plates 4 to 6.

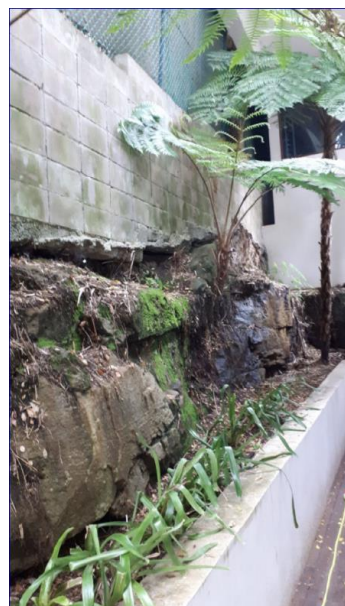
Most of the retaining walls appeared to be in reasonable condition although the rubble wall is an ‘ad-hock’ structure and one section of the lower masonry wall is clearly being pushed over by the growth of a palm tree (Plate 4). The southern garden is also landscaped with a row of detached sandstone boulders. Separate to the row of boulders is an exposure of sandstone, at the base of steps leading to the lawn. We expect this is bedrock but it could be an embedded boulder/‘floater’.

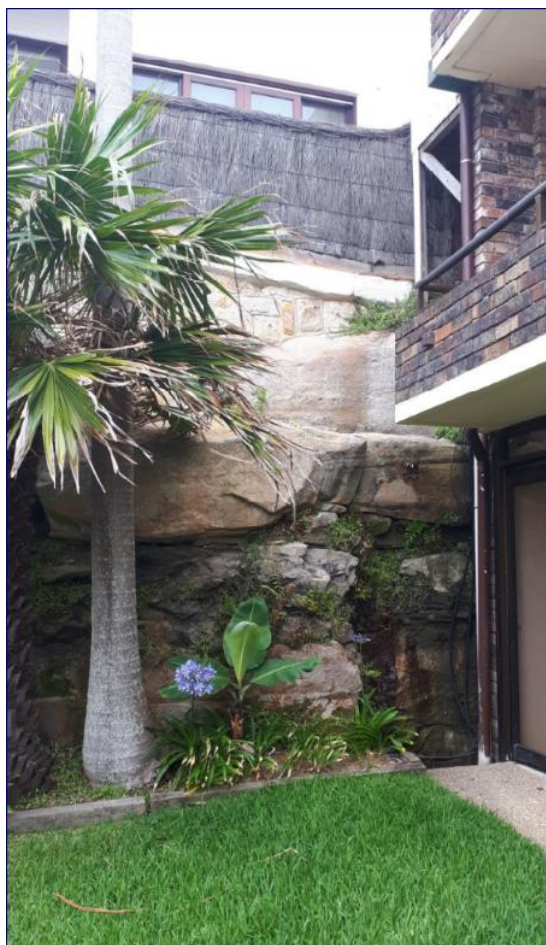
**Plate 7**

To the north of the house a rock face is present along the eastern boundary ranging from about 1m to 3.6m in height, with the greatest height at the corner of the house within No 88. The rock features two subvertical joints striking at an acute angle to the rock face, and a horizontal (discontinuous) shale seam about 1m to 1.5m above the garden level (with some fractured rock above), forming a large detached boulder and a potential flake of rock behind it. Refer to Plates 7 and 8.

- The large potentially detached sandstone boulder on the eastern boundary is potentially unstable (Hazard B). It was discussed during the site meeting with the structural engineer, Ms Marie O’Looney, of SDA Structures, that it may be difficult to arrange permission to stabilise the boulder using permanent rock bolts as the bolts would extend across the boundary. Instead it was agreed to permanently support the boulder and fragmented rock around it with a new retaining wall constructed as part of the lower ground floor patio works.

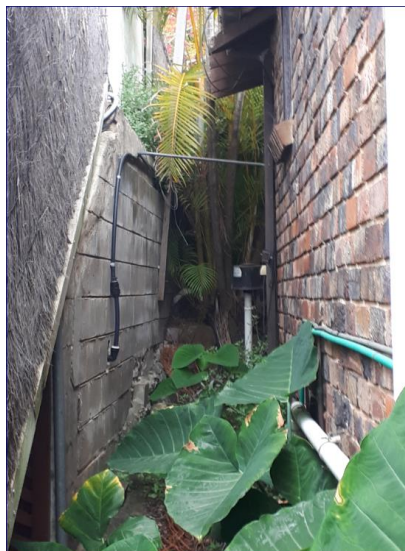
**Plate 9: Looking southwards, at about Level 1**

The rockface appears to extend southwards but with only a very narrow gap between it and the eastern wall of the house this could not be confirmed. The strength of the exposed rock was generally assessed to be at least medium strength. At the crest of the rock face is a stone wall supporting a cement rendered house within the adjoining property at No 86. About mid-length along the eastern boundary the neighbouring garage abuts the boundary and is supported by a 1.6m to 2m high masonry wall which is tilting over towards the subject site. Refer to Plate 9.

- The tilting retaining wall supporting the garage of No 86 (Hazard E) will require stabilisation prior to any excavation or demolition works that may be required below it.
