**GEOTECHNICAL INVESTIGATION REPORT**

PROPOSED RSL CLUB REDEVELOPMENT  
20 - 22 MELWOOD AVENUE, FORESTVILLE NSW

PREPARED FOR THE FORESTVILLE RSL CLUB LTD  
REPORT ID: E24016FOR-R01F (REV 1)

**Date:** 13th May 2025

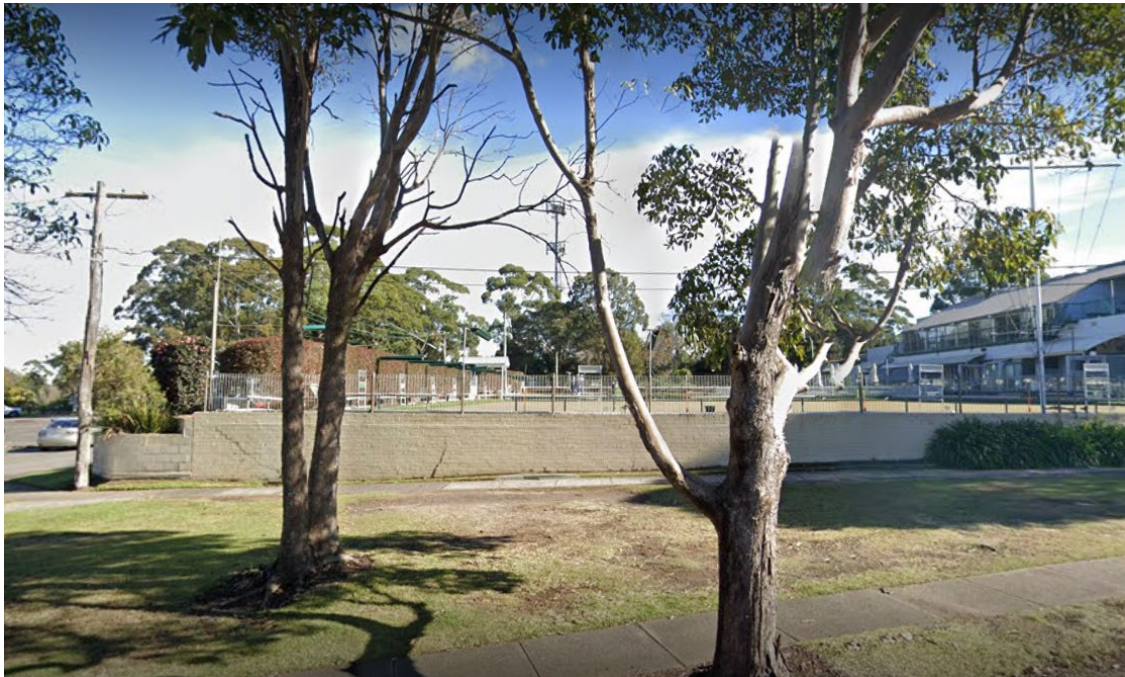
**Plate 9** – Google Maps view of the mortared brick retaining wall at the southeastern corner of the site, prior to painting, detailing existing cracking.

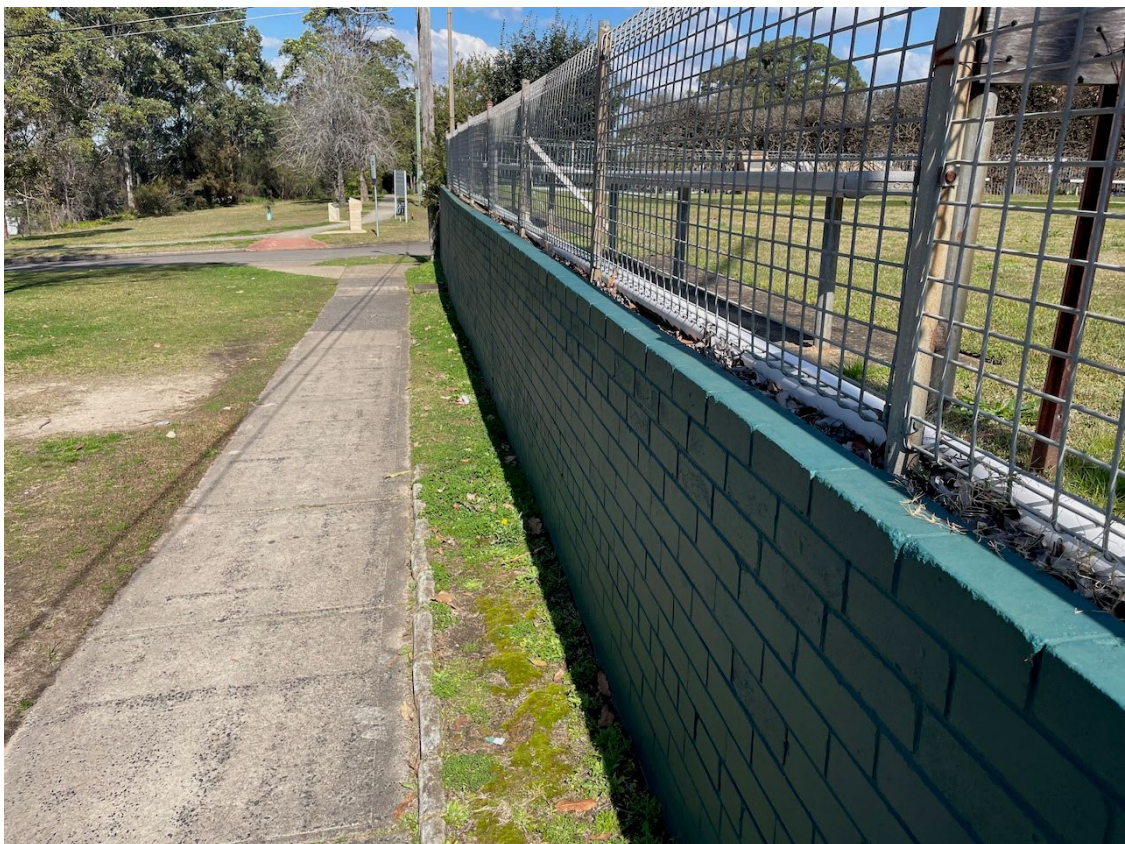
**Plate 10** – Developed lean in highest section of the mortared brick retaining wall, viewed to south.

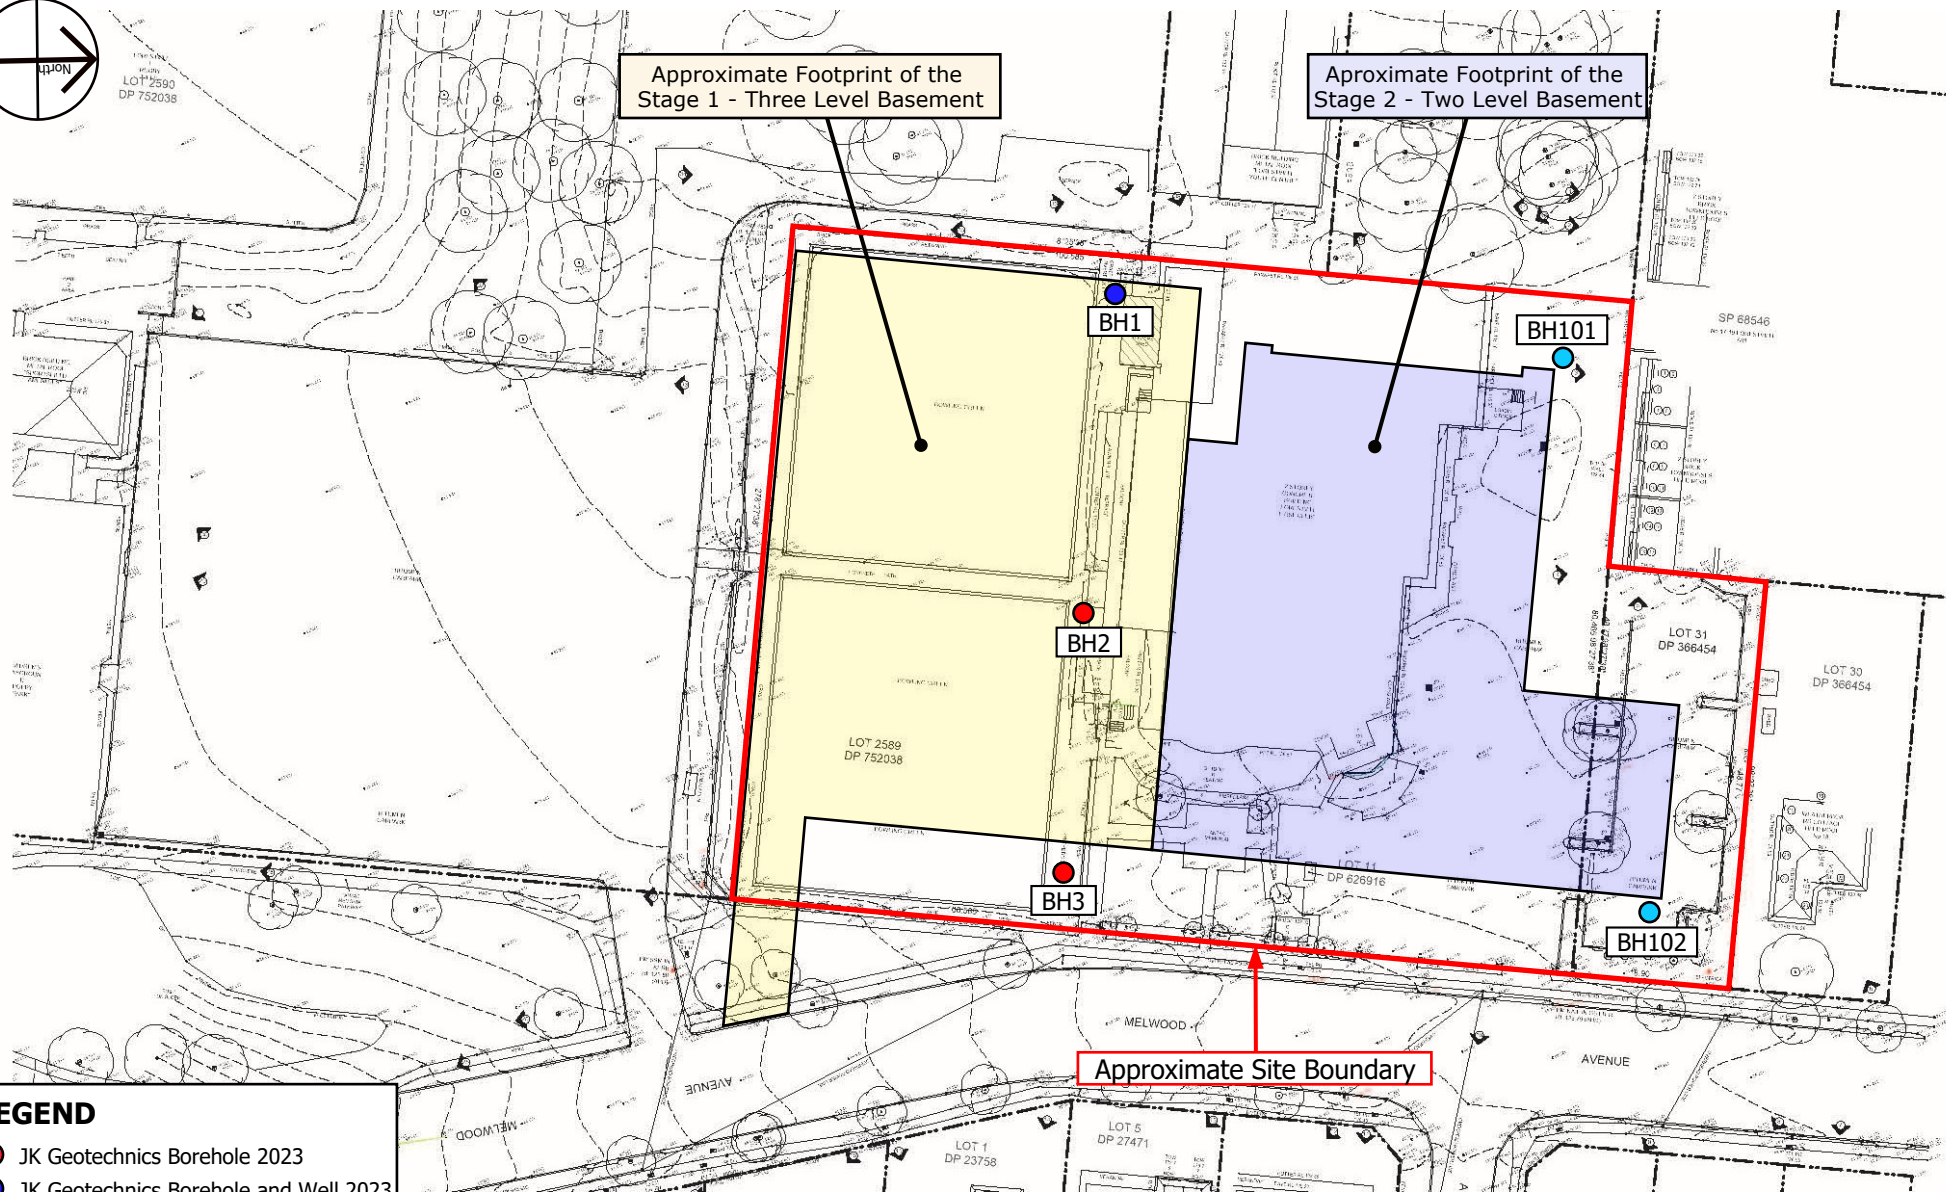
The information from these boreholes and well have been incorporated into our summary of the subsurface conditions across the site, while the borehole logs are also provided in **Appendix B**. The approximate locations of these boreholes are also shown on **Figure 2** and **Figure 3**.

Approximate Footprint of the  
Stage 1 - Three Level Basement

Approximate Footprint of the  
Stage 2 - Two Level Basement

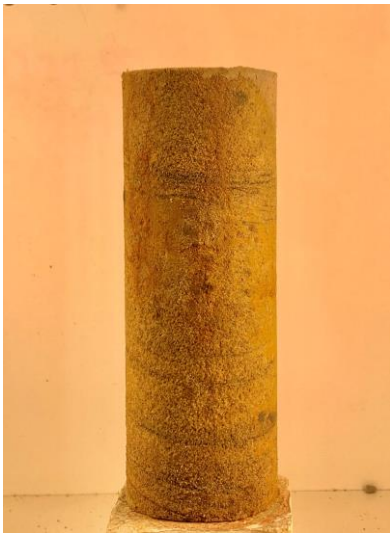
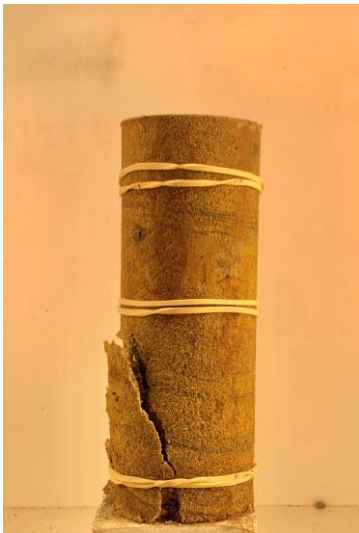
| <b>Uniaxial Compressive Strength</b> | | | |
|---|---|---|---|
| <b>Uniaxial Compressive Strength      9.8      MPa</b> | | | |

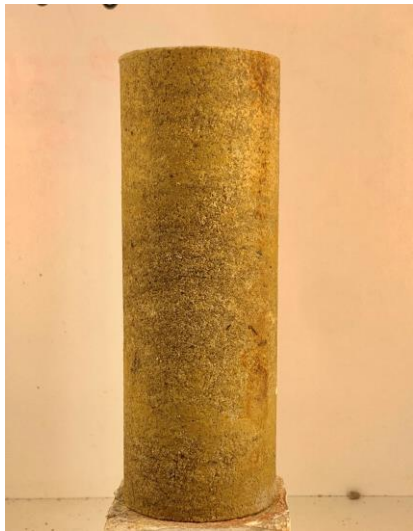
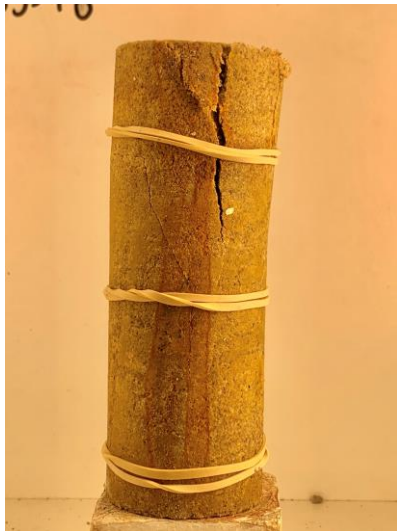
| Uniaxial Compressive Strength | | | |
|---|---|---|---|
| Uniaxial Compressive Strength | | 22 | MPa |

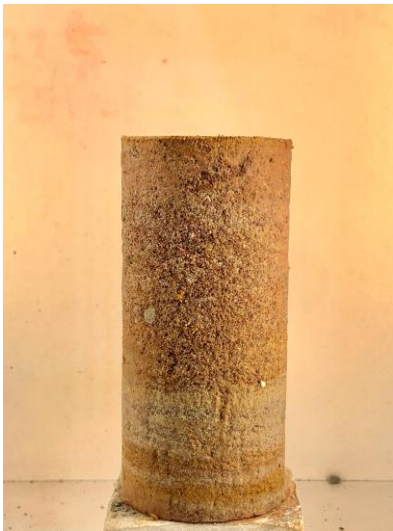
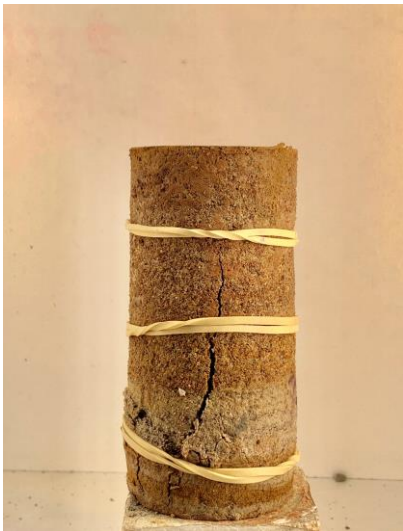
| Uniaxial Compressive Strength | | | |
|---|---|---|---|
| <b>Uniaxial Compressive Strength</b> | | <b>3.4 MPa</b> | |
