Remedial Action Plan

Opal Seaside Aged Care 184-194 Garden Street, Warriewood, NSW

55792/124336 (Rev 0)

JBS&G Australia Pty Ltd

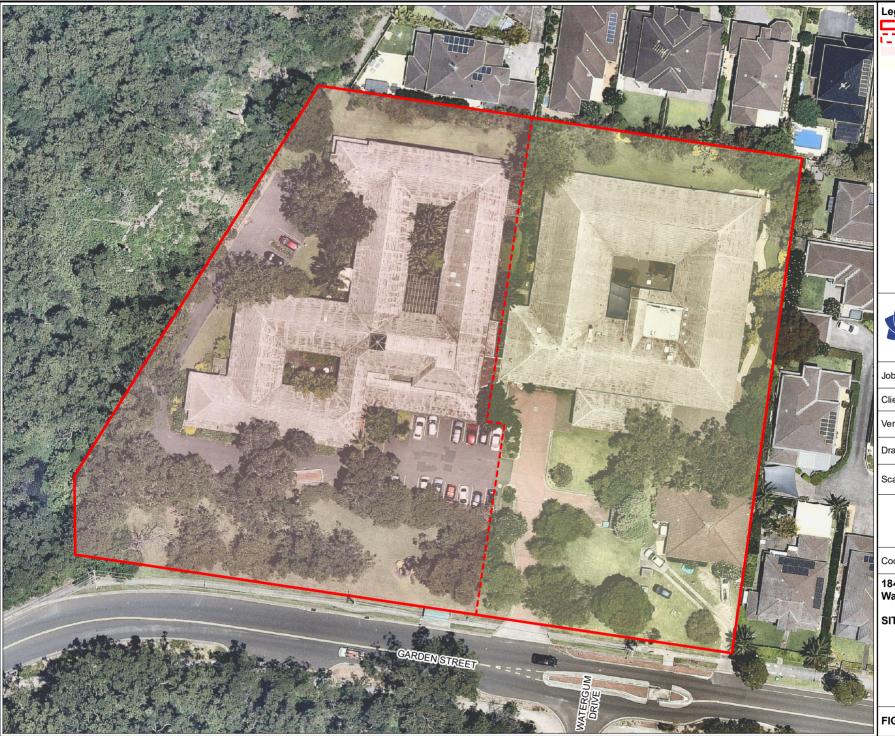
FIGURE 2

SITE LAYOUT

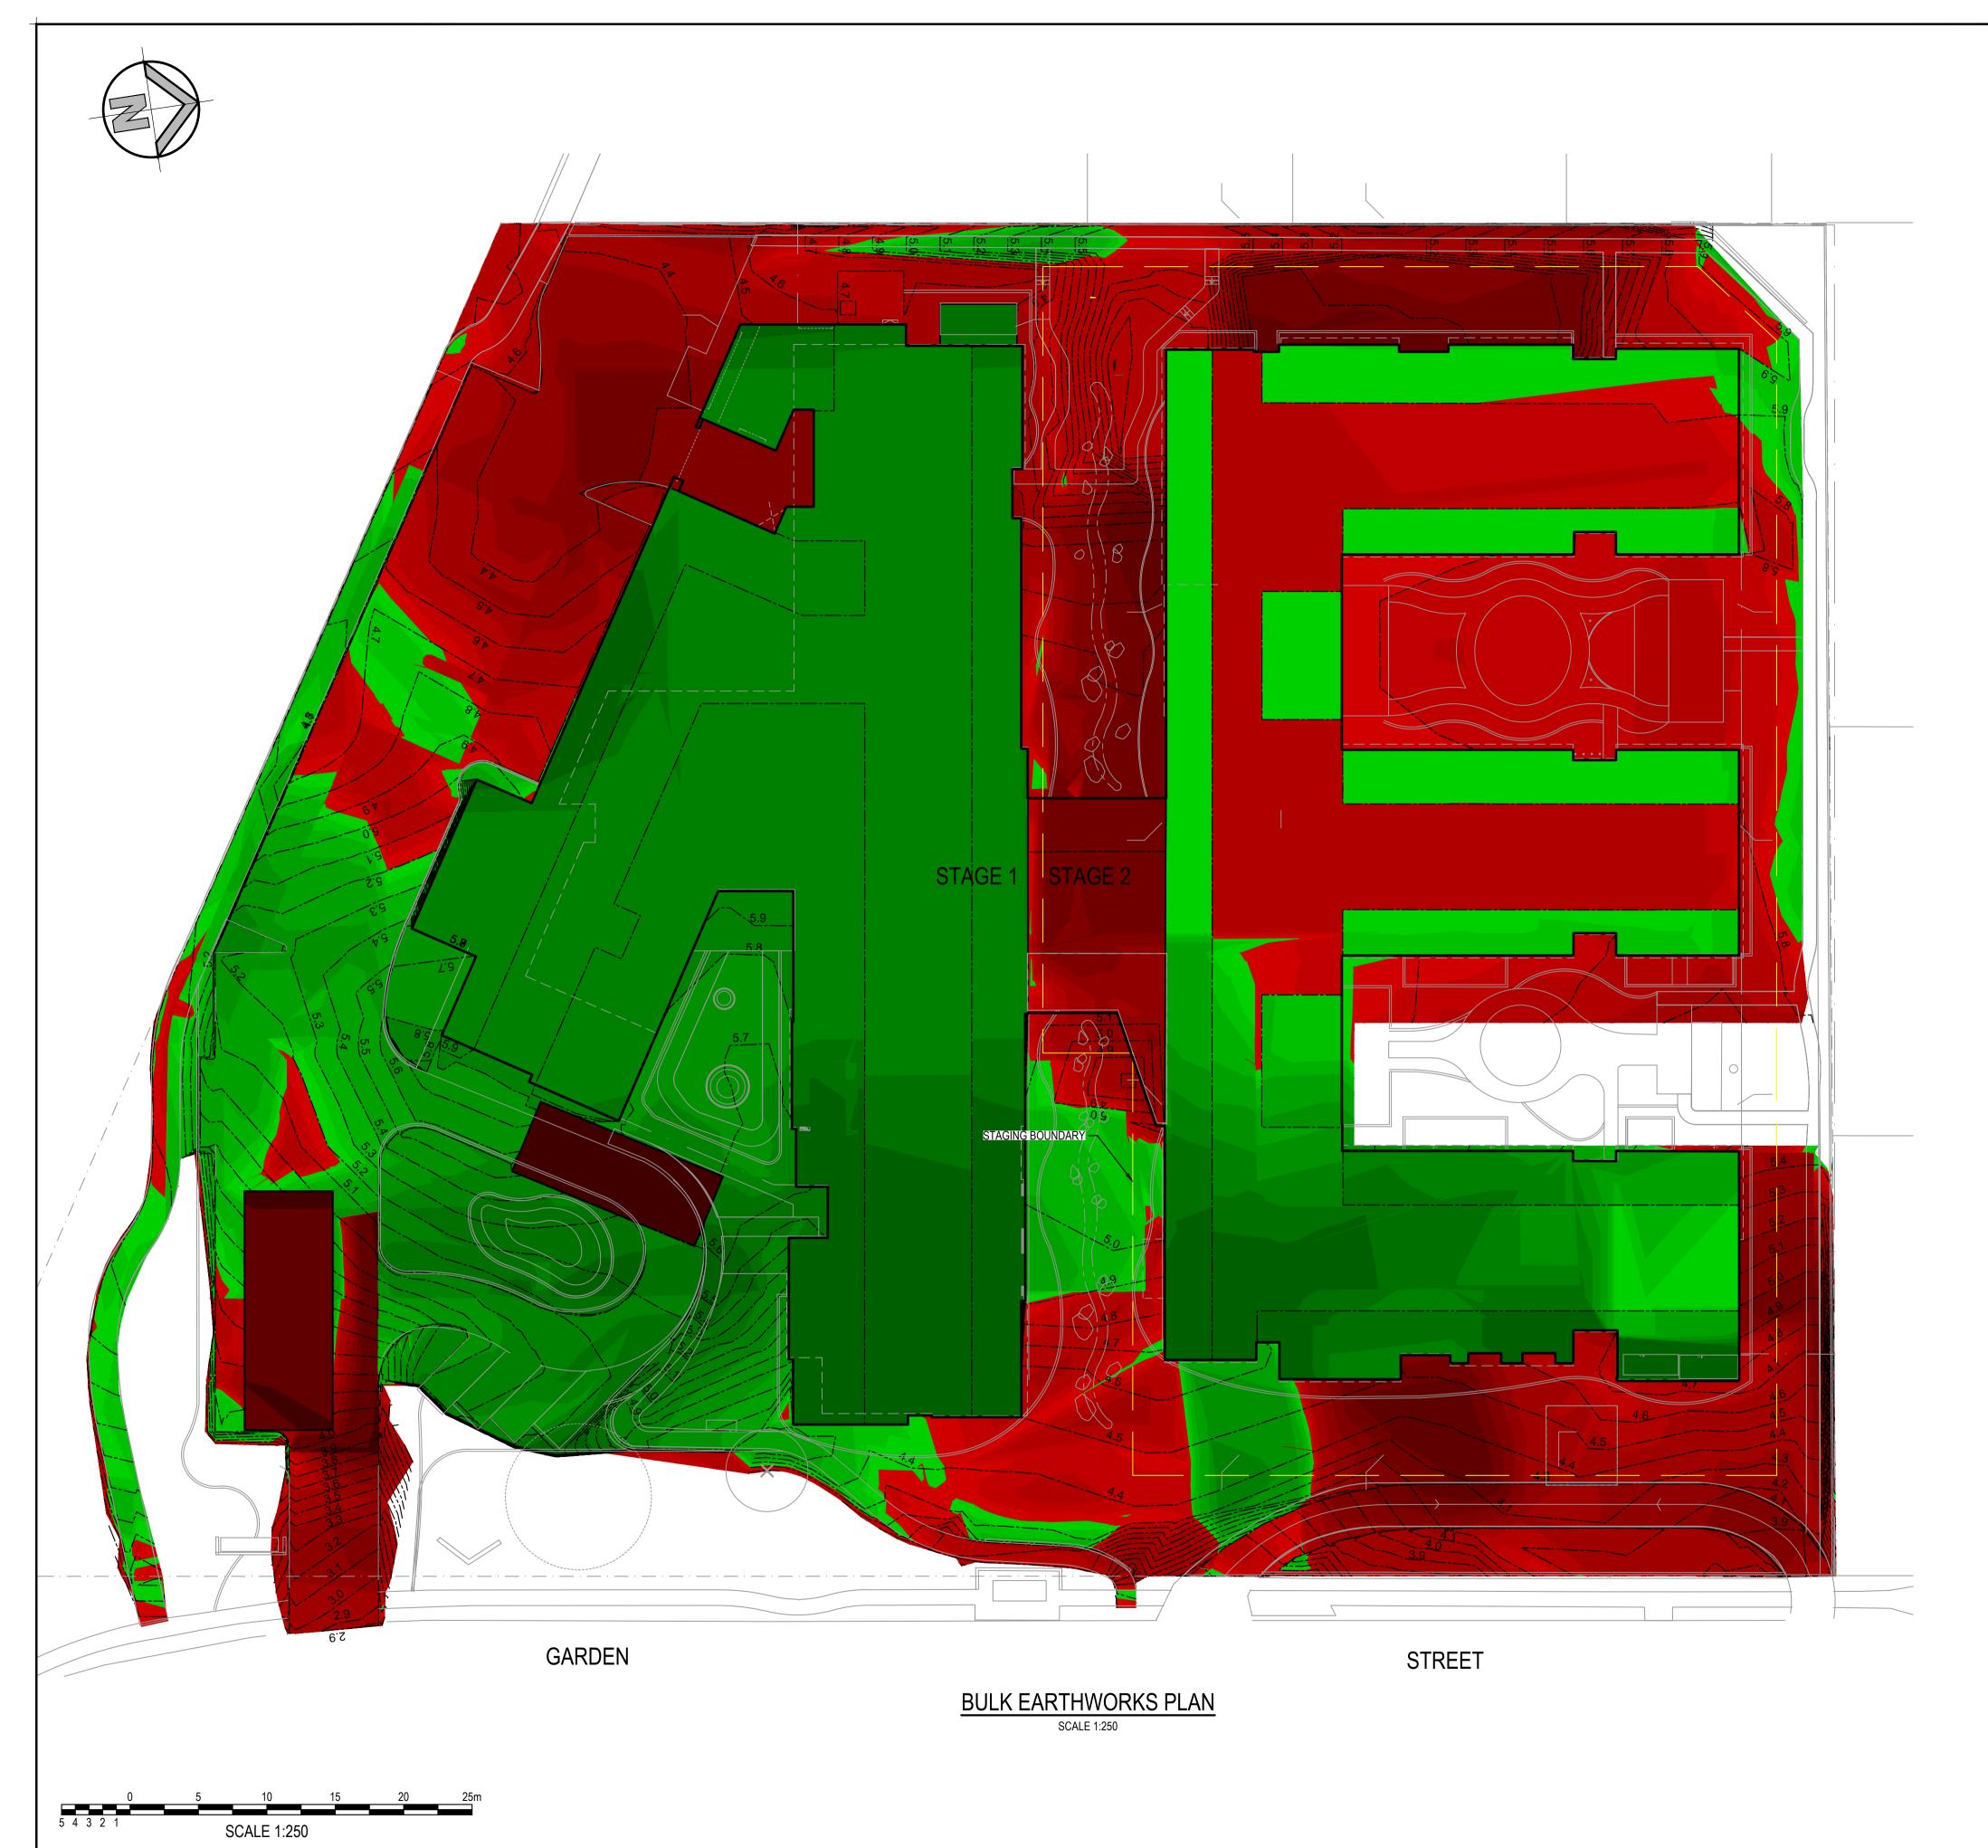
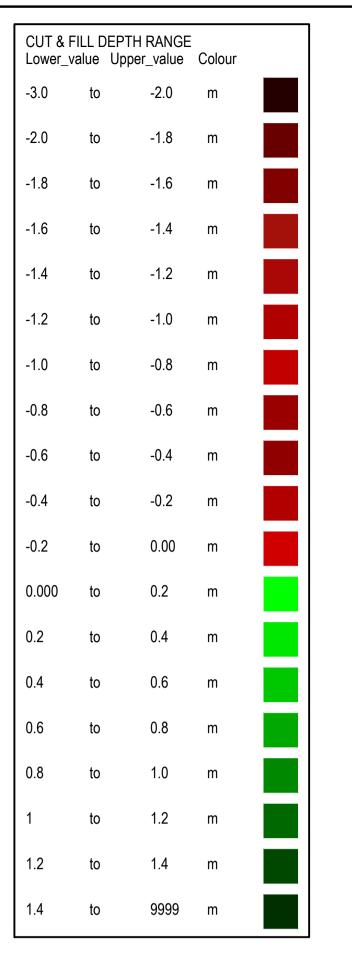
STAGE 1 EARTHWORKS QUANTITIES TOTAL AREA (5418 m²) 1032 m³ 2509 m³ EXCESS OF FILL OVER CUT 1454 m³ ASSUMED DEPTH OF 100mm EXISTING STRIPPING. TOTAL VOLUME =542 m³

- 2. SUB-GRADE SHALL BE COMPACTED TO 98% STANDARD DRY DENSITY RATIO AT OPTIMUM MOISTURE CONTENT ± 2% IN ACCORDANCE WITH AS 1289 5.1.1., TOP 300MM TO 100% SDD.
