## CONSTRUCTION CERTIFICATE

**CONSTRUCTION CERTIFICATE NO:** 2003/251

**Type of Work** ☒ Building work ☐ Subdivision work  
**Description** Onsite wastewater disposal system

# BUSHLAND MANAGEMENT PLAN

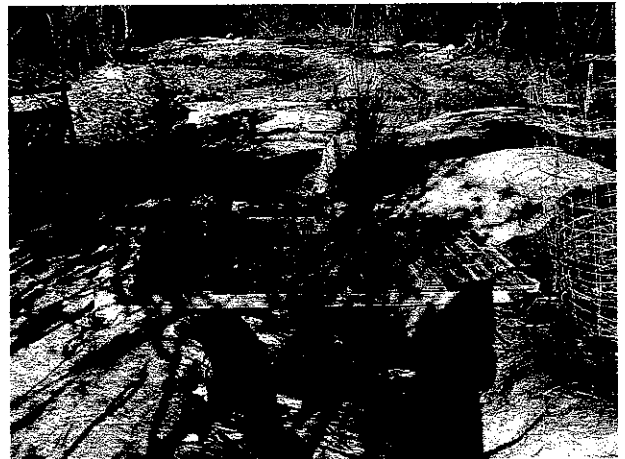
Plate 4. Channel leading to pond

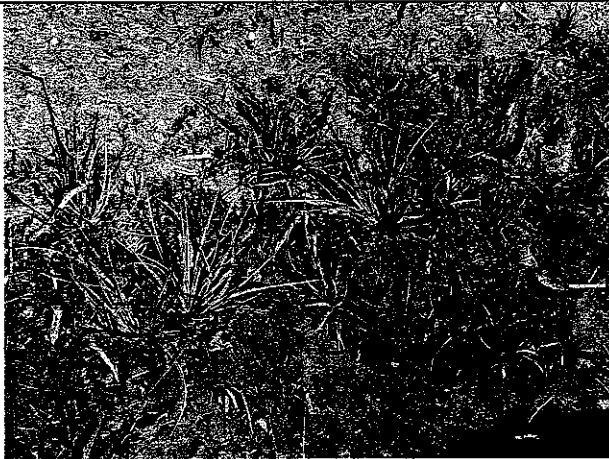
Plate 5. *Isolepis proliferata* to be removed

1. Hand remove *Isolepis prolifera* (Plate 5) and Arum Lily (Plate 6) from pond area. The site is the top of the catchment and both plants are invasive. It is important to remove these plants before they spread.
2. Batter the edges of pond (grade of 1:4) using a shovel or equivalent (refer to Cross Section A, Figure 1).

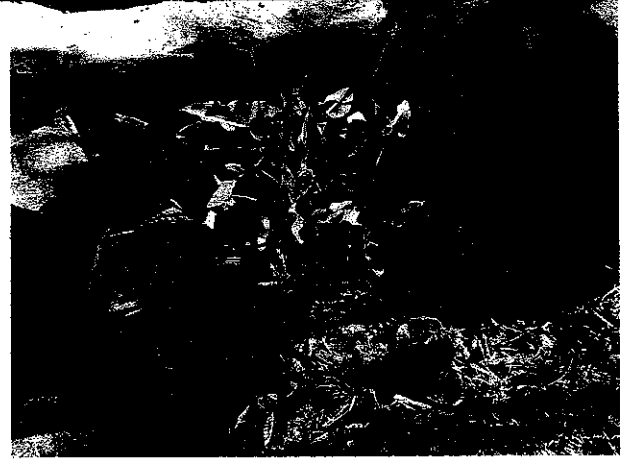
Plate 6. Arum lily to be removed

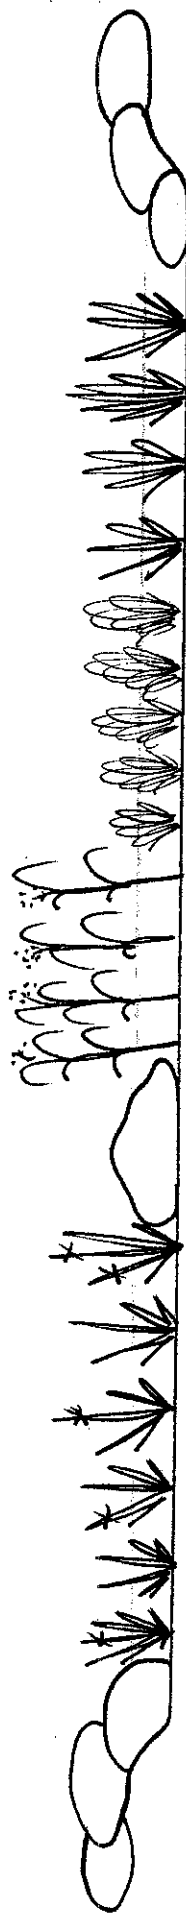
CROSS SECTION B MARSH ZONE

EPHEMERAL CREEK/MARSH ZONE. DENSELY PLANTED OUT FOR  
FROG HABITAT.

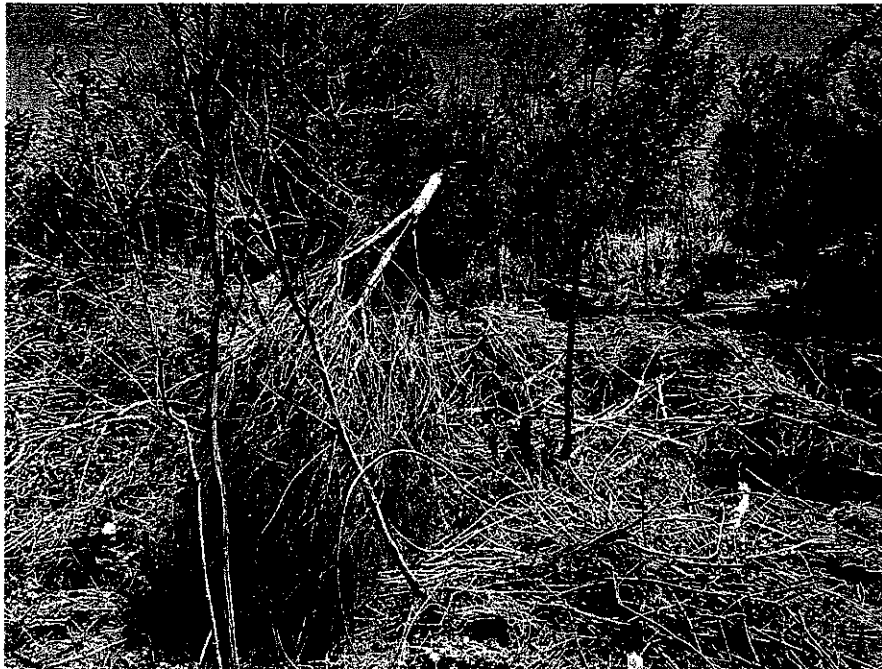
Plate 7. Downslope of waste-water systems (adjacent properties). Weeds species surrounding natives (Bottlebrush and Cheese Tree).

The cause of the existing weed plume should be controlled (Waste-water systems on adjacent land). Plate 7 shows entry area for nutrient rich water and recently cleared weed species.

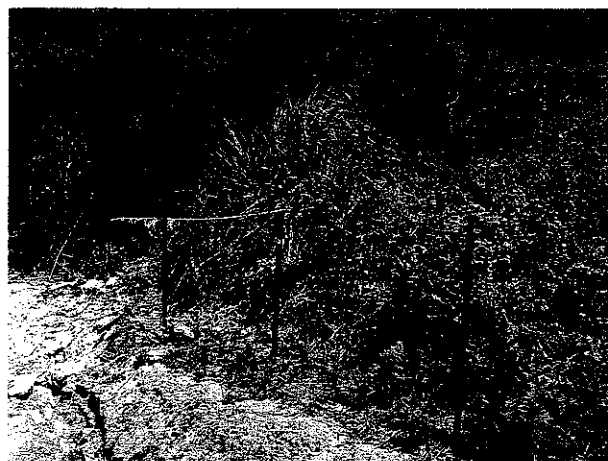
Plate 10. Mature Pampas Grass (and other weeds) on adjacent property, one seed head—most seeds have already dispersed.

Flower heads should always be removed as soon as they are seen. Flowerheads must be bagged in a long-lasting bag, or burnt. Once Flowerheads have been removed Pampas Grass can be controlled with applications of Glyphosate. Non-chemical control involves the removal of the flowerheads, then leaves, then removal of the crown by slicing or sawing below the foliage. Plants may grow back and removal of entire plants is sometimes necessary.

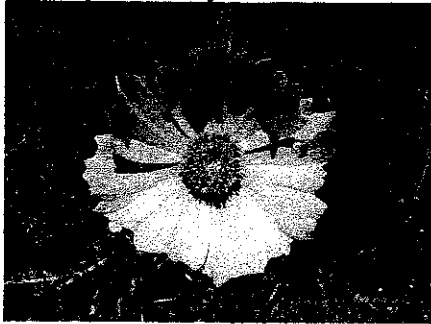
Nearby but not yet on the site.

Plate 11. Yellow Daisy,  
*Coreopsis lanceolata* growing  
~50m from the site.

Yellow Daisy, *Coreopsis lanceolata* is a weed species that would be a direct threat to the long-term survival of native species on the site. The Yellow Daisy is a vigorous grower and prolific seeder it quickly colonises areas and becomes dominant to the exclusion of native species (as can be seen along the Wakehurst Parkway). *Coreopsis lanceolata* should be removed from the site as soon as it is seen.

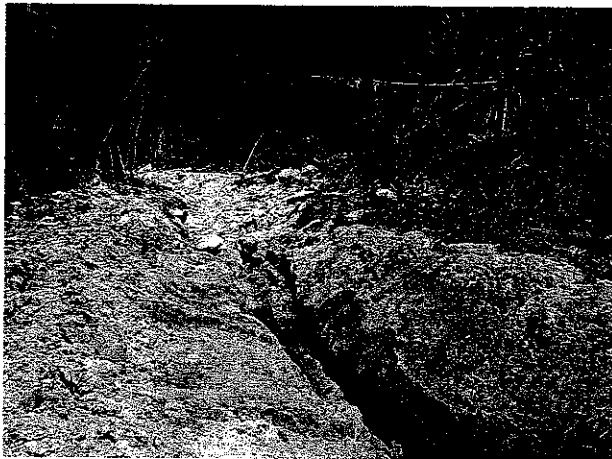
Plate13. Stormwater drainage ditch leading to wet/dry pond area.

This stormwater swale must be stabilised and planted ASAP (see Plate13). Hesion, coir, mulch mat or similar material should be used to line/stabilise the banks. Plants, particularly *Juncus* spp. should be planted into banks through stabilising material.

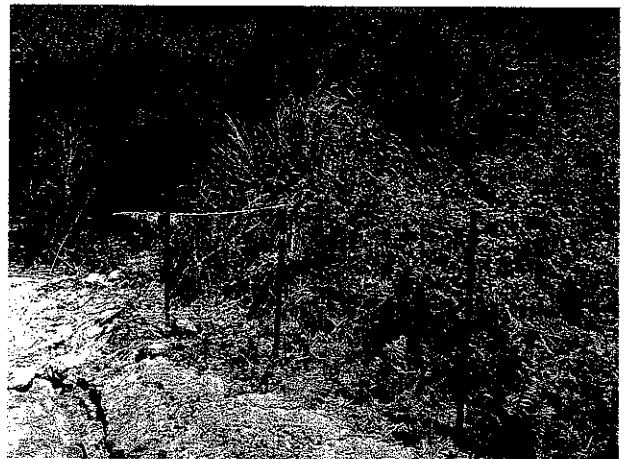
Plate 14. Stormwater drainage ditch showing weed plume and slope where water drains onto the site.

Stormwater from Boronia Road is not adequately managed and should be dealt with by the RTA/Council. Currently water is draining onto the site from the road and the adjacent property. A stormwater swale has been recently created to drain water off the site and direct it to an ephemeral pond (refer Flora and Fauna Report).
