Our Ref: 304600719/001/L001:PDT  
Contact: Doug Treloar

3 November 2022

**PROPOSED REDEVELOPMENT AT 518 BARRENJOEY ROAD, AVALON –  
COASTAL PROCESSES ASSESSMENT**

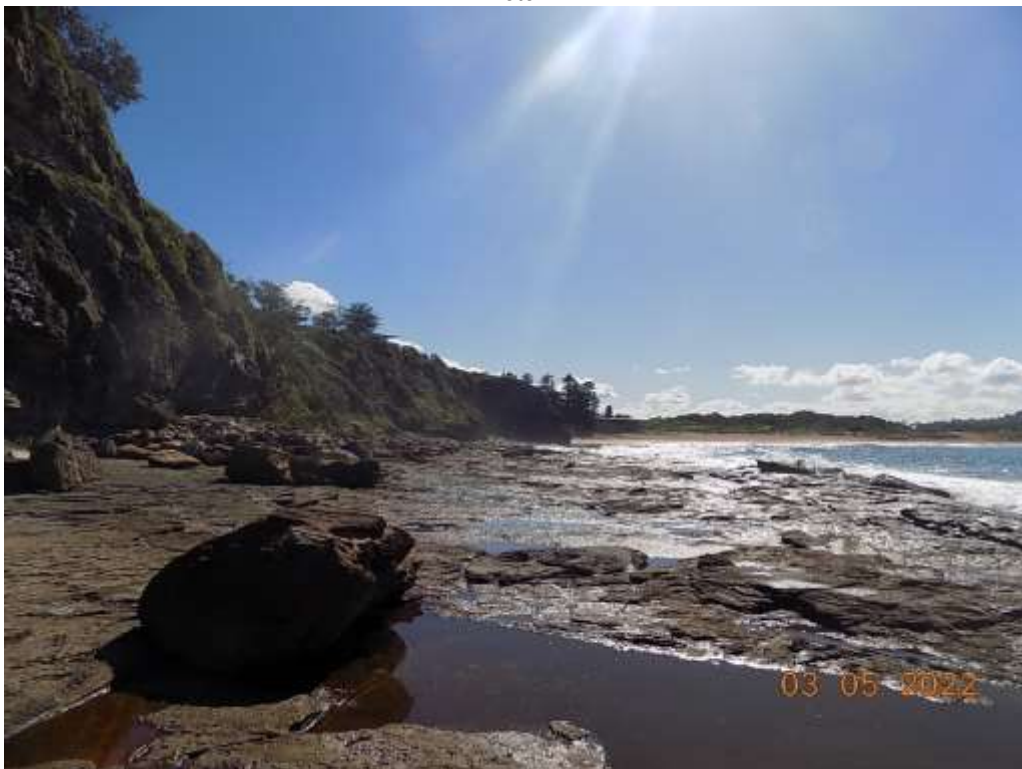
The White Geotechnical report provides images at the cliff base, please refer to photographs 7, 8 and 9, of their report in **Annexure B**. In terms of potential cliff stability failure, White Geotechnical have advised that the cliff face below the property is absent of any major undercutting or joints. Hence, apart from any minor failures, they consider the cliff face at this site to be stable.

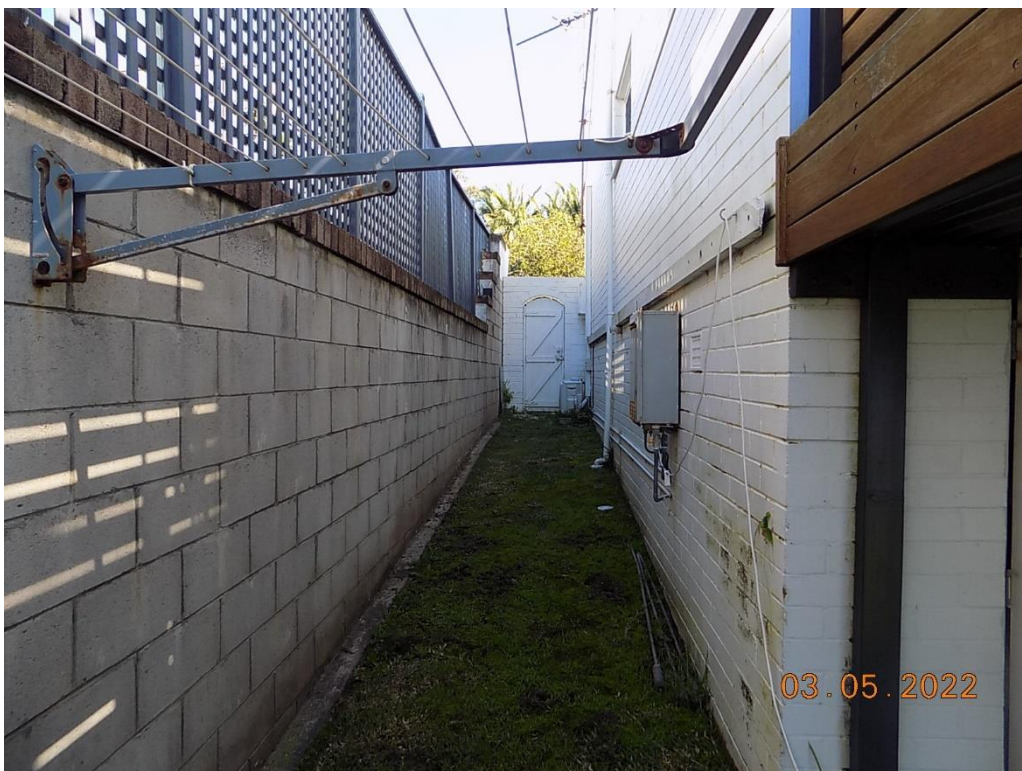
Photo 10

No geotechnical hazards were observed above or beside the property. The gently graded slope that rises and falls across the property and continues below is a potential hazard (**Hazard One**). The large sea cliff that drops vertically below the lower boundary of the property is a potential hazard (**Hazard Two**). The additional surcharge loads from the

proposed extension acting on the existing N boundary wall is a potential hazard (Photo 10) (Hazard Three).

| HAZARDS | Hazard One | Hazard Two | Hazard Three |
|---|---|---|---|
| COMMENTS | This level of risk is 'ACCEPTABLE'. | This level of risk is 'ACCEPTABLE'. | This level of risk to life and property is 'UNACCEPTABLE'. To move the risk to 'ACCEPTABLE' levels the recommendations in <b>Section 12</b> are to be followed. |
