GEOTECHNICAL INVESTIGATION

PROPOSED STORAGE BUILDING

4 CROSS STREET, BROOKVALE, NSW

Ref: 32885Srpt

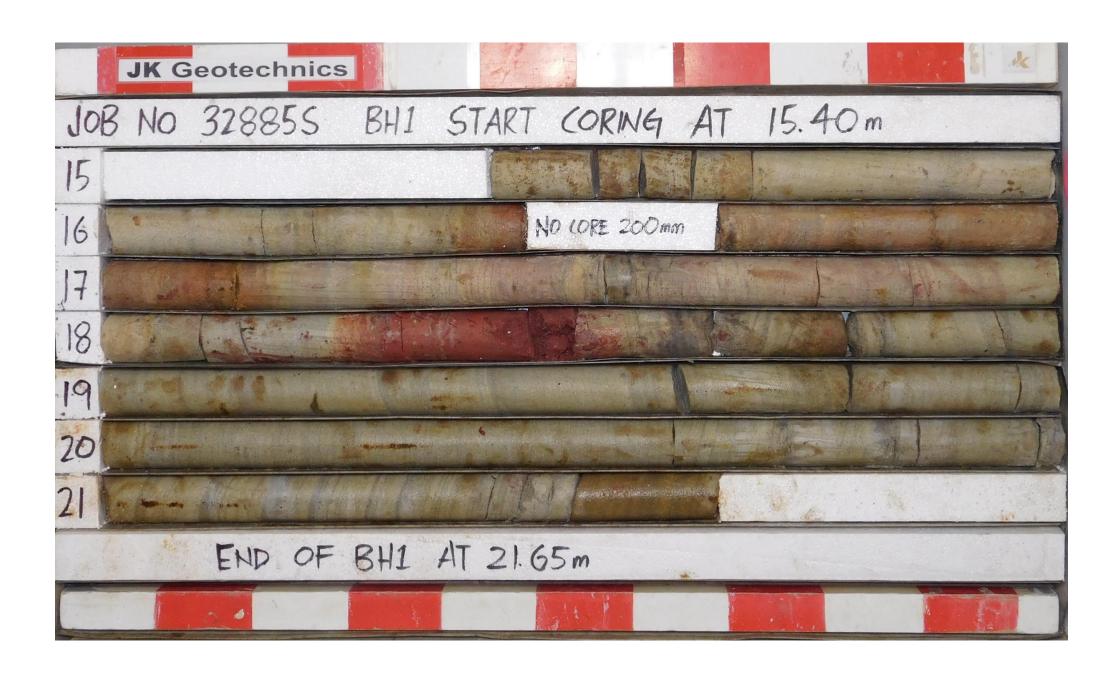
BOREHOLE LOG

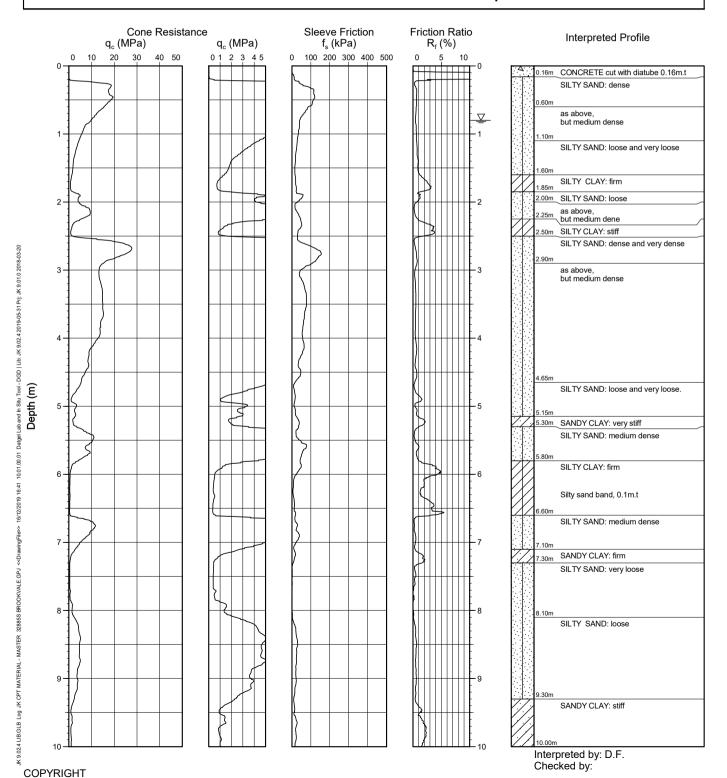
CONE PENETROMETER TEST RESULTS

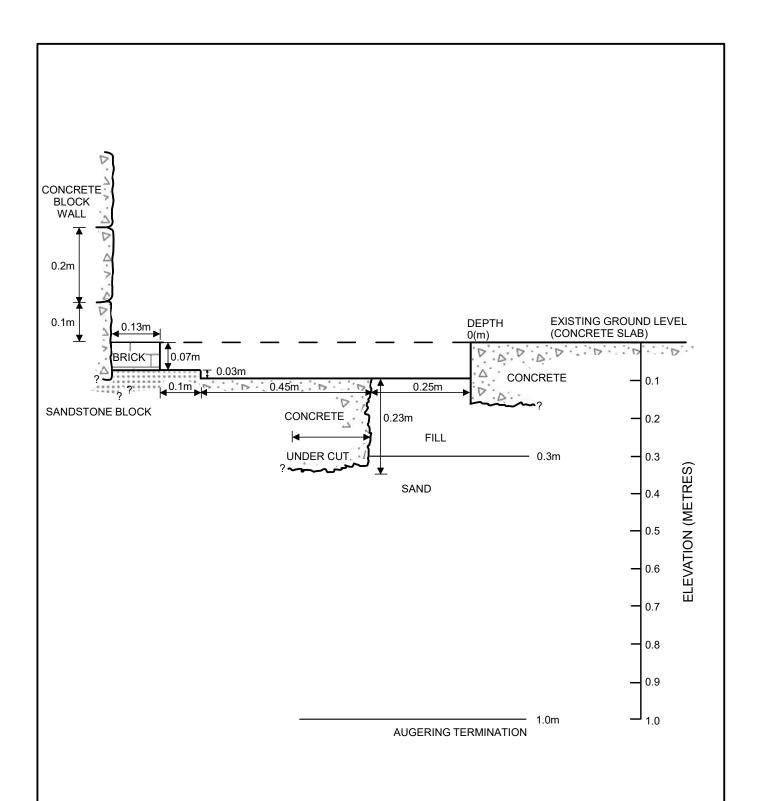
Figure No. 3

TEST PIT 6 CROSS SECTIONAL SKETCH LOOKING NORTH
