## KEIGHRAN GEOTECHNICS

**Re: Geotechnical Assessment  
New Double Garage and Dwelling  
145A Crescent Road - Newport**

## GEOTECHNICAL ASSESSMENT

**NEW DOUBLE GARAGE AND DWELLING  
145A CRESCENT ROAD  
NEWPORT**

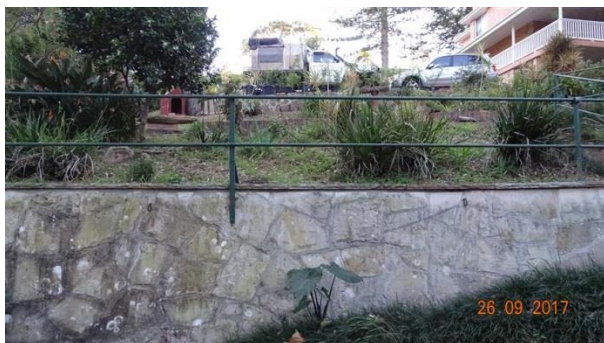
Western Side of Property Above Retaining Wall

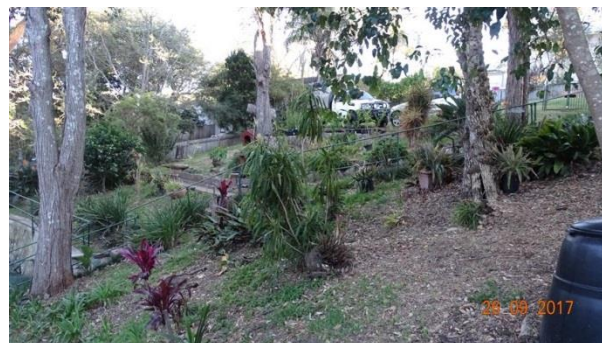
Western Side of Property from front of Dwelling
