Concrete Scan Report

ID: CSS1539AAR
19 Mar 2025

Client	Site
Synthetic paddle group 4/20-22 Yalgar Rd Kirrawee NSW 2232 Contact: Dane Salter (0447 899 239)	Voyager Tennis - Seaforth Upper Clontarf St Seaforth NSW 2092 Contact: Dane Salter (0447 899 239)

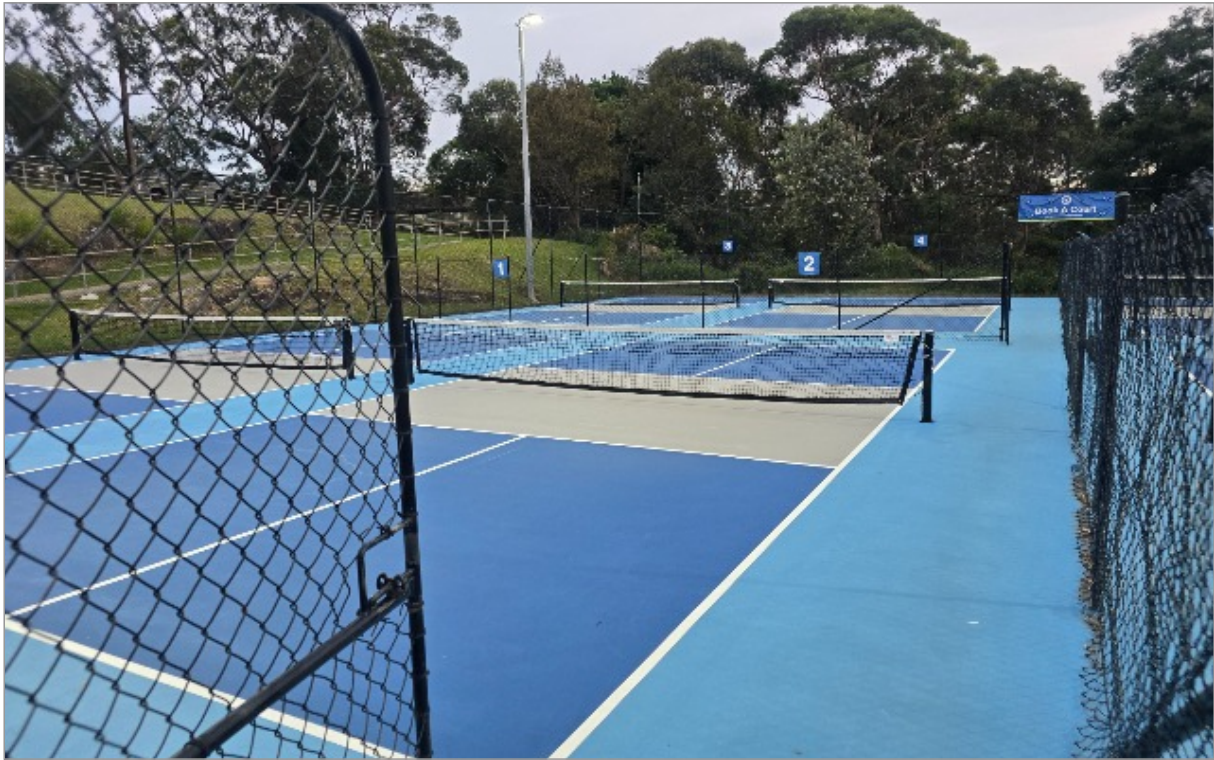
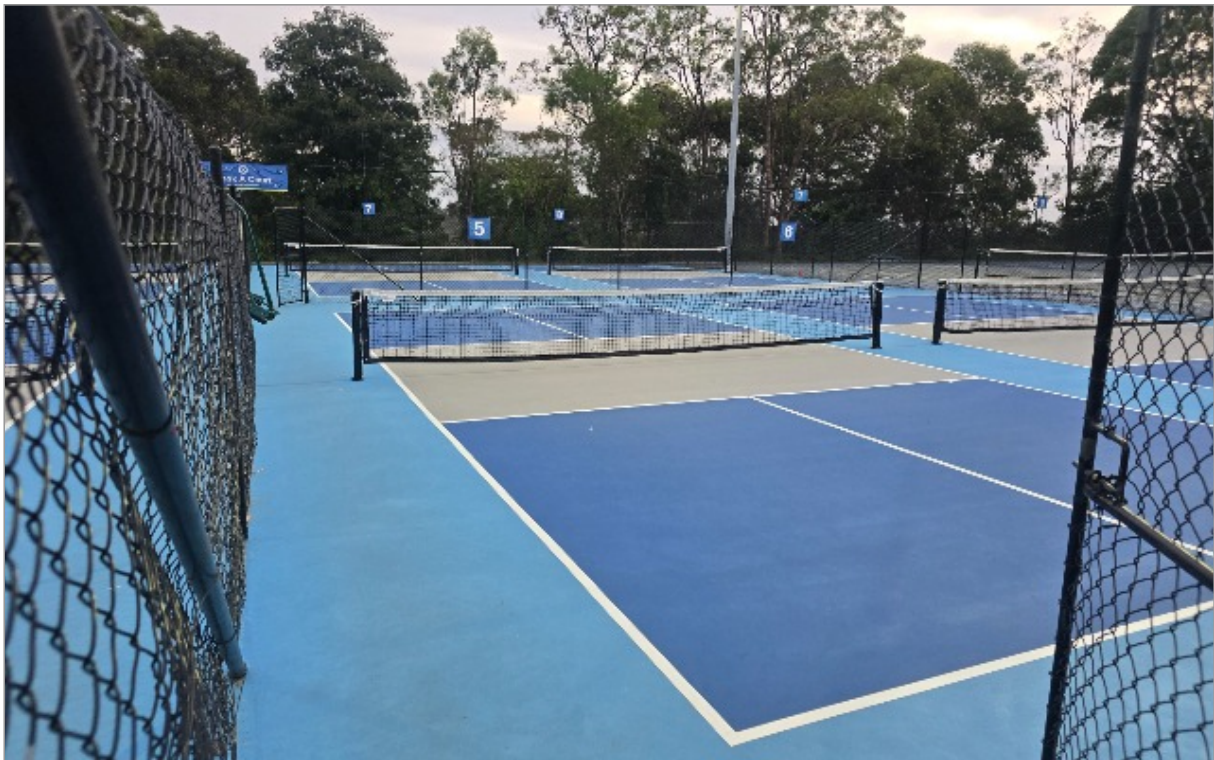
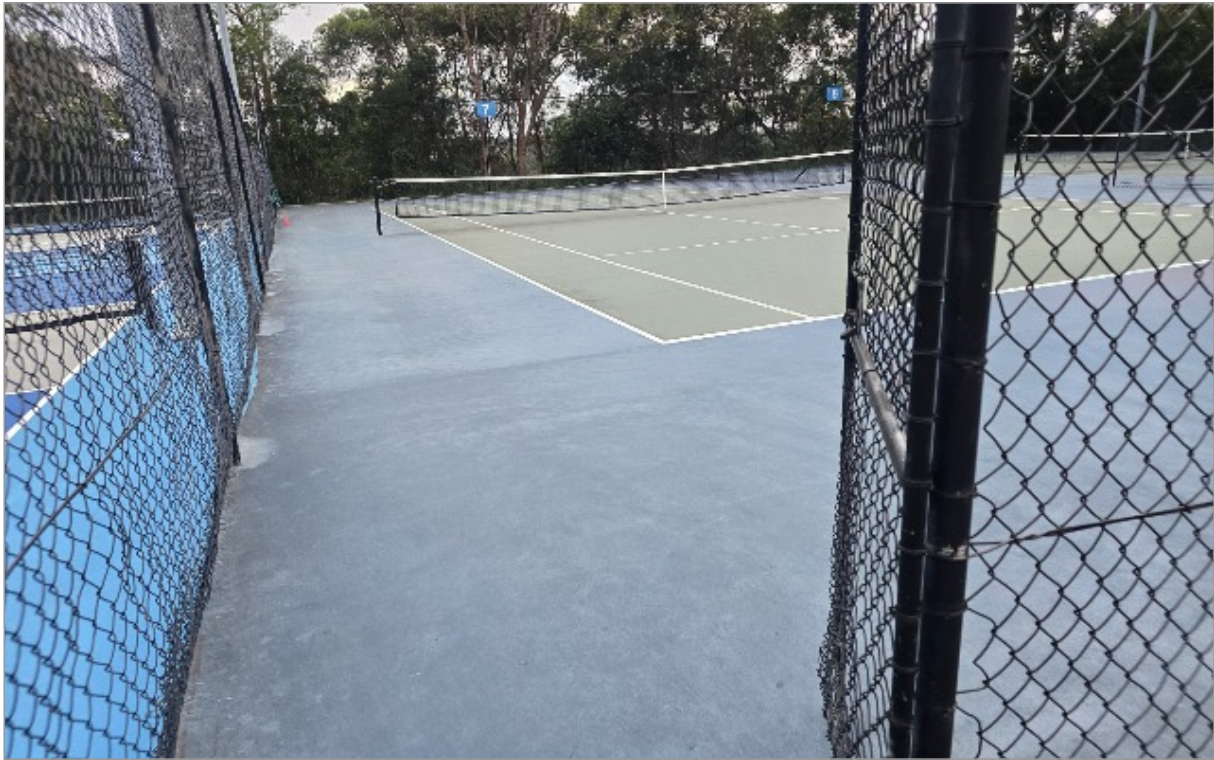
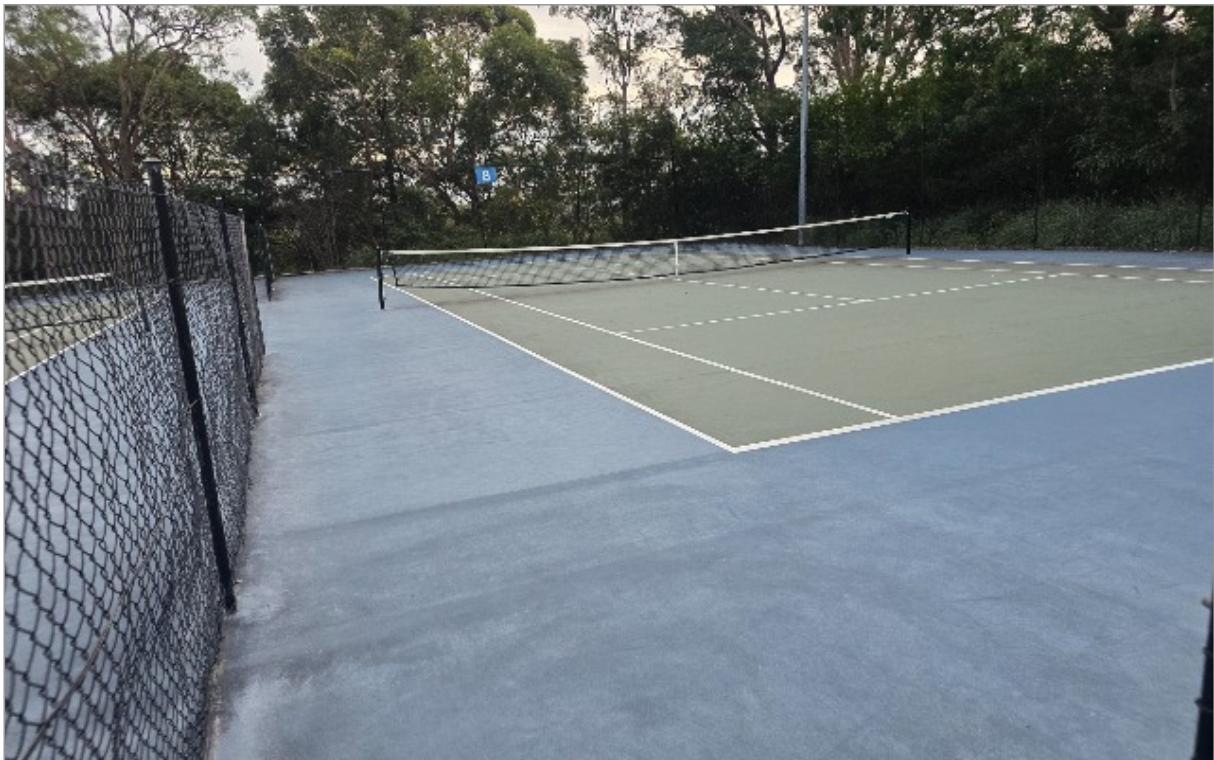
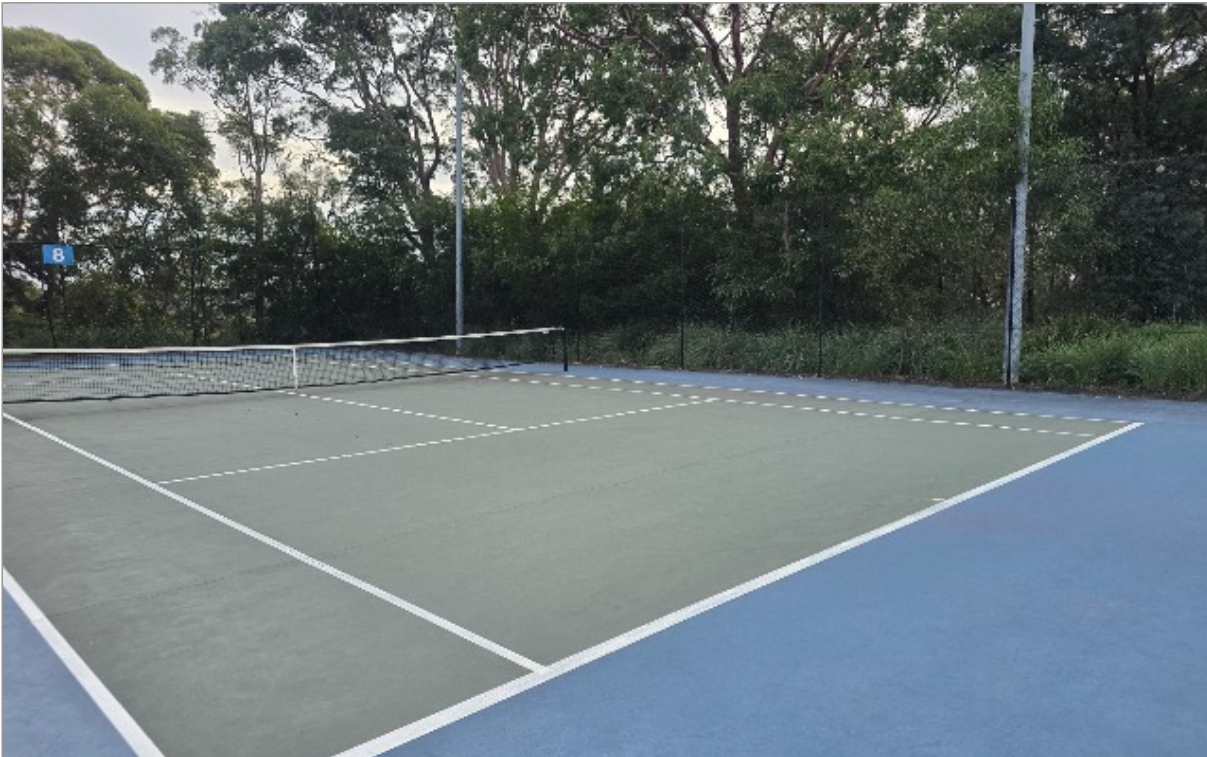
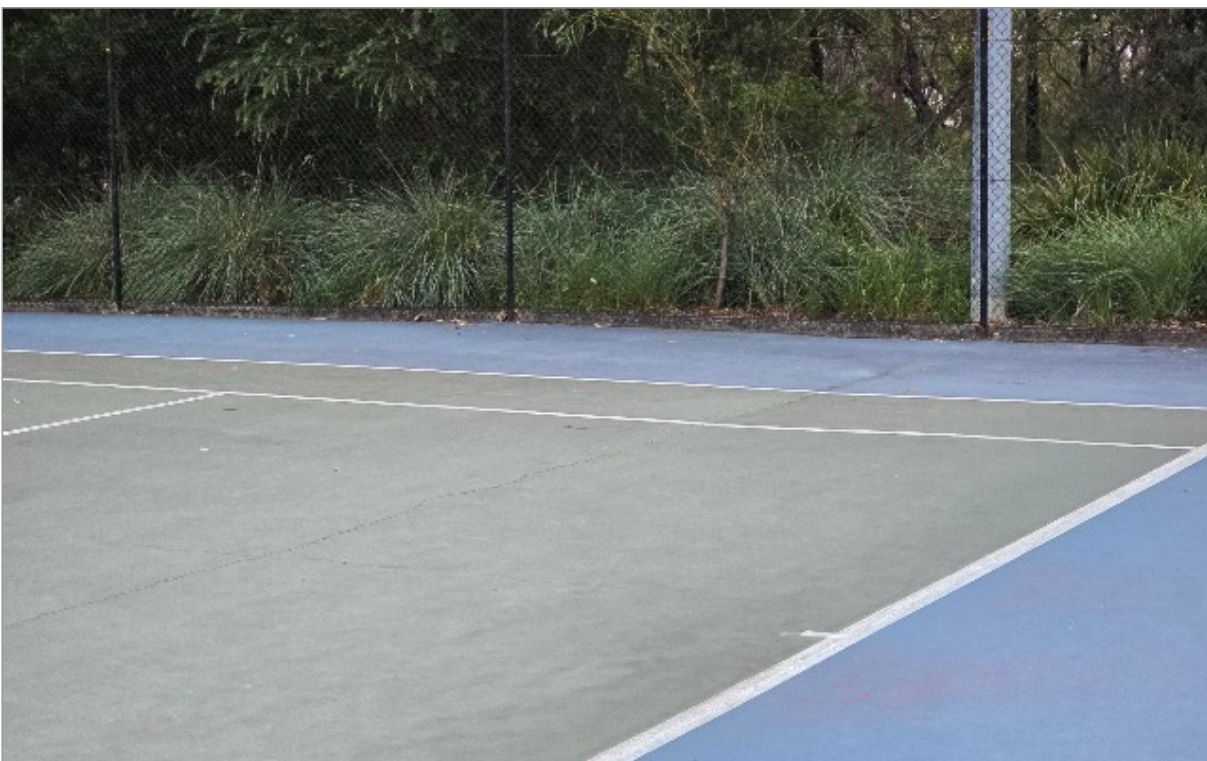
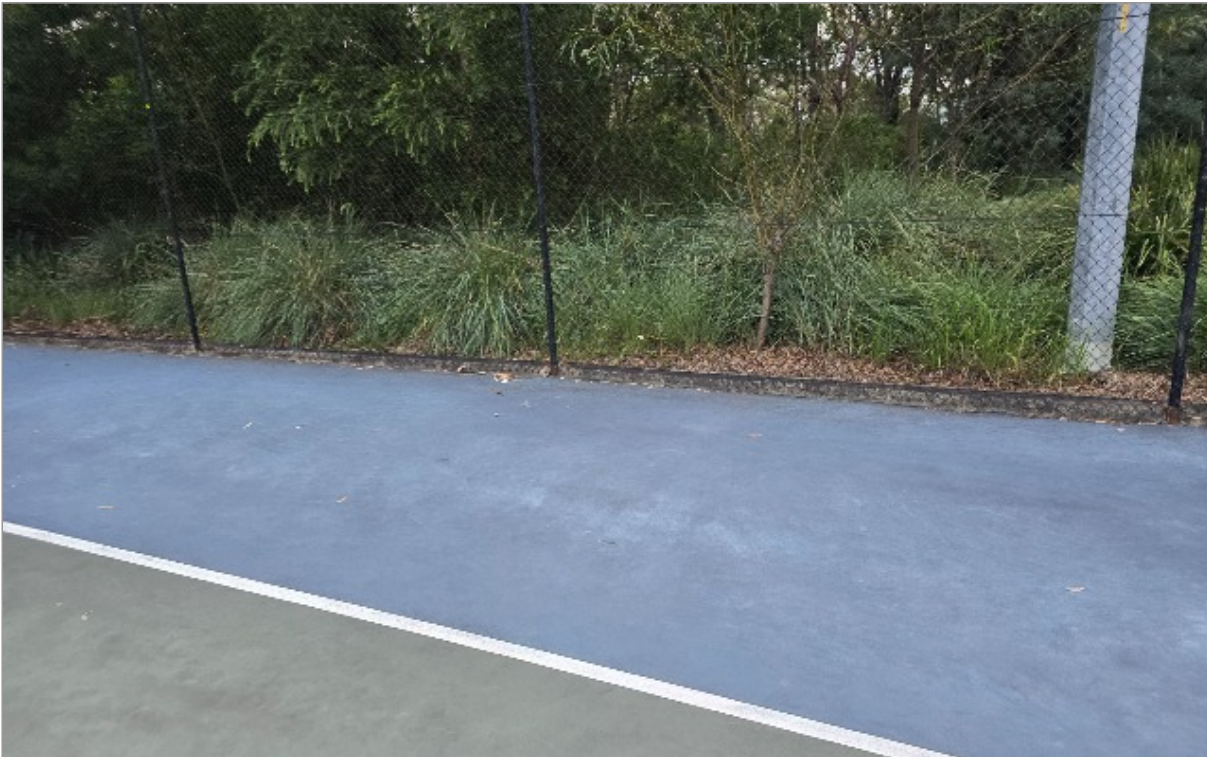
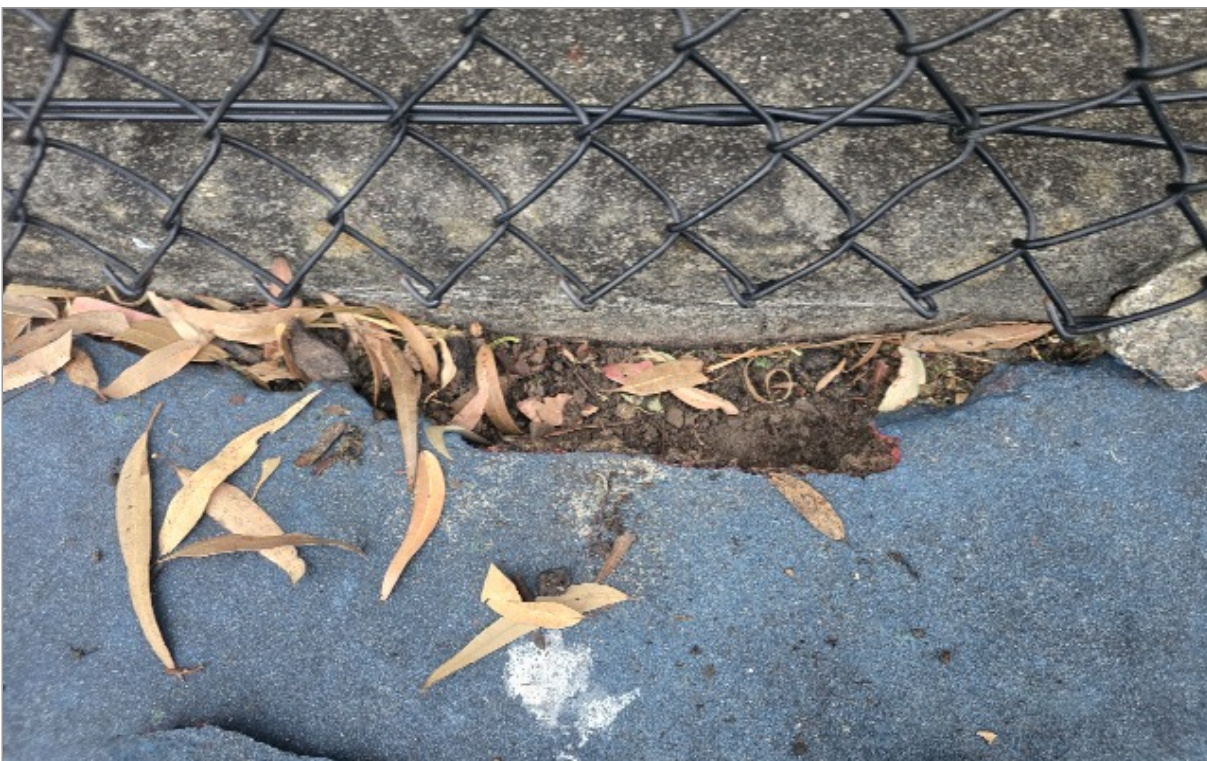
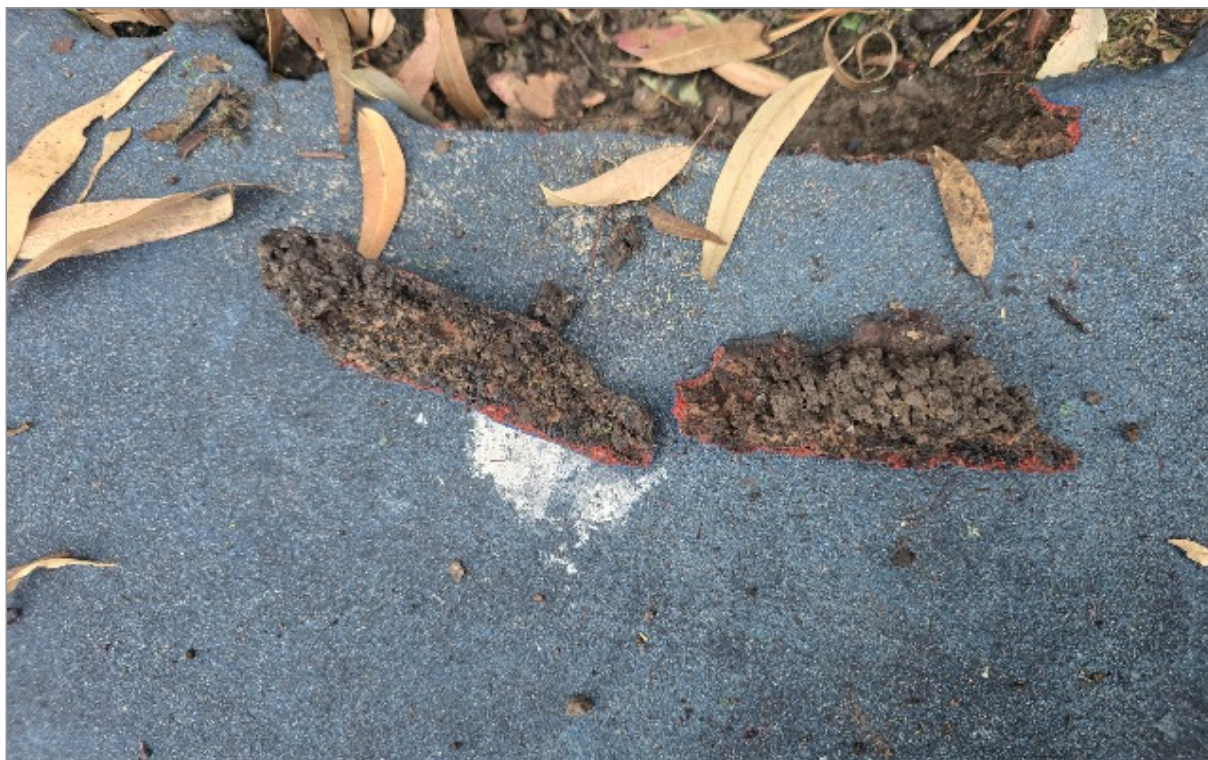
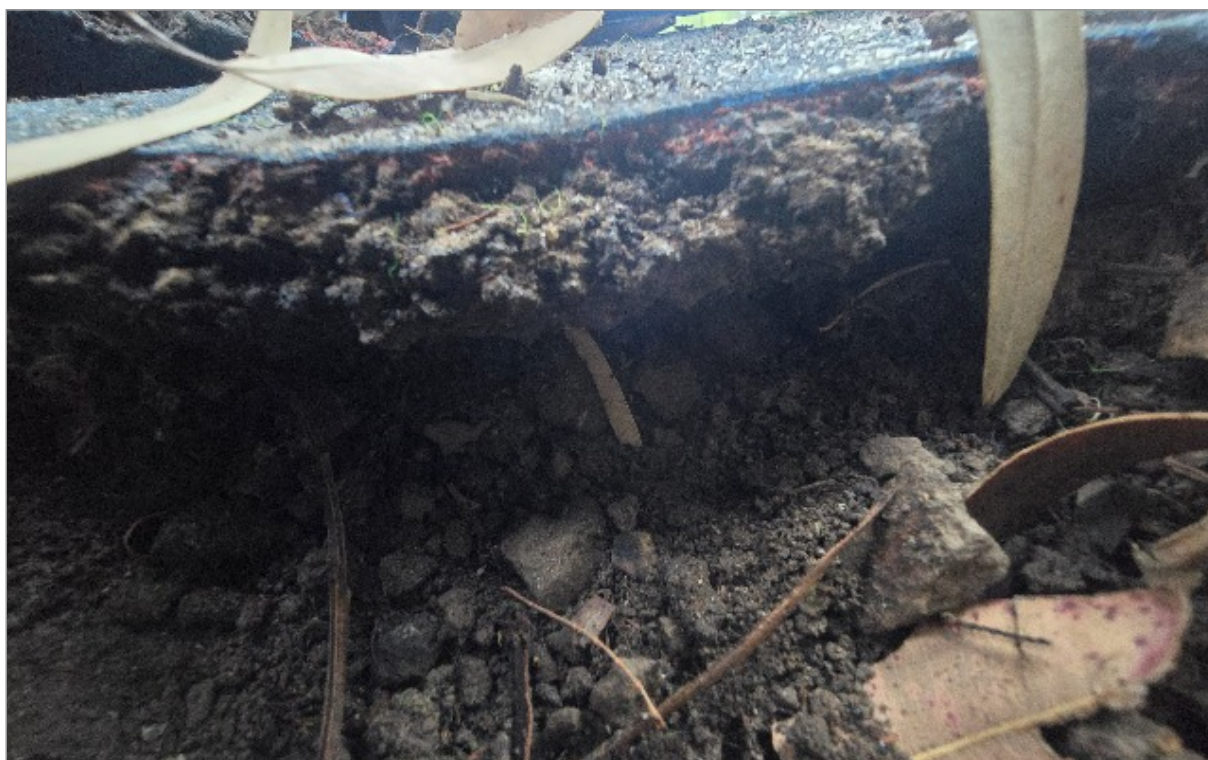
Information Summary
<p>Ground Penetrating Radar (GPR) and Covermeter scan of tennis court/pickle-ball courts to determine slab type and reinforcement presence.</p> <p>Scanned multiple locations to determine slab type. All courts scanned appear to be Asphaltic Concrete (AC) or similar. An exposed area was found at the far end of the courts (court 9, right hand side) where the slab material was visually inspected.</p> <p>Please see images below for markings/scan areas.</p>
