DESIGN CONFIDENCE

Fire & Life Safety Upgrade Strategy

Unit 1, 162 Harbord Road  
Brookvale

Project: Unit 1, 162 Harbord Road, Brookvale  
 Document Type: Fire and Life Safety Upgrade Strategy  
 Report Number: P217\_152-2 (FLSUS) NH

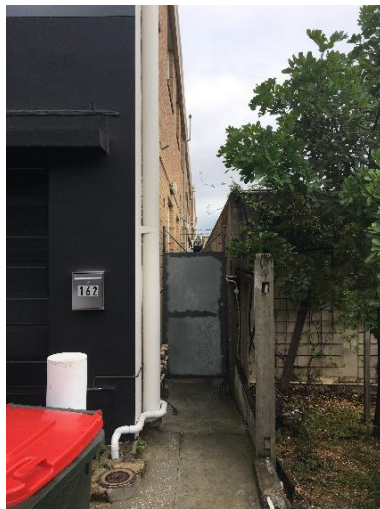
**Figure 5.2.1a** – East elevation

- (i) External walls consisting of masonry;

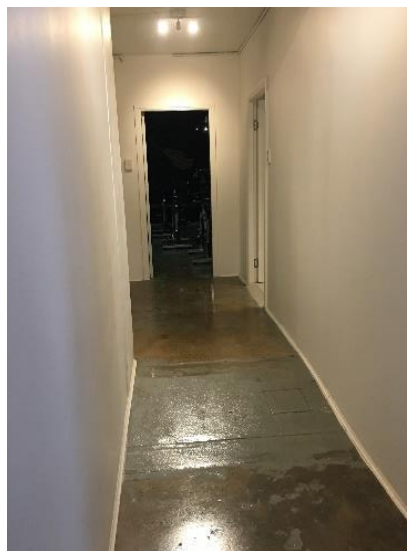
**Figure 5.2.2 – Internal walls and ceilings in the corridor**

The plasterboard used for walls and ceilings have unknown fire hazard properties.

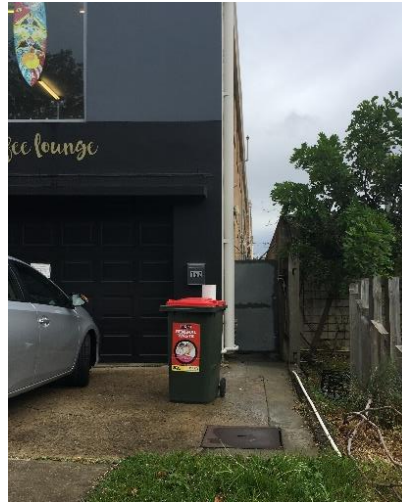
**Figure 5.2.3a** – Opening along the eastern elevation

In terms of exposure, the subject opening within the external wall of the eastern elevation is setback located ~1.8m perpendicular from the northern side boundary.

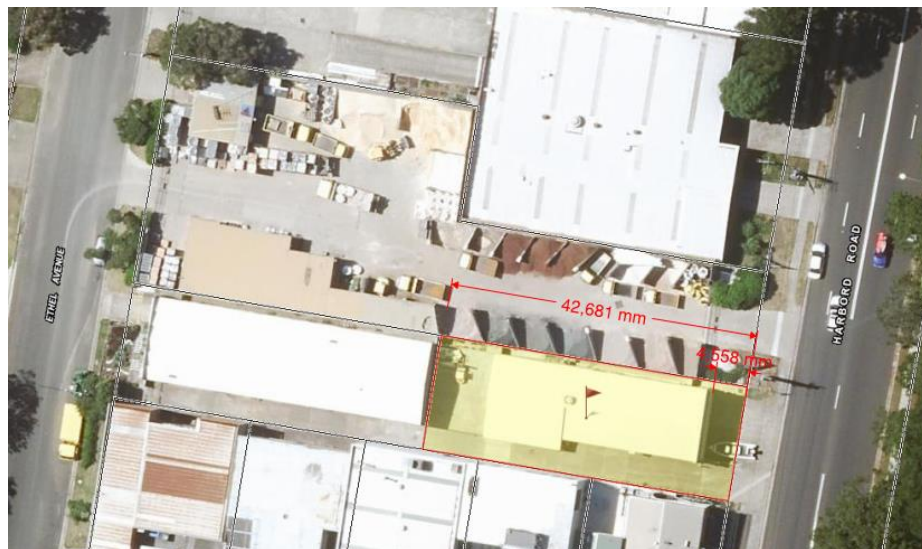
**Figure 5.2.3b** – Aerial plan indicating setbacks

In this regard, the risk of radiant heat exposure and fire spread to the neighbouring property is negligible on the basis the subject opening is set back ~5m from the front boundary and the neighbouring building on the allotment is set back ~ 40m from the front boundary.

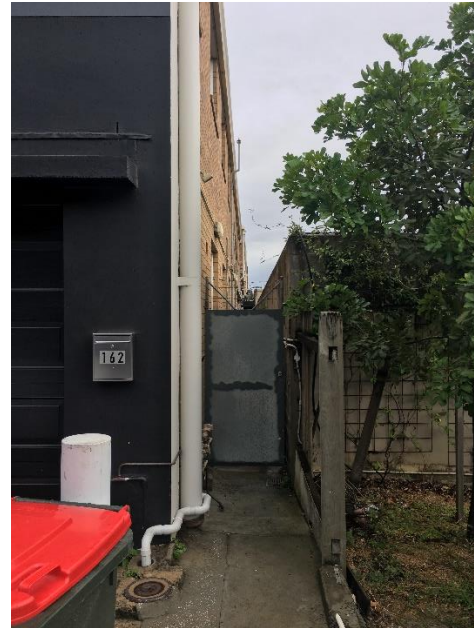
**Figure 5.2.3d** – view of external wall along northern boundary

It should be noted that the neighbouring boundary is comprised of core filled masonry blockwork to a height equal to or above the top sill of the doorways or windows located less than 3m from the boundary. Additionally, the building on the allotment is set back ~40m from the front boundary and the height variation between the top of the block work wall and the subject openings increases based on the sloping level of the land.

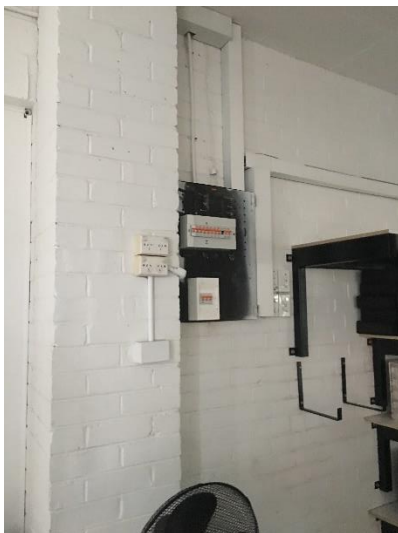
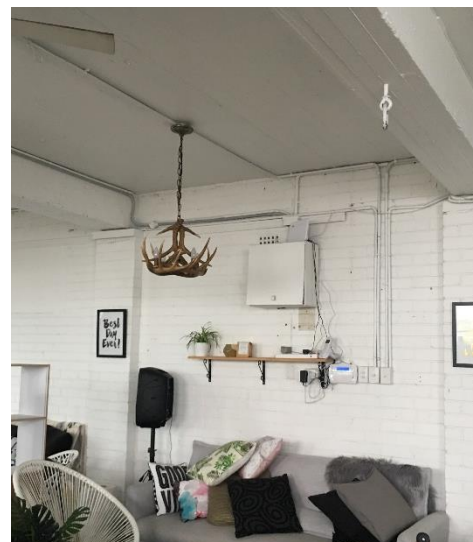
The central telecommunications board, electrical meter and distribution board located within the entry foyer and Yoga/ Pilate's room are not provided with a non-combustible enclosure or fire-protective covering.

**Figure 5.3.3a** – View of electrical meters / distribution boards 1

**Figure 5.3.3b** – View of electrical meters / distribution boards 2

| ITEM | DESCRIPTION OF PROBLEM | CLAUSE | EXTENT OF WORKS |
|---|---|---|---|
| 7. | The electrical meters, distribution board and central telecommunications board are not separated from the building with a non-combustible enclosure. | D2.7 | The electrical meters, distribution board and central telecommunications board are to be enclosed by non-combustible construction or fire protective covering and suitably sealed against smoke spread. |

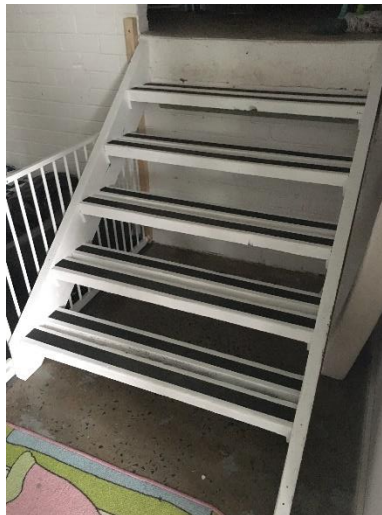
Figure 5.3.7 – Stairway serving the storage area

The stairway serving the storage area is not provided with at least one handrail to the stairway flight in accordance with Clause D2.17 of the BCA.

| ITEM | DESCRIPTION OF PROBLEM | CLAUSE | EXTENT OF WORKS |
|---|---|---|---|
| 11. | The stairway serving the storage area is not provided with a handrail to at least one side of the stairway flight. | D2.17 | (i) Provide a handrail to at least one side of the stairway flight complying with Clause D2.17 of the BCA; or<br>(ii) Demolish and decommission the subject stairway. |

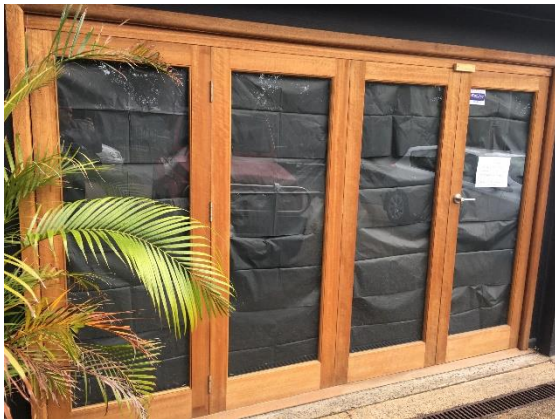
**Figure 5.3.8a** – Main entrance door

The main entrance door serving as a required exit door swings against the direction of egress.

| ITEM | DESCRIPTION OF PROBLEM | CLAUSE | EXTENT OF WORKS |
|---|---|---|---|
| 13. | (i) The main entrance door serving as a required exit, swings against the direction of egress; and<br>(ii) The swing door serving as a required exit, impedes in the path of egress to the road along the northern boundary. | D2.20 | (i) Nil, Council accept existing;<br>(ii) The main entrance doorway shall be fitted with a hold open device so as to remain open whilst the building is in use; and<br>(iii) The swing door discharging to the open space at the northern boundary shall be fitted with a hold open device so as to remain locked open when occupants discharge via the doorway. |

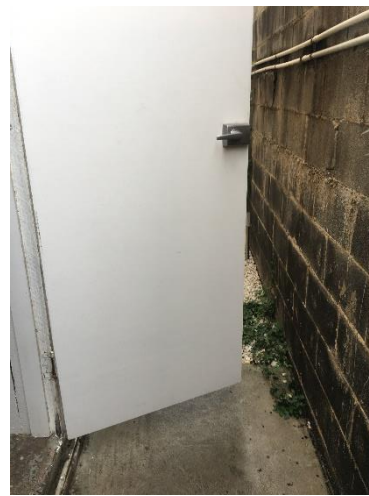
**Figure 5.3.8b** – Door impeding path of egress

The door located adjacent to the reception area, serving as a required exit impedes in the path of egress to the road along the northern boundary.

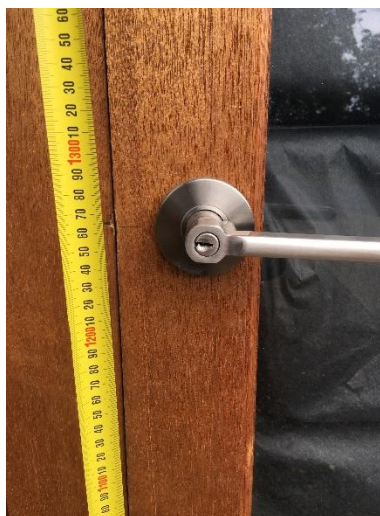
**Figure 5.3.9** – Height of operative latch

The operative latch of the door serving as the main entrance is provided at height above 1,100mm from the floor (being ~1,270mm).

| ITEM | DESCRIPTION OF PROBLEM | CLAUSE | EXTENT OF WORKS |
|---|---|---|---|
| 14. | The operational latch of the door serving as a required exits is located above 1,100mm from the floor. | D2.21 | The operational latch of the main entry door shall be relocated to a height 900mm-1,100mm above the floor level and operable without a key from the side that faces a person seeking egress in accordance with D2.21 of the BCA. |

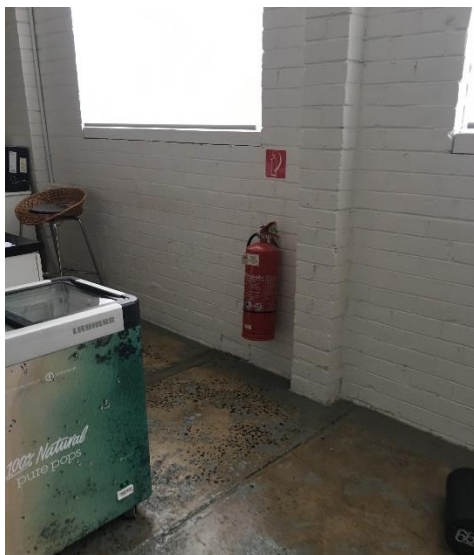
**Figure 5.4.3** – Portable fire extinguisher installed

The signage of the portable fire extinguishers installed are not in accordance with AS2444-2001 and not installed at height not less than 2.0m above the floor level.

| ITEM | DESCRIPTION OF PROBLEM | CLAUSE | EXTENT OF WORKS |
|---|---|---|---|
| 17. | Inadequate installation of portable fire extinguishers signage throughout the building. | E1.6 | Install portable fire extinguishers, including signage throughout the building in accordance with Clause E1.6 of the BCA and AS2444-2001. |

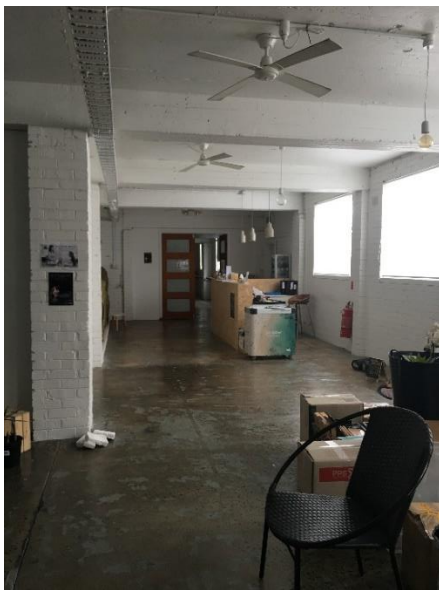
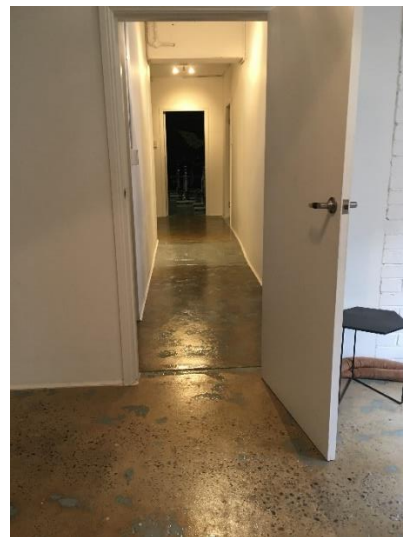
An exit sign is not provided above or adjacent to each door forming part of a required exit, and directional exit signage has not provided at appropriate positions to indicate the direction to a required exit.

**Figure 5.4.5c** – No directional exit signage

**5.4.5d** – No directional exit signage above doorway

| ITEM | DESCRIPTION OF PROBLEM | CLAUSE | EXTENT OF WORKS |
|---|---|---|---|
| 19. | Inadequate provision of exit signage throughout the building. | E4.5 | Install exit signage (incl. directional signage) throughout all parts of the building in accordance with Clause E4.5, E4.6 & E4.8 of the BCA and AS2293.1-2005. |
