GEOTECHNICAL INVESTIGATION

ST LUKES GRAMMAR SCHOOL, 1973 PITTWATER ROAD, BAYVIEW

REPORT GG10708.001A

17 OCTOBER 2022

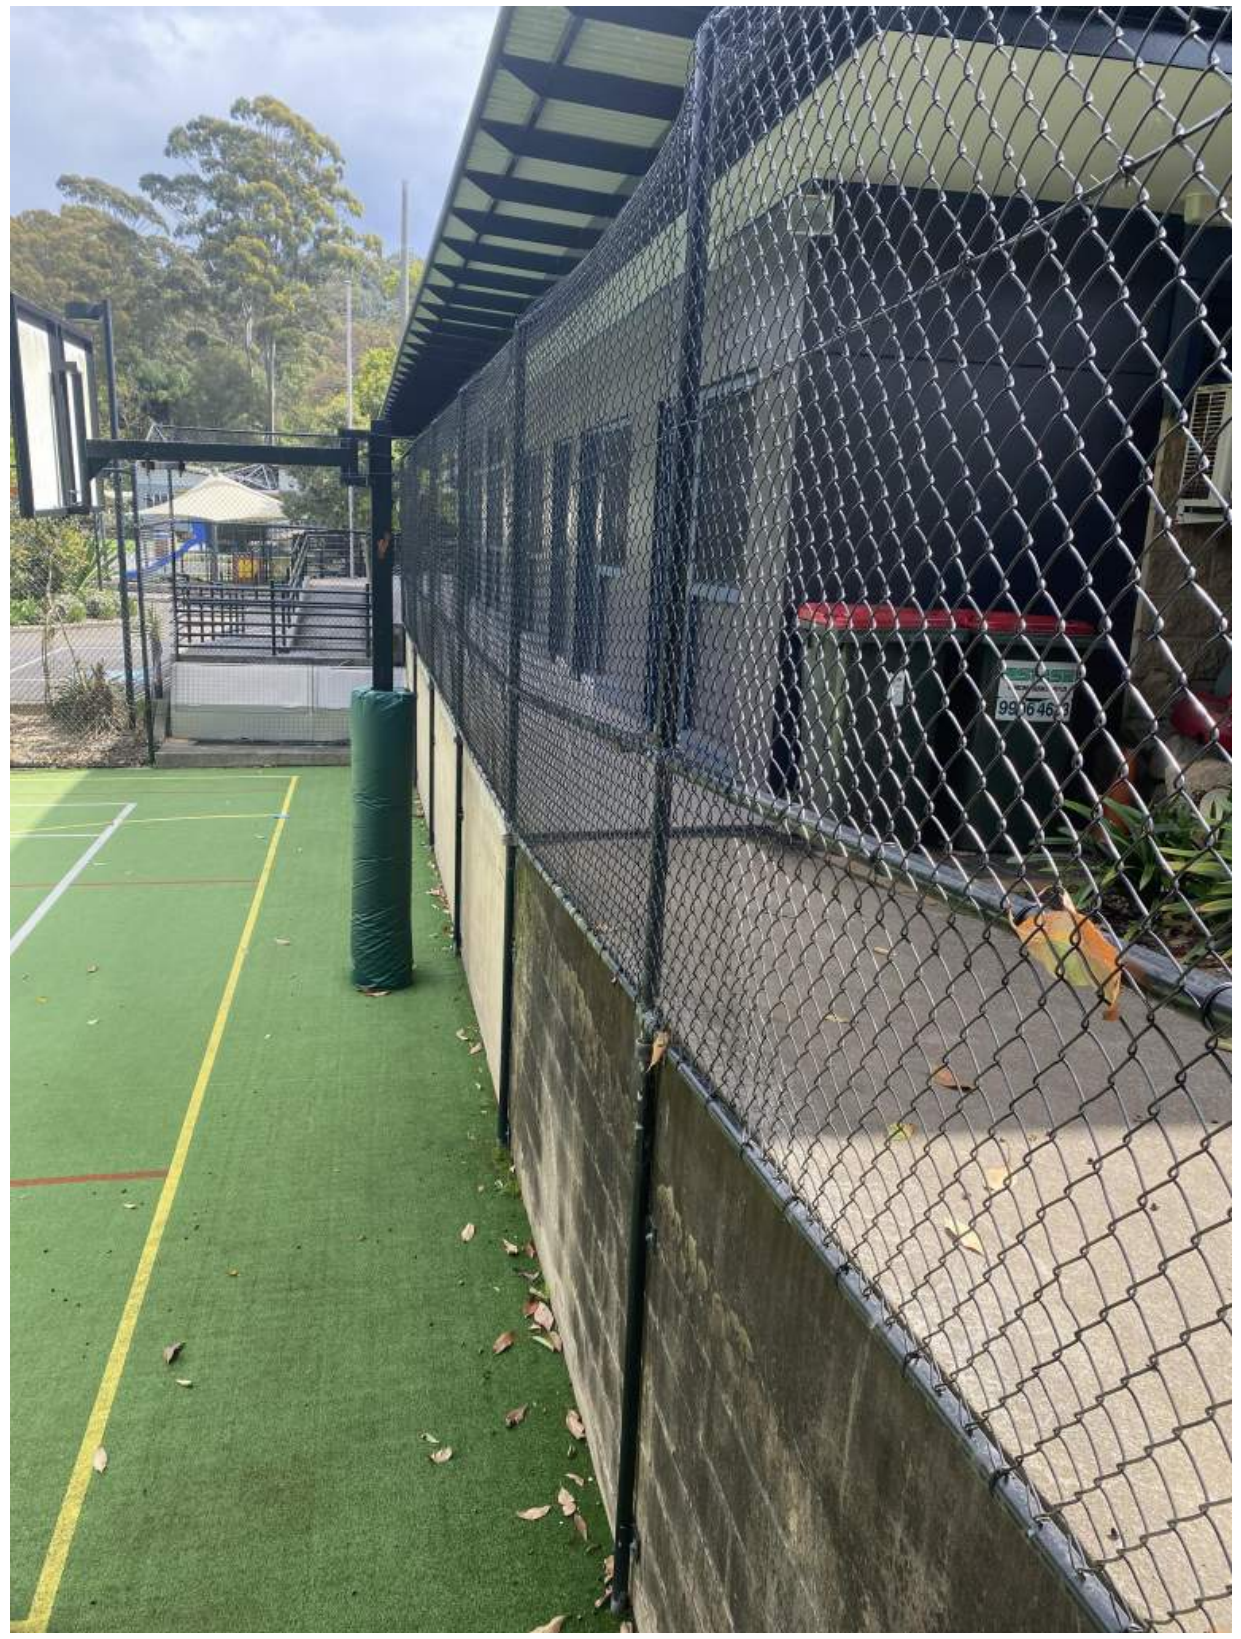
There are numerous retaining walls on the site which vary in height from around 0.6 metres to up to 1.5 metres. The walls are constructed of a combination of brick and concrete block and appear in good condition. There are exposed soil slopes below the suspended school structures with slope angles up to 15°.

Retaining walls on north western boundary
