27 July 20232
Our ref: JOE/S1589

Proposed Knockdown Rebuild – 272 Whale Beach Road, Whale Beach, NSW
Site Classification & Slope Stability Risk Assessment Report

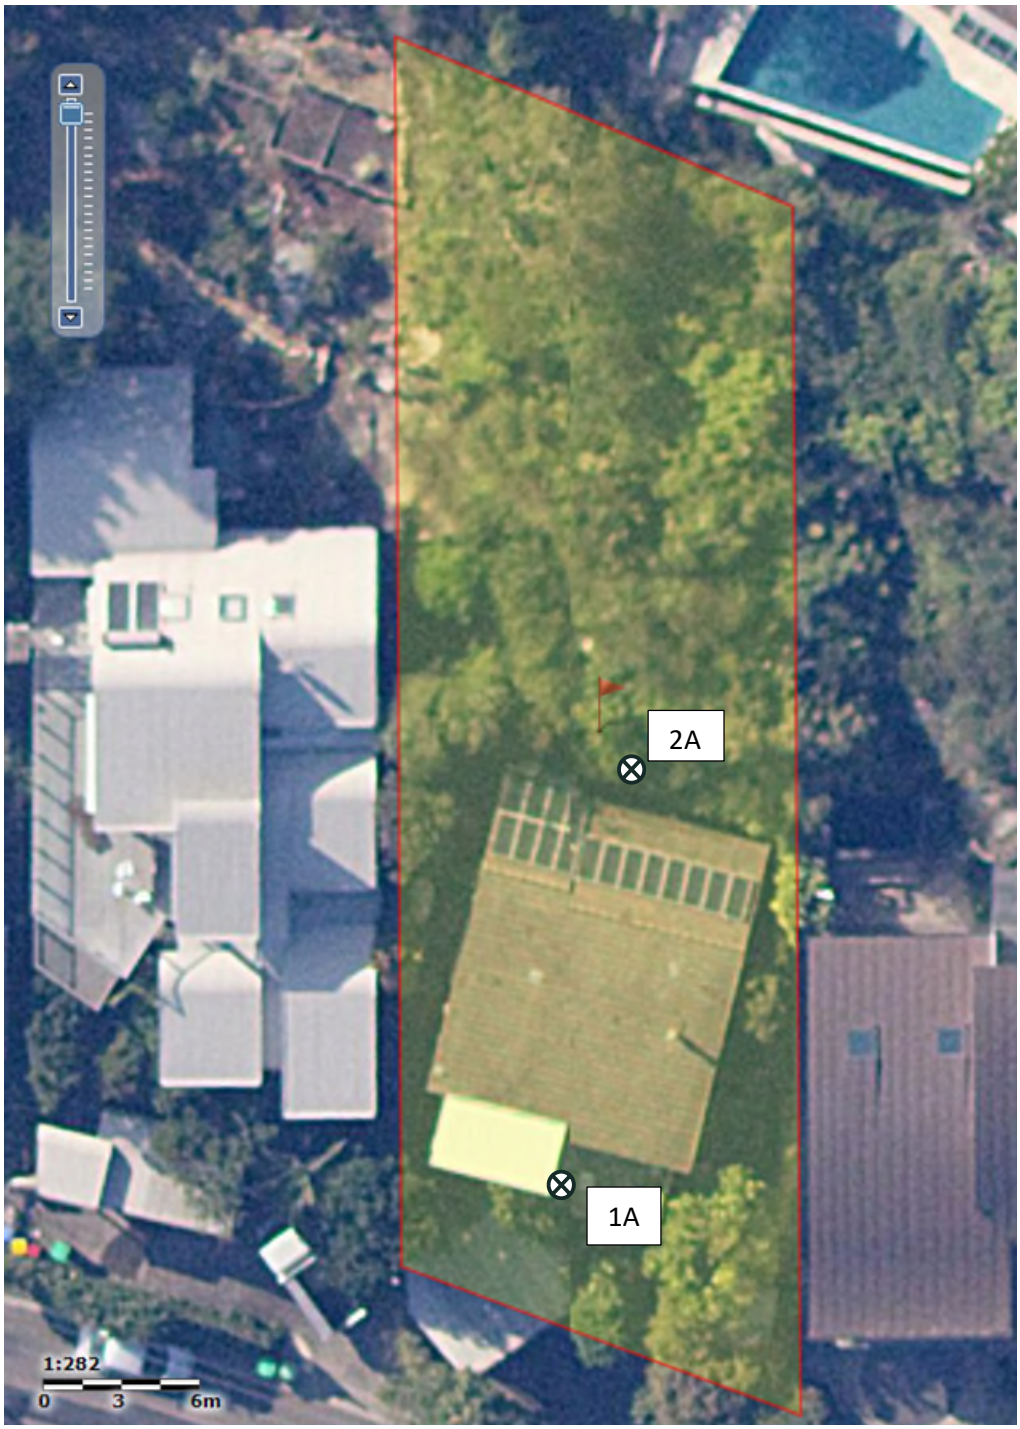
AERIAL PHOTOGRAPH AND BOREHOLE LOCATIONS	S1589	FIGURE 2

To establish the site subsurface conditions, a handheld hydraulic push-tube was used to excavate two boreholes on the property. Borehole 1A was drilled at the front of the property, and borehole 2A was drilled at the rear of the property. The subsurface profile was logged in accordance with the Unified Soil Classification System (USCS) and the logs are attached to the end of this report. Dynamic Cone Penetrometer (DCP) testing was conducted near the location of borehole 1A. Figure 2 is an aerial photograph showing the approximate borehole locations.

The site is located on 272 Whale Beach Road, Whale Beach, NSW. The ~700m^2 site is presently occupied by an existing residence towards the southern end of the block. The northern side of the block is covered by thick vegetation with visible sandstone bedrock. The site dips to the south at ~36^o. There is no evidence of deep existing site cuts or large-scale placement of fill. Figure 1 shows the site locality, whilst Figure 2 is a recent aerial photograph which also shows the approximate borehole locations.

The subsurface conditions of the proposed development were investigated by two boreholes designated 1A and 2A. Borehole 2A was conducted just behind a 0.6m high retaining wall. The borehole logs in Appendix A can be referred to for more detail.
