GEOTECHNICAL INVESTIGATION:

New Seniors Housing Complex at **36 Bardo Road, Newport**

SITE PLAN – showing test locations

TYPE SECTION – Diagrammatical Interpretation of expected Ground Materials

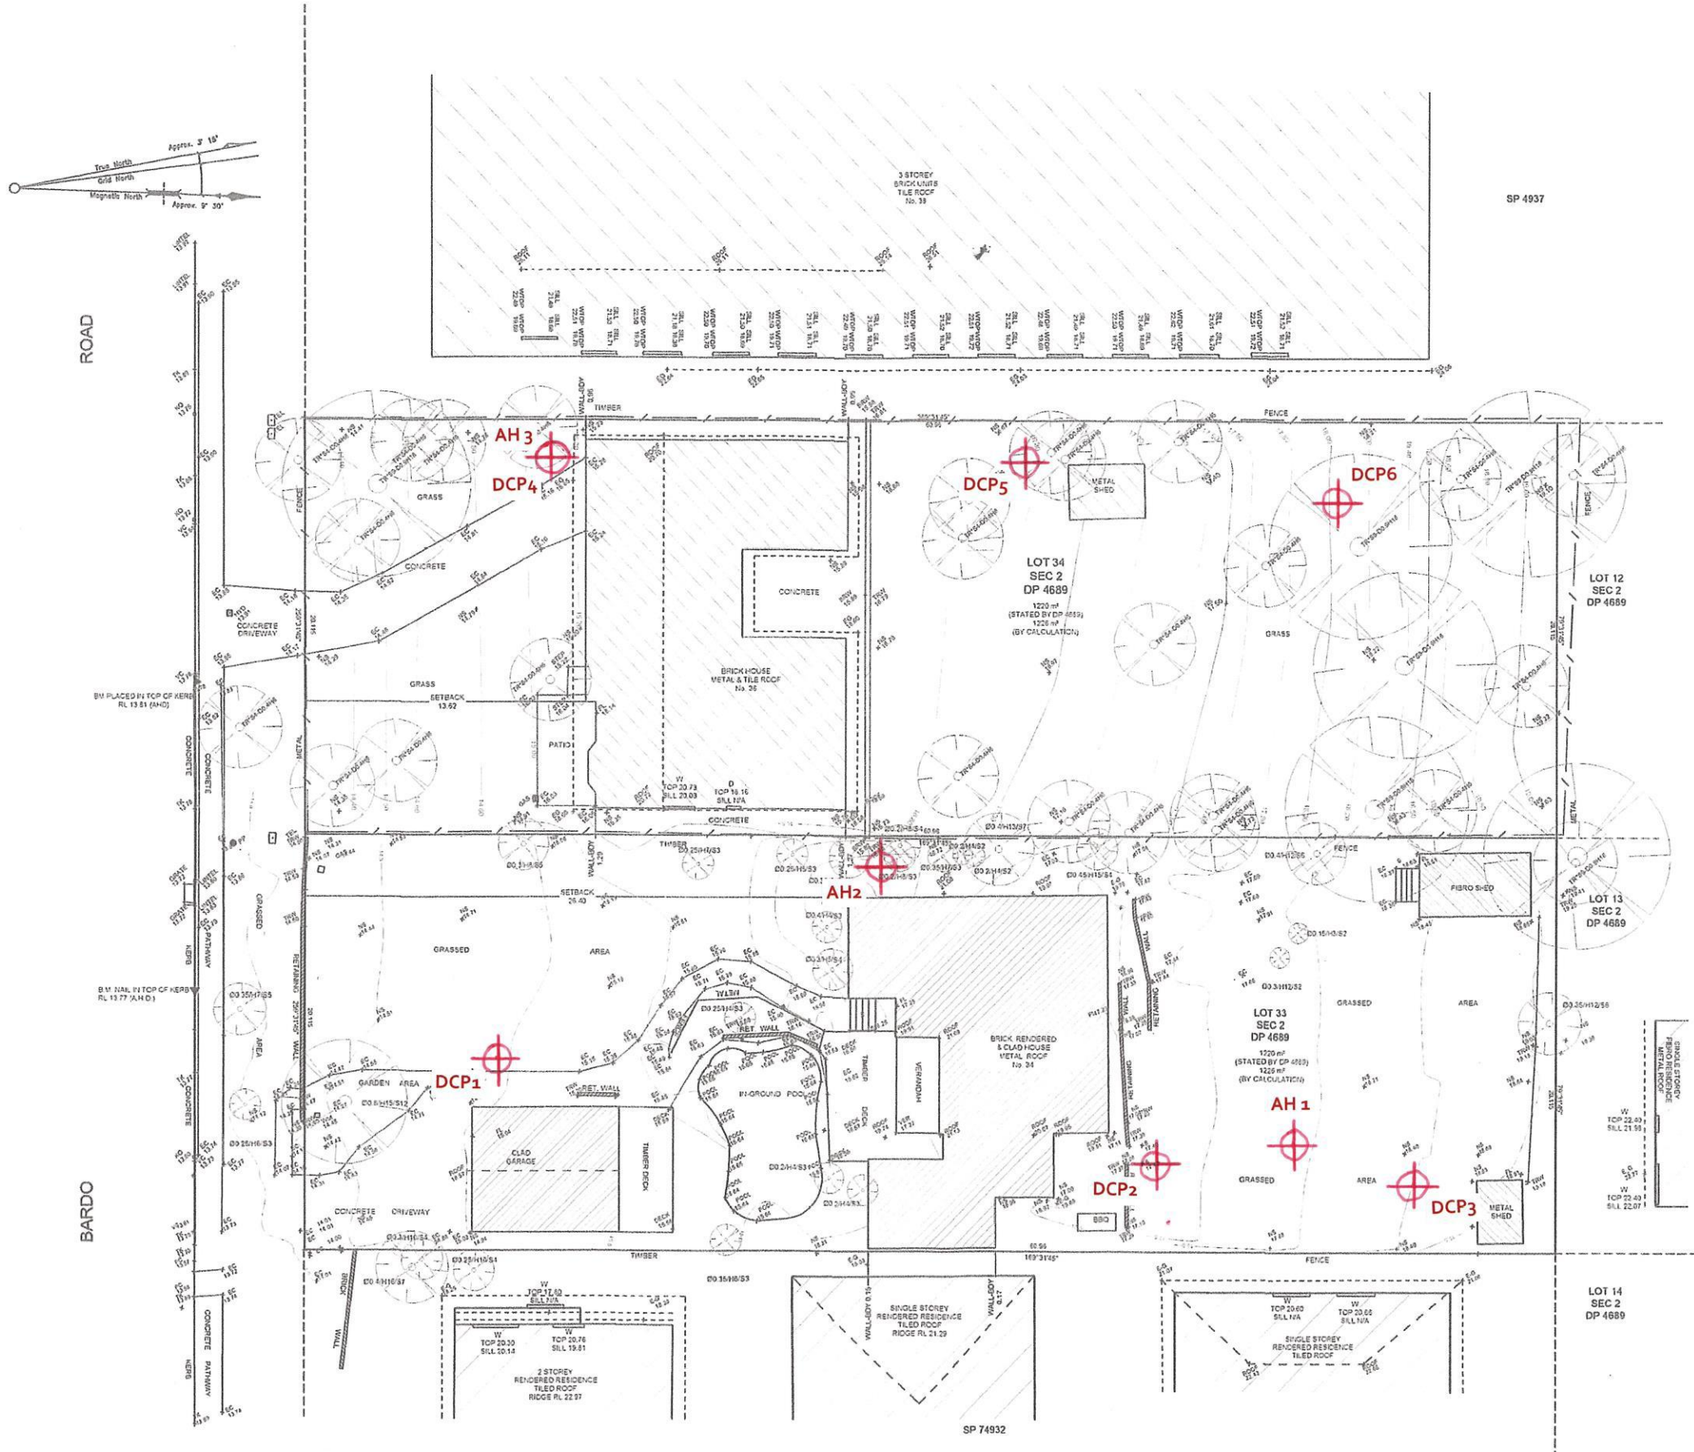
Three hand Auger Holes (AH) were put down to identify the soil materials. Six Dynamic Cone Penetrometer (DCP) tests were put down to determine the relative density of the overlying soil and the depth to weathered rock. The locations of the tests are shown on the site plan attached. It should be noted that a level of caution should be applied when interpreting DCP test results. The test will not pass through hard buried objects so in some instances it can be difficult to determine whether refusal has occurred on an obstruction in the profile or on the natural rock surface. This is not expected to be an issue for the testing on this site. However, excavation and foundation budgets should always allow for the possibility that the interpreted ground conditions in this report vary from those encountered during excavations. See the appended "Important information about your report" for a more comprehensive explanation. The results are as follows:

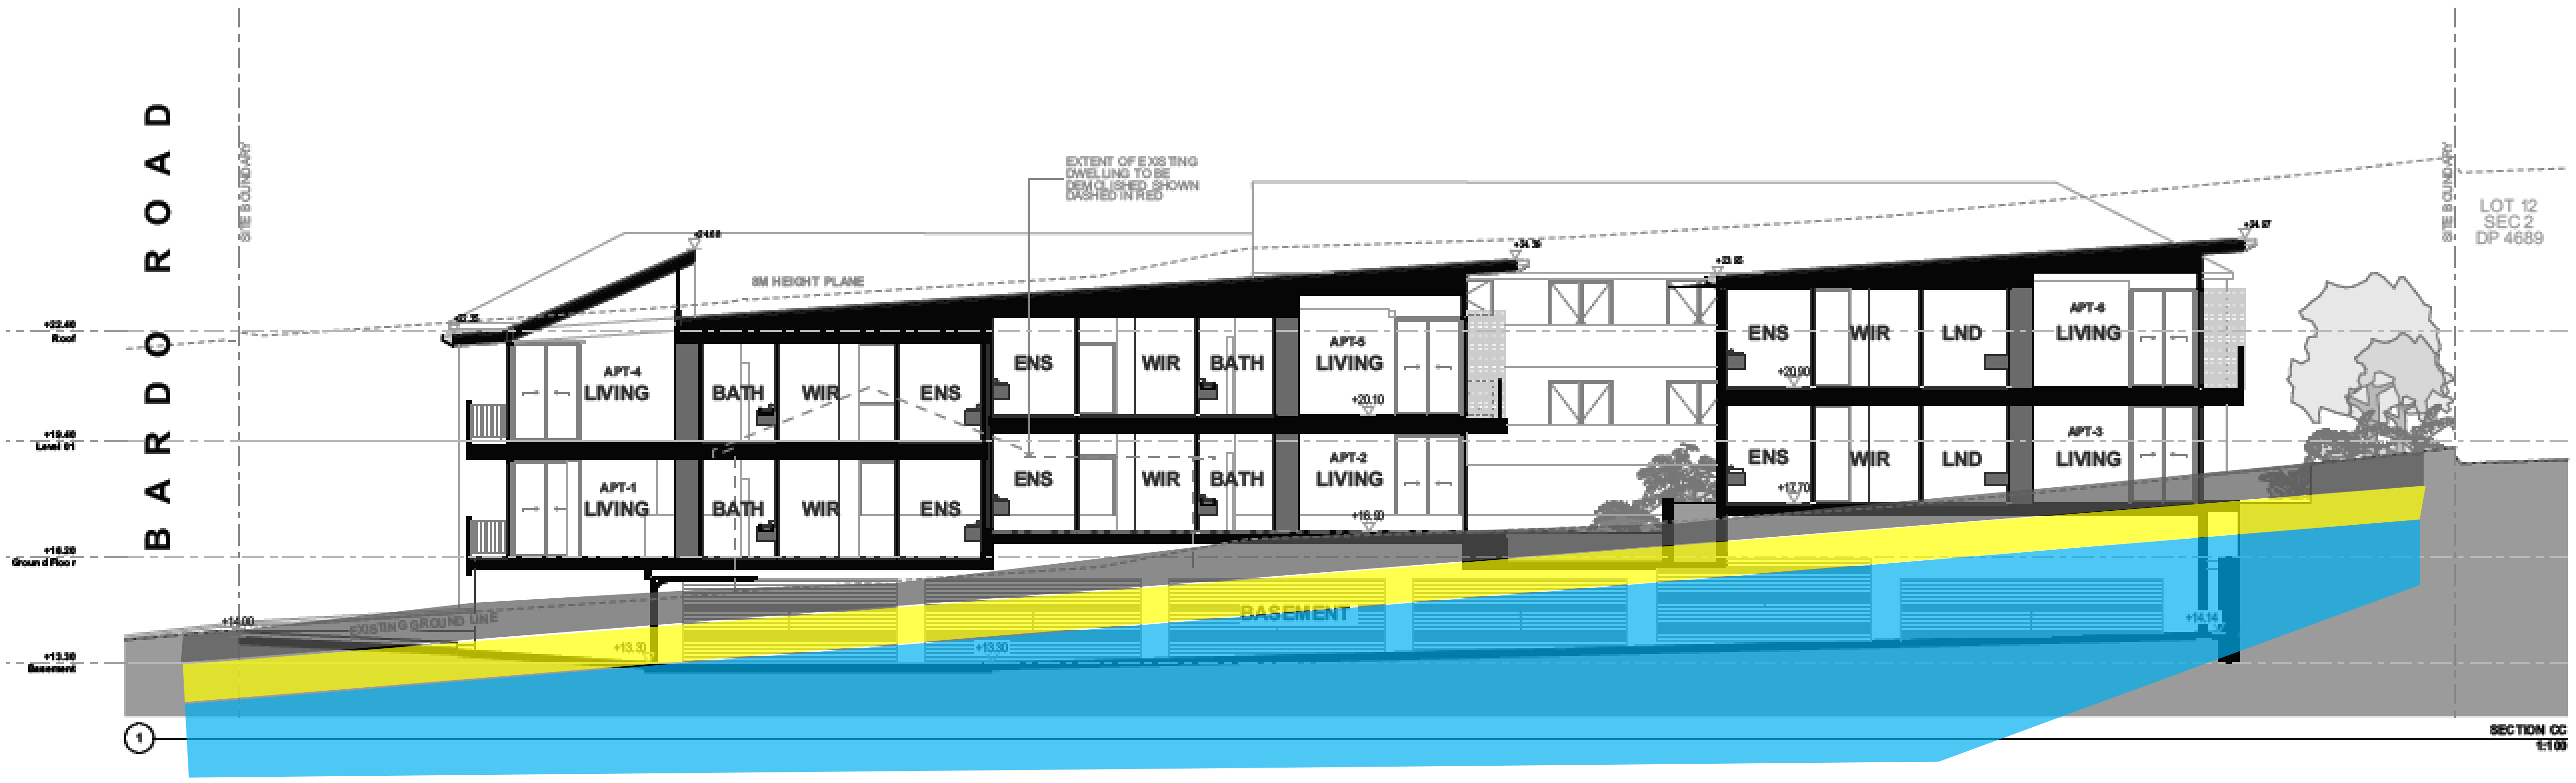
The slope materials are colluvial at the near surface and residual at depth. Across the property, they consist of a sandy topsoil and sand averaging a depth of ~0.9m and to a maximum depth of ~1.5m. These overlie sandy clays that extend to a maximum depth of ~2.4m. In the test locations, the sandy clays merge into the weathered zone of the underlying shale at an average depth of ~1.8m below the current surface. The weathered zone is interpreted as Extremely Low Strength Shale. It is to be noted that this material can appear as a mottled stiff clay when it is cut up by excavation equipment. See Type Section attached for a diagrammatical representation of the expected ground materials.

- Fill
- Sandy Soil and Sand
- Sandy Clay – Firm to Stiff
- Narrabeen Group Rocks – Extremely Low Strength Shale - after being cut up by excavation equipment can resemble a stiff to hard clay.

We recommend heavy ground support be installed prior to the commencement of the excavation to ensure the safety of any workers below the cut and integrity of the neighbouring properties and structures. As the topsoil and sand layers of the profile are relatively thick across the properties, a secant or contiguous piled wall is the suggested method of support around the perimeter of the excavation. Secant piles are the preferred option but if contiguous piles are used, the gaps between the piles are to be grouted closed as the excavation is lowered so no sand/sediment moves through the wall. The piers can be supported by embedment, propping, temporary, or permanent rock anchors (depending on the location of the excavation) installed as the excavation is lowered. To drill the pier holes for the walls, a pilling rig that can excavate through Medium Strength Rock will be required. If a machine of this type is not available, we recommend carrying out core drilling before the construction commences to confirm the strength of the rock and to ensure the excavation equipment is capable of reaching the required depths. The wall is to be tied into the concrete floor and ceiling slabs after which any temporary support can be released.
