ON
GEOTECHNICAL SLOPE STABILITY RISK ASSESSMENT
(In Accordance with Pittwater Council Risk Management Policy)

FOR
PROPOSED STAGES 4 TO 6 OF
WARRIEWOOD BROOK RETIREMENT VILLAGE

AT
6 TO 14 MACPHERSON STREET, WARRIEWOOD, NSW

5 July 2013
Ref: 21140SB3rpt

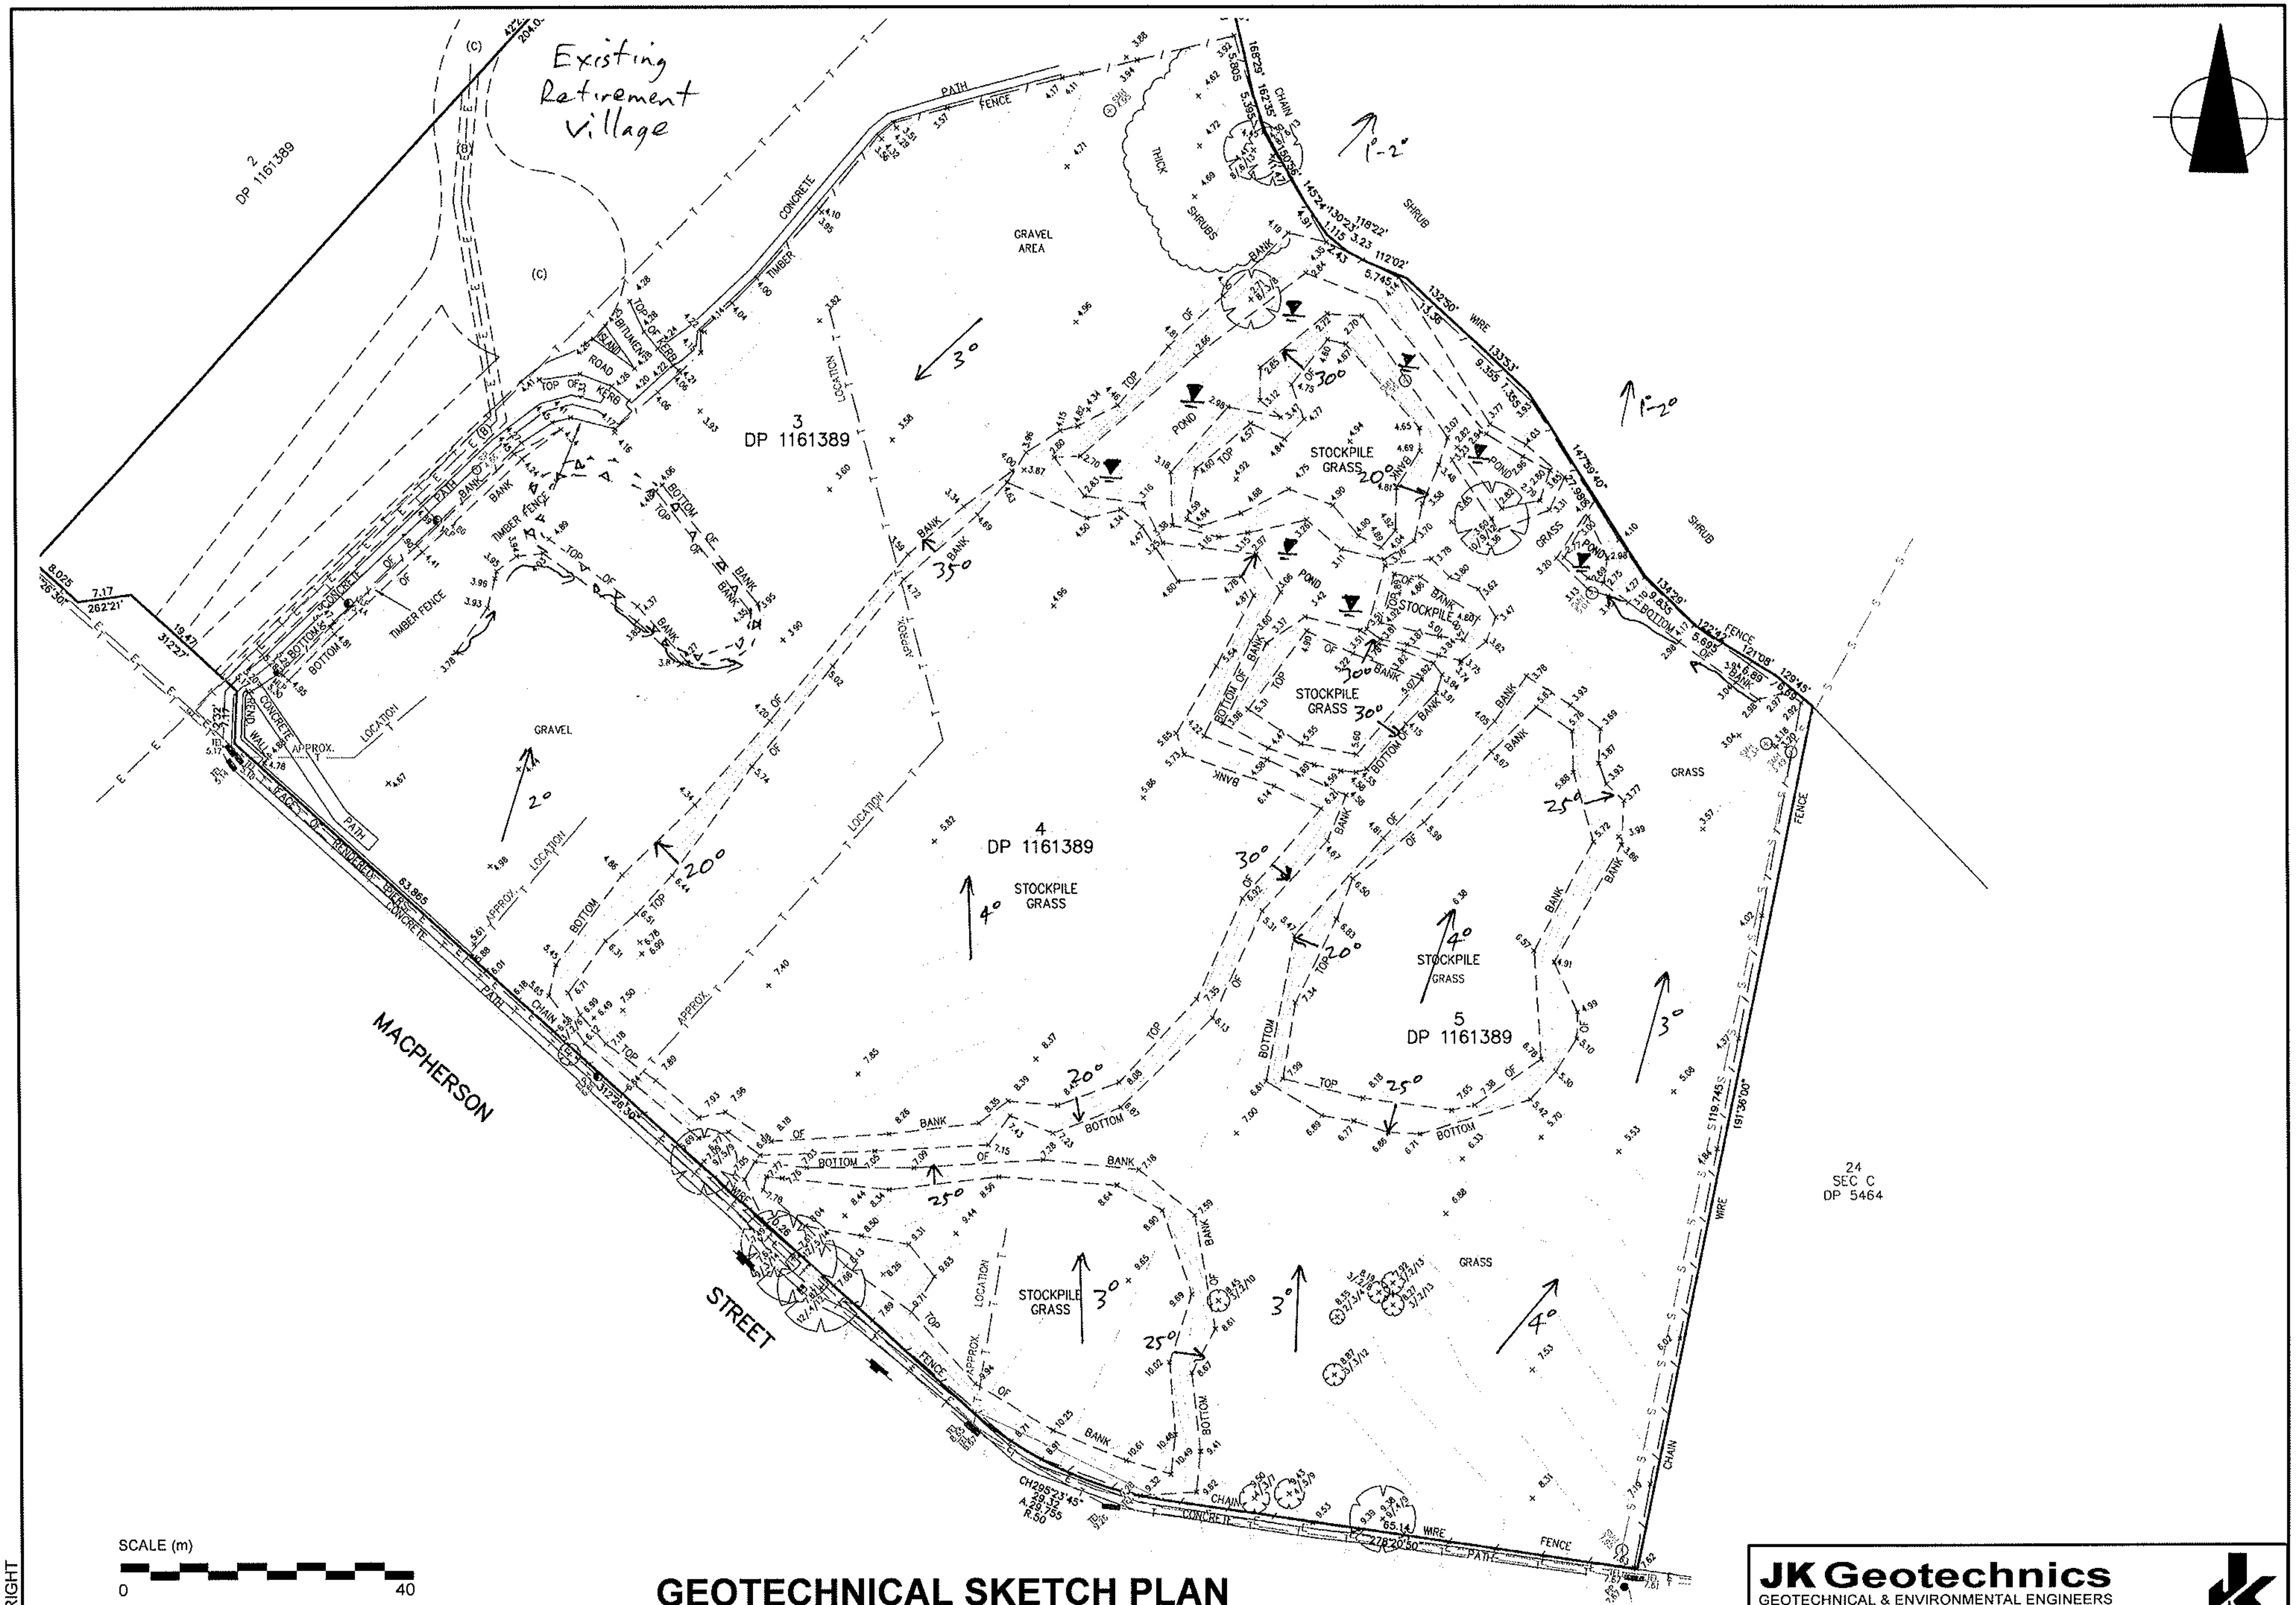
GEOTECHNICAL SKETCH PLAN

We recommend that the summary of observations which follows be read in conjunction with the attached Figure 1.

To the north-west of the site are the existing earlier stages of Warriewood Brook Retirement Village, with an entry road and village green immediately adjacent to the subject site and then two to four storey brick and rendered buildings. These buildings appeared to be in good external condition. To the south-west of the site is MacPherson Street, with three storey rendered unit buildings on the far side of Macpherson Street.

Along the south-eastern boundary is a row of thick trees limiting inspection within the adjoining property. However, for the majority it appeared that the ground surface across this boundary was similar to the subject site, with the adjoining property mostly occupied by garden areas. At the MacPherson Street frontage is a one storey house, in good condition, located about 8m to 10m from the common boundary. Opposite the house the ground surface slopes down from the common boundary at about 20° to the top of a brick retaining wall of about 1m high. The retaining wall is located about 5m from the common boundary.
