GEOTECHNICAL ASSESSMENT

PROPOSED ALTERATIONS AND ADDITIONS

7 BRUCE AVENUE, MANLY, NSW

Ref: 31325SFrptRev2

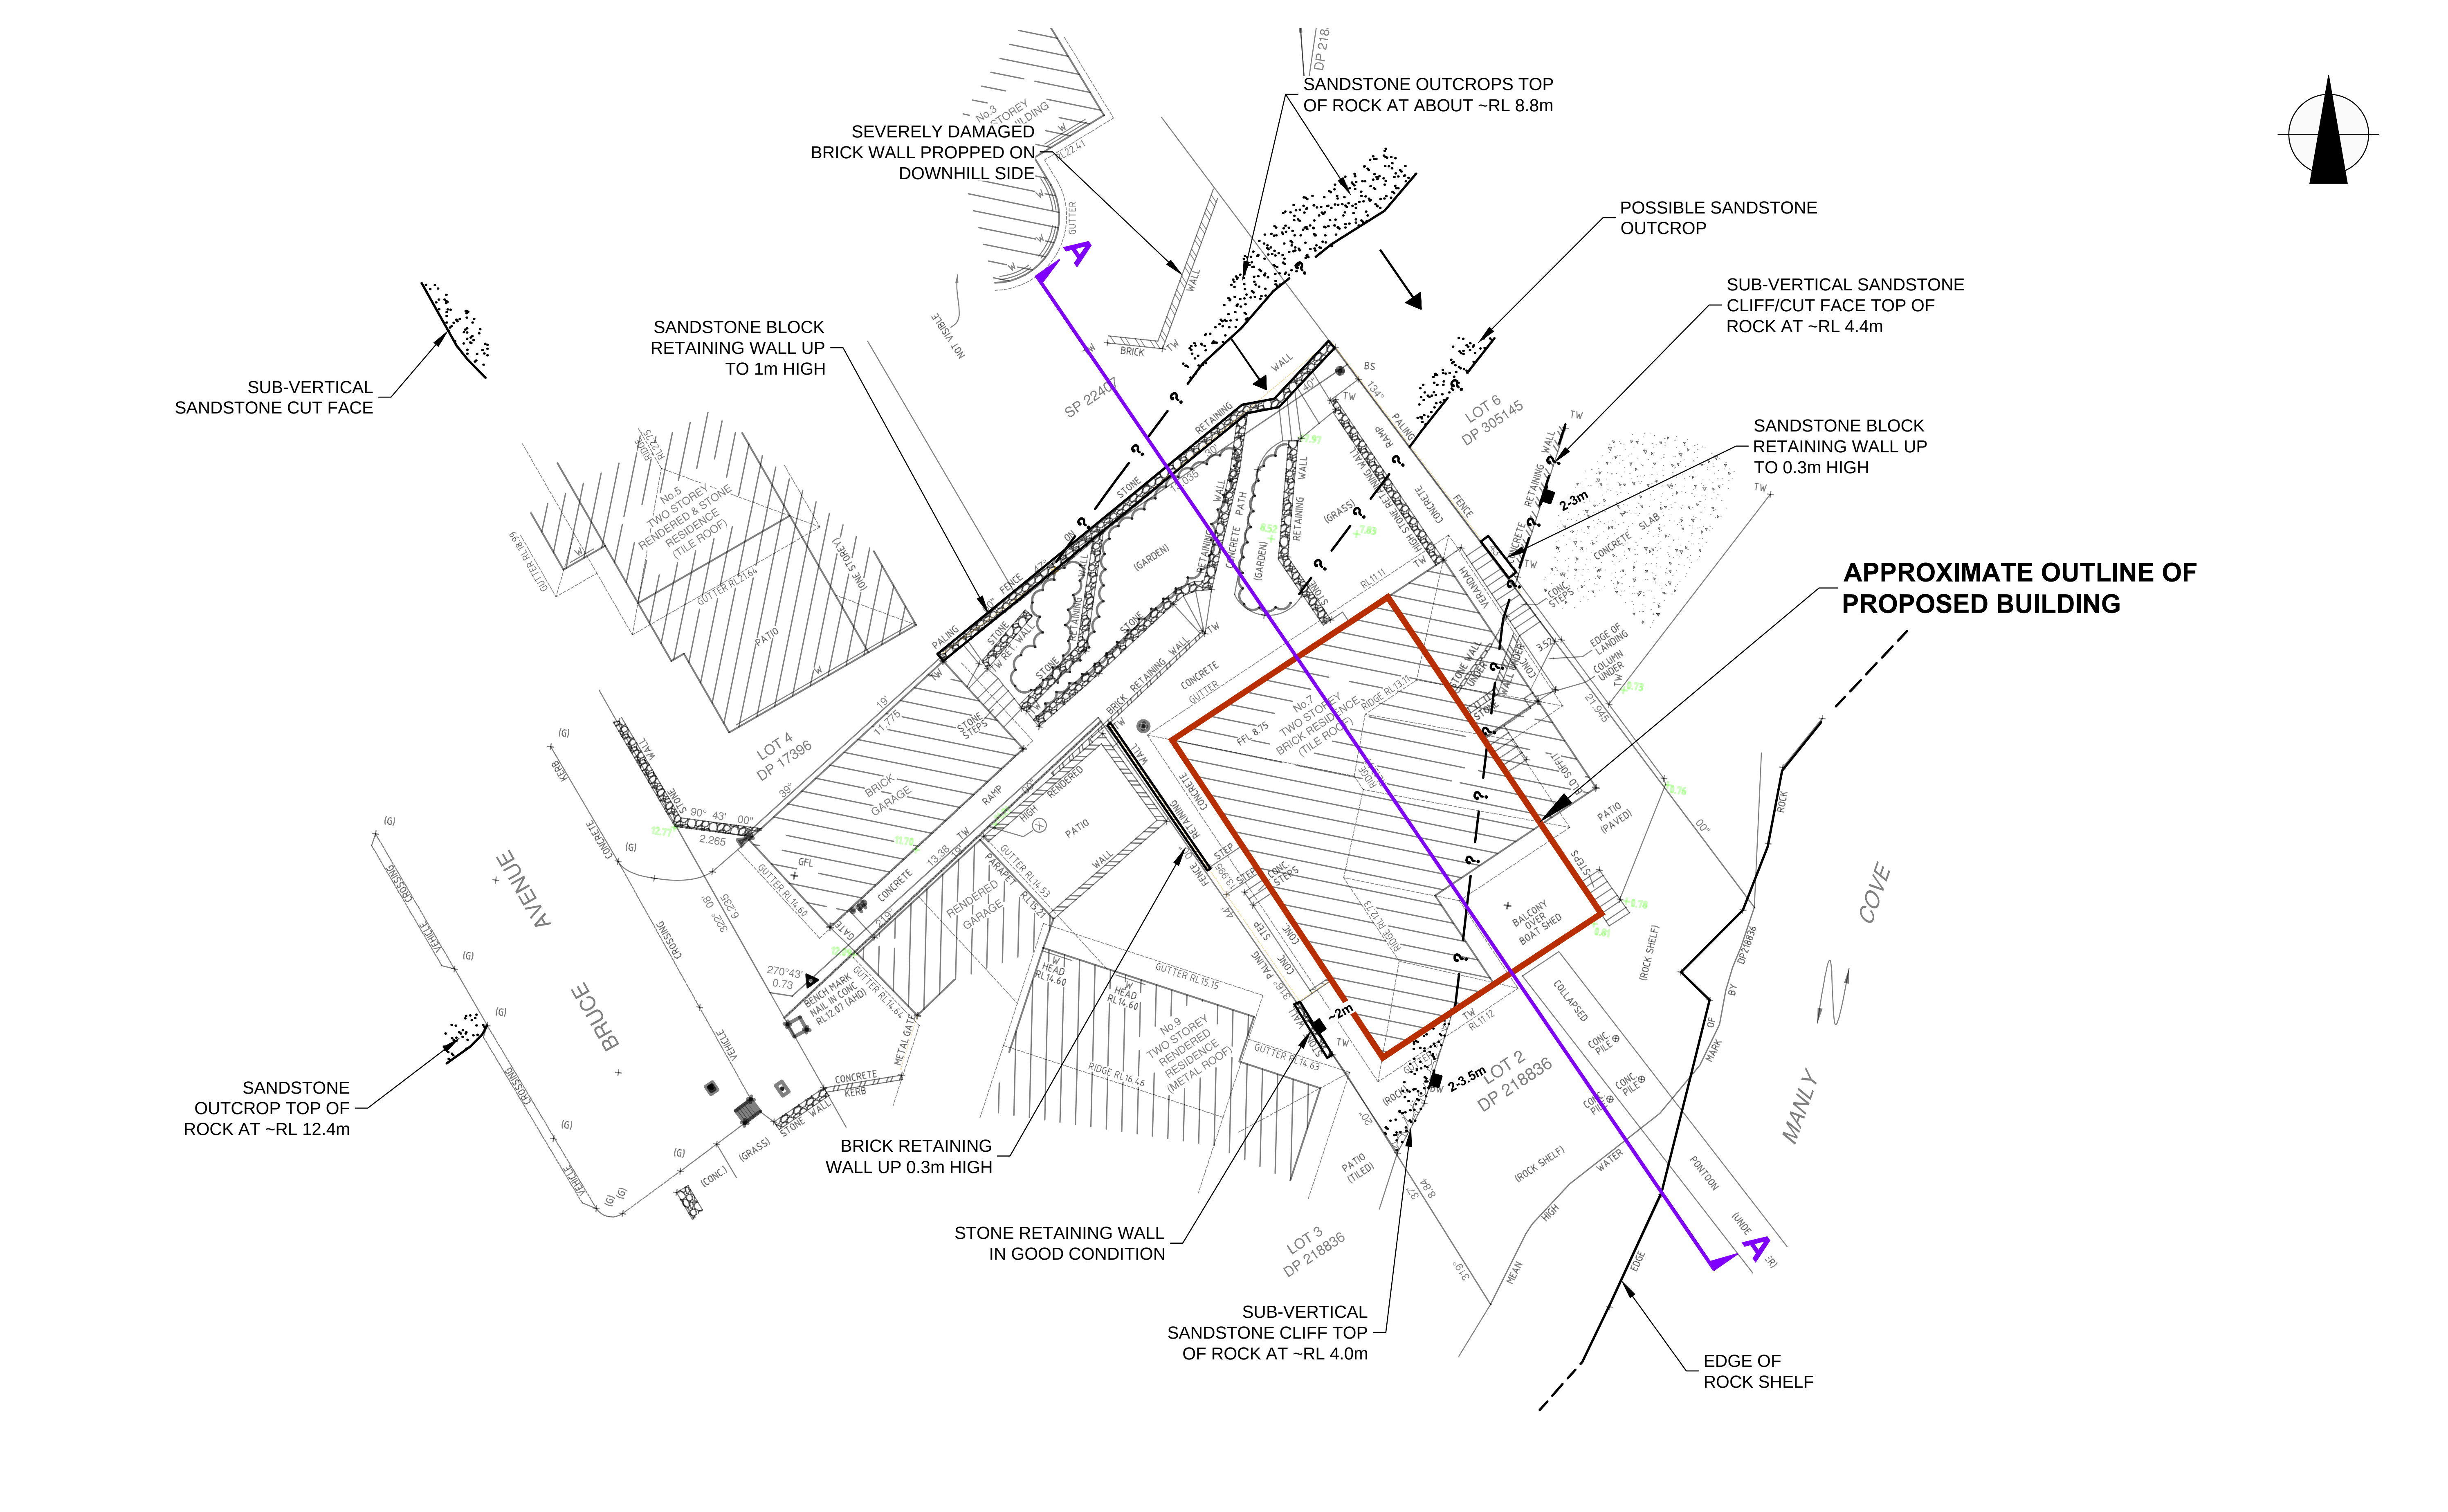
Figure No: 2

The principal geomorphological features are presented on the attached Figure 2 and a cross-sectional sketch (Figure 3) orientated north-west to south-east. The figures have been based upon the supplied survey plan prepared by Norton Survey Partners (Ref: 25186, Sheet 1 dated 02/12/16). The datum for Reduced Levels (RL) is the Australian Height Datum. The relative levels referenced within this report were generally interpolated from spot heights shown on the survey plan and are therefore approximate.

Sandstone bedrock was exposed over the lower portion of the site within, and around, the existing boatshed and also below the existing patio. Based upon our examination of the bedrock using a geopick, the bedrock was generally assessed to be slightly weathered and at least medium strength. Furthermore, based upon observations from within the subject site of sandstone outcrops within the neighbouring north-eastern and north-western properties and along Bruce Avenue, there appears to be at least three stepped rock shelves that intersect the subject site. The vertical faces of the rock shelves generally have an approximate north to south orientation and vary in height roughly between 1m and 5m. Groundwater seepage was regularly observed over the sandstone outcrops.

The 1:100,000 Geological Map of Sydney indicates the site is underlain by Hawkesbury Sandstone of the Wianamatta Group. The presence of sandstone was confirmed by the presence of outcrops. The following should be read with reference to Figures 2 and 3.

Sandstone outcrops were observed across the site and also within adjacent properties and along Bruce Avenue. From our examination of the sandstone outcrops, we assessed the bedrock to be slightly weathered and of at least medium strength. This is consistent with the sandstone outcrops observed within the adjacent properties and from our past assessment at 5 Bruce Avenue. The sandstone bedrock appears to step down to the south-east towards Manly Cove.

We observed groundwater seepage flows over the sandstone outcrops which we expect to have originated at the soil/rock interface and through defects in the sandstone.

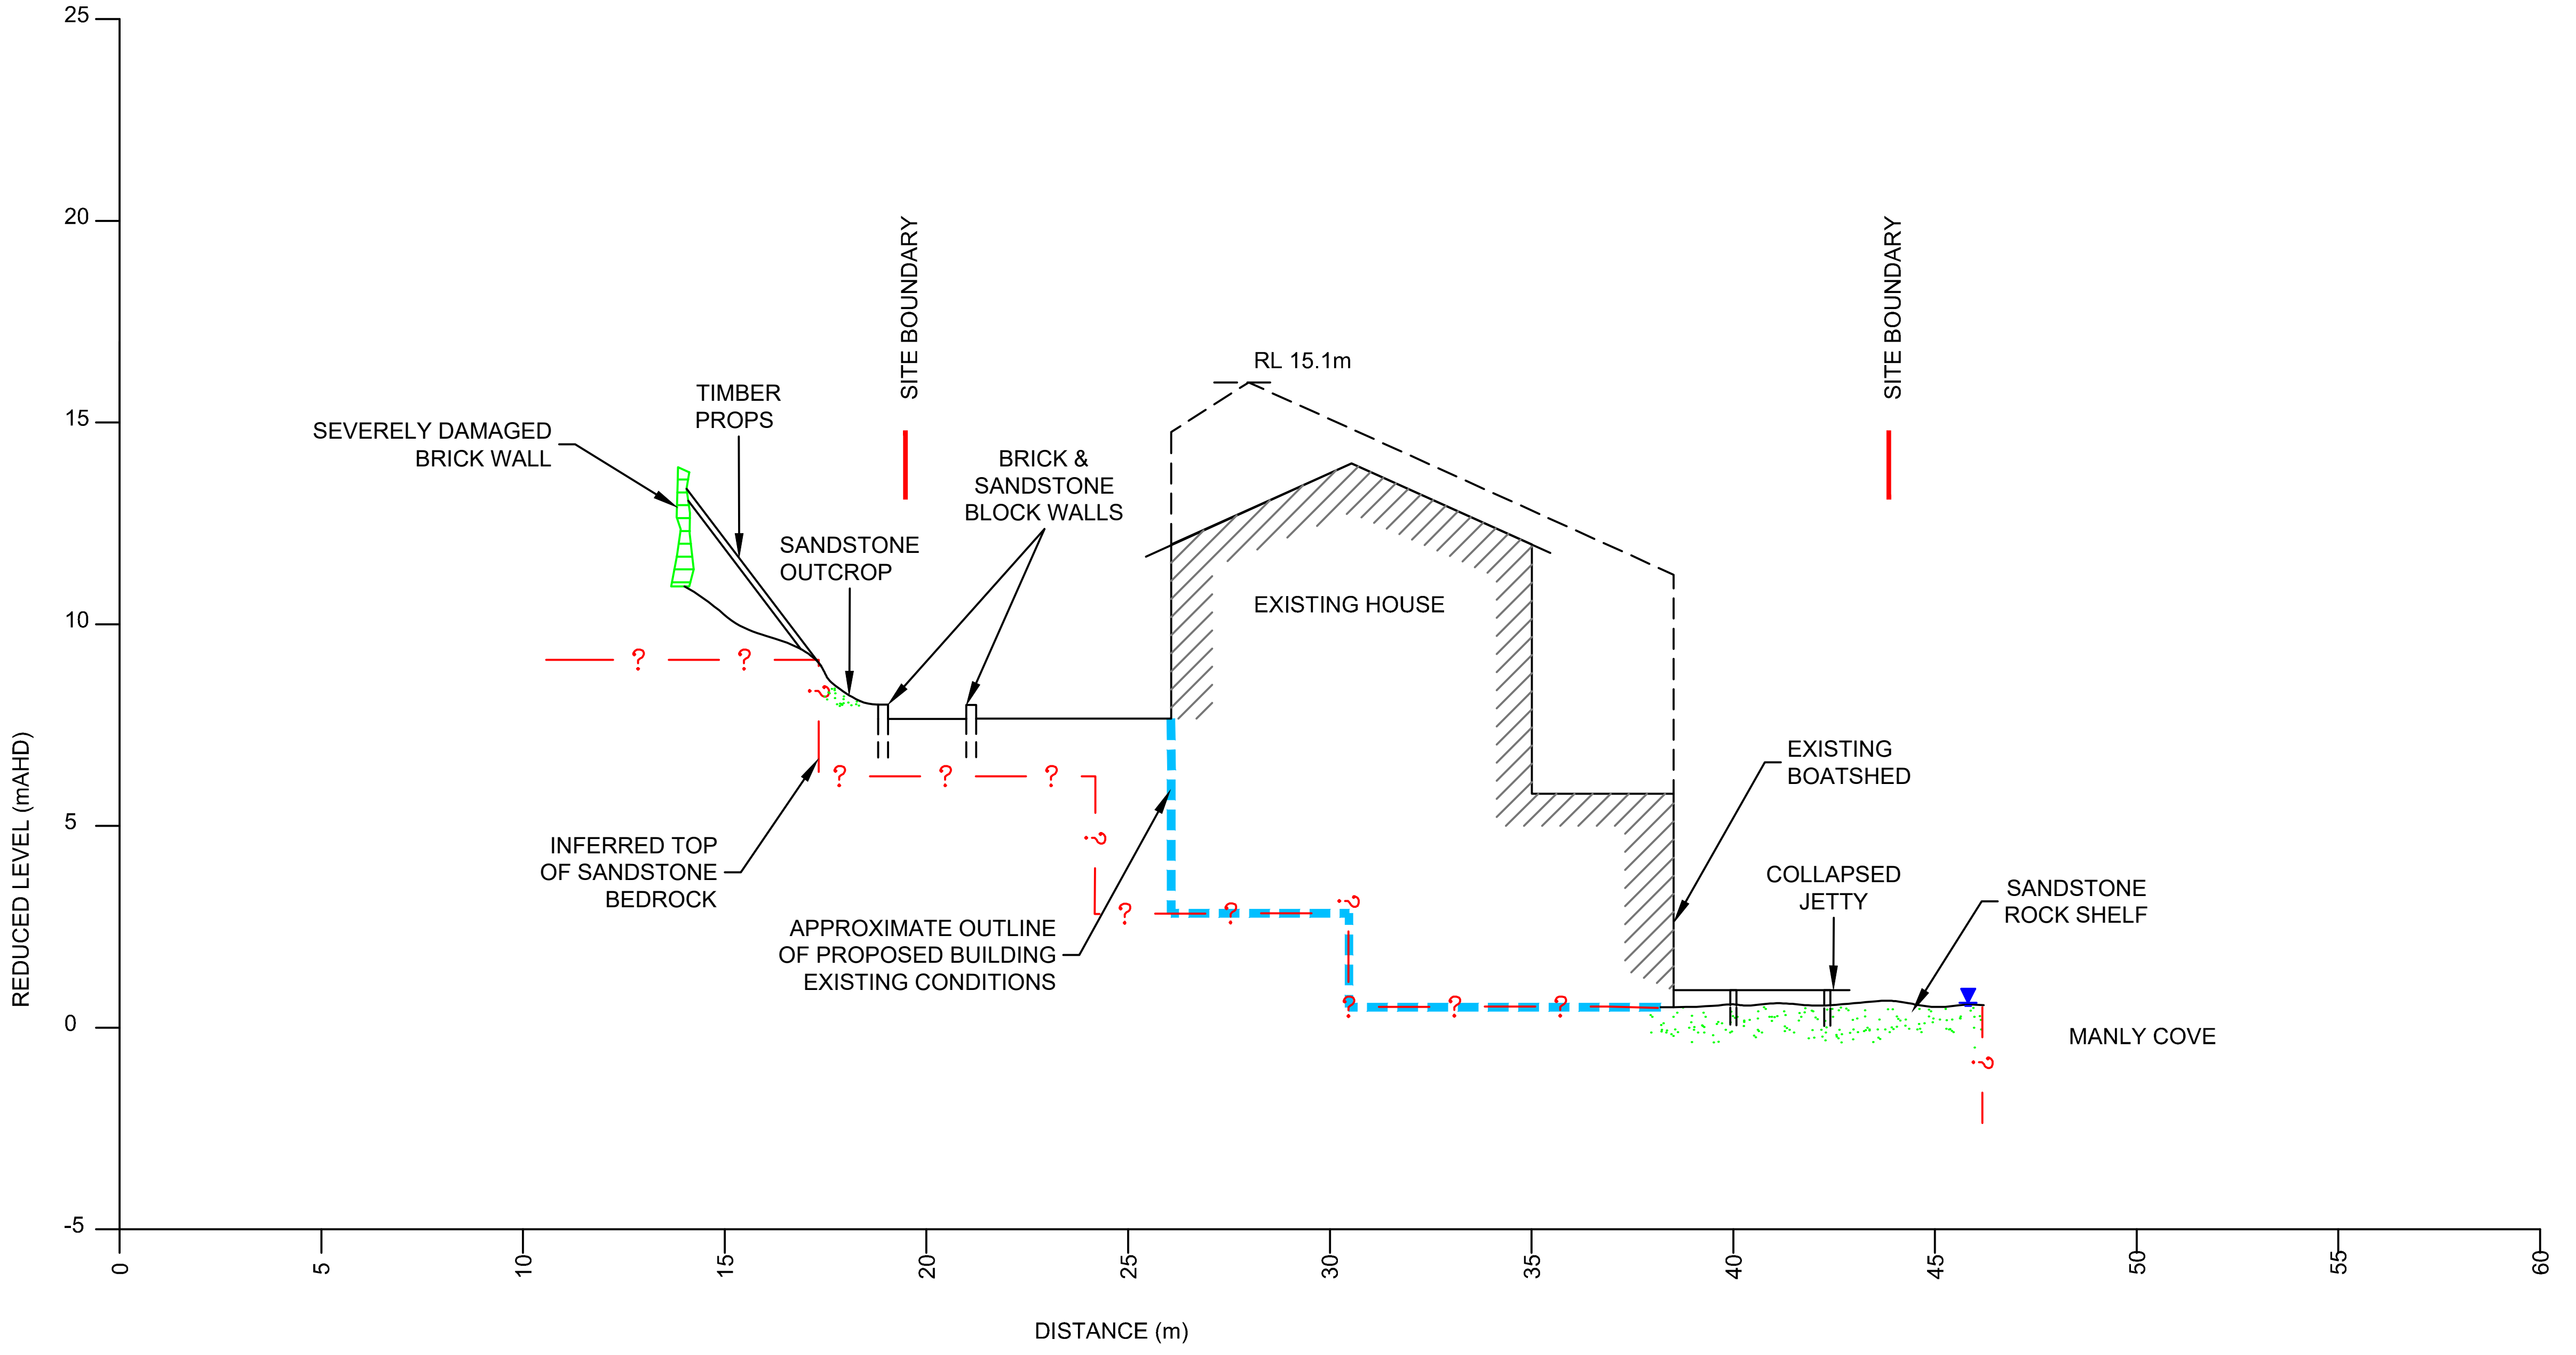
Figure No: 3

Based upon our observations and consideration of the geological setting and topography of the site, the soil cover is inferred to be generally shallow (less than 1m) over the sandstone bedrock. However, we note the fill may be locally deeper behind existing retaining walls which will be dependent on the wall height. Our inspection indicated no evidence of any recent mass soil slope instability or major rock falls within the subject site.
