Address of site 337 WHALE BEACH RD, PALM BEACH

Report Date: 30 Aug 2022 Report Ref No: 20064Zrpt2

GEOTECHNICAL HAZARD ASSESSMENT

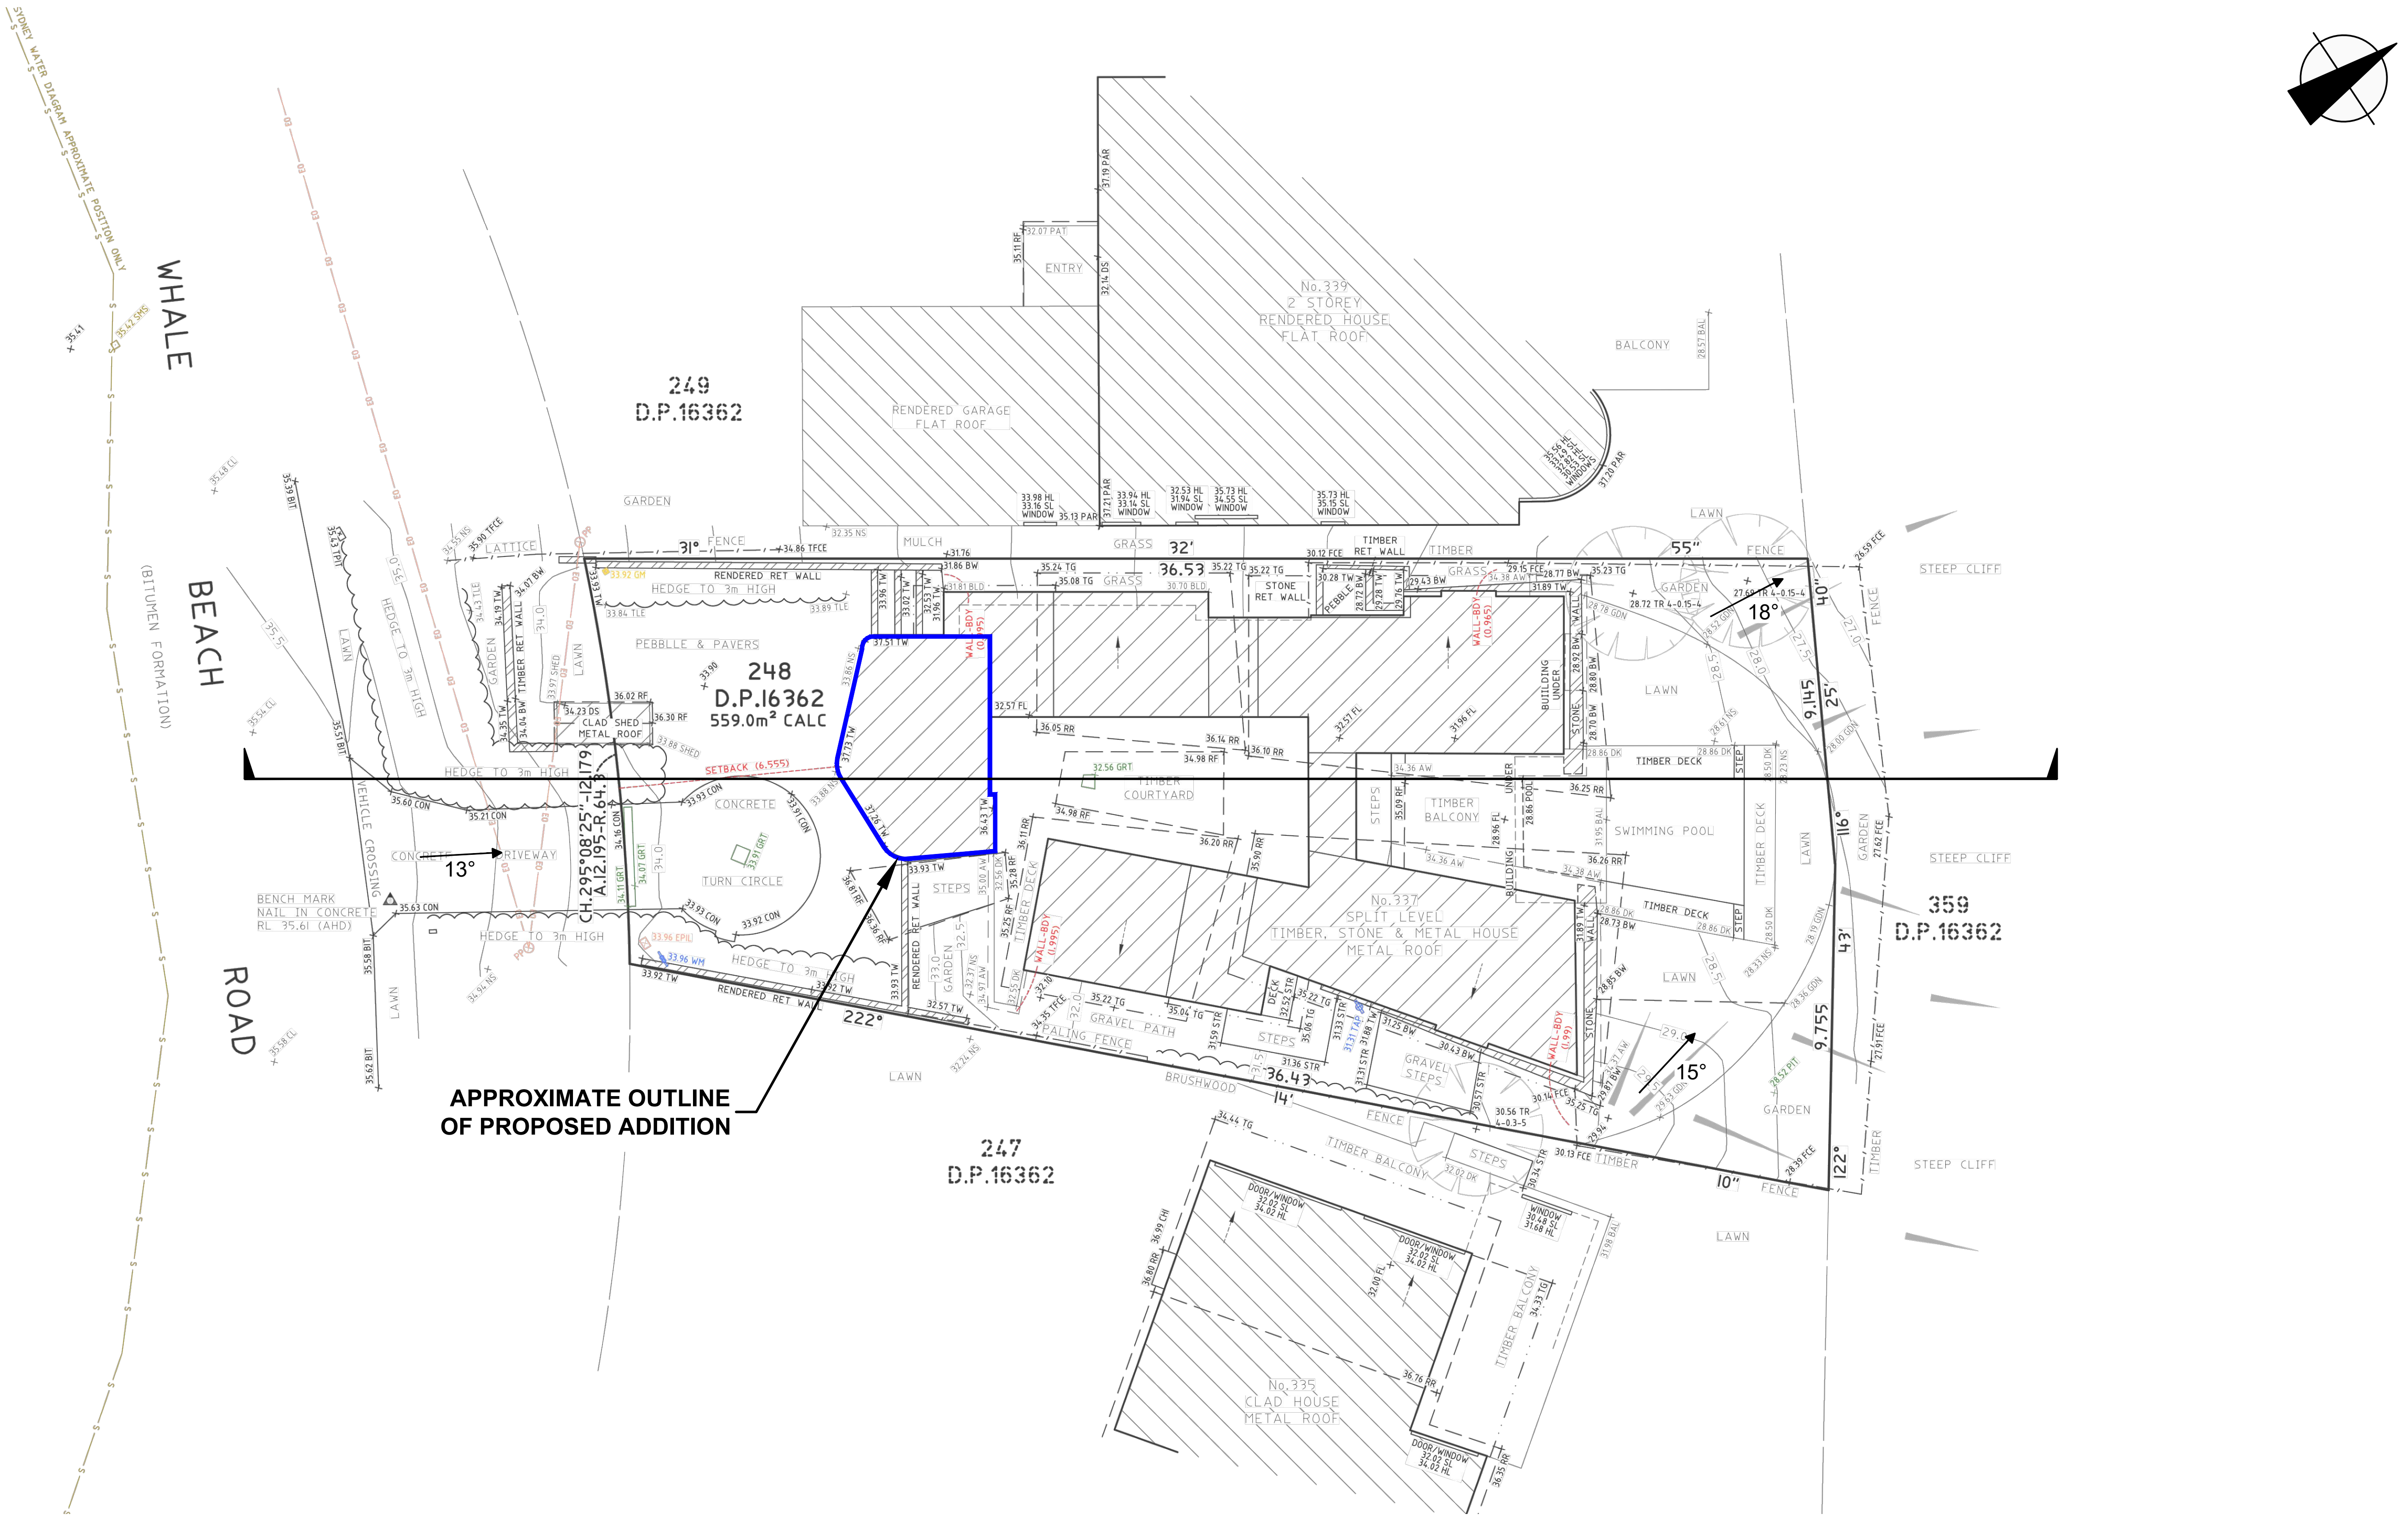
The attached Figure 2 presents a geotechnical sketch plan showing the principle geotechnical features present at the site. Figure 2 is based on the CMS survey (21158A) dated 28 April 2022. Additional features on Figure 2 have been measured by hand held inclinometer and tape measure techniques and hence are only approximate. Should any of the features be critical to the proposed development, we recommend they be located more accurately using instrument survey techniques. Figure 3 presents a typical cross-section through the site based on the survey data augmented by our mapping observations.

We recommend that the summary of observations which follows be read in conjunction with the attached Figure 2. For the purpose of this report, we have assumed that Whale Beach Road bounds the site along the south with 'site north' indicated on Figure 2:

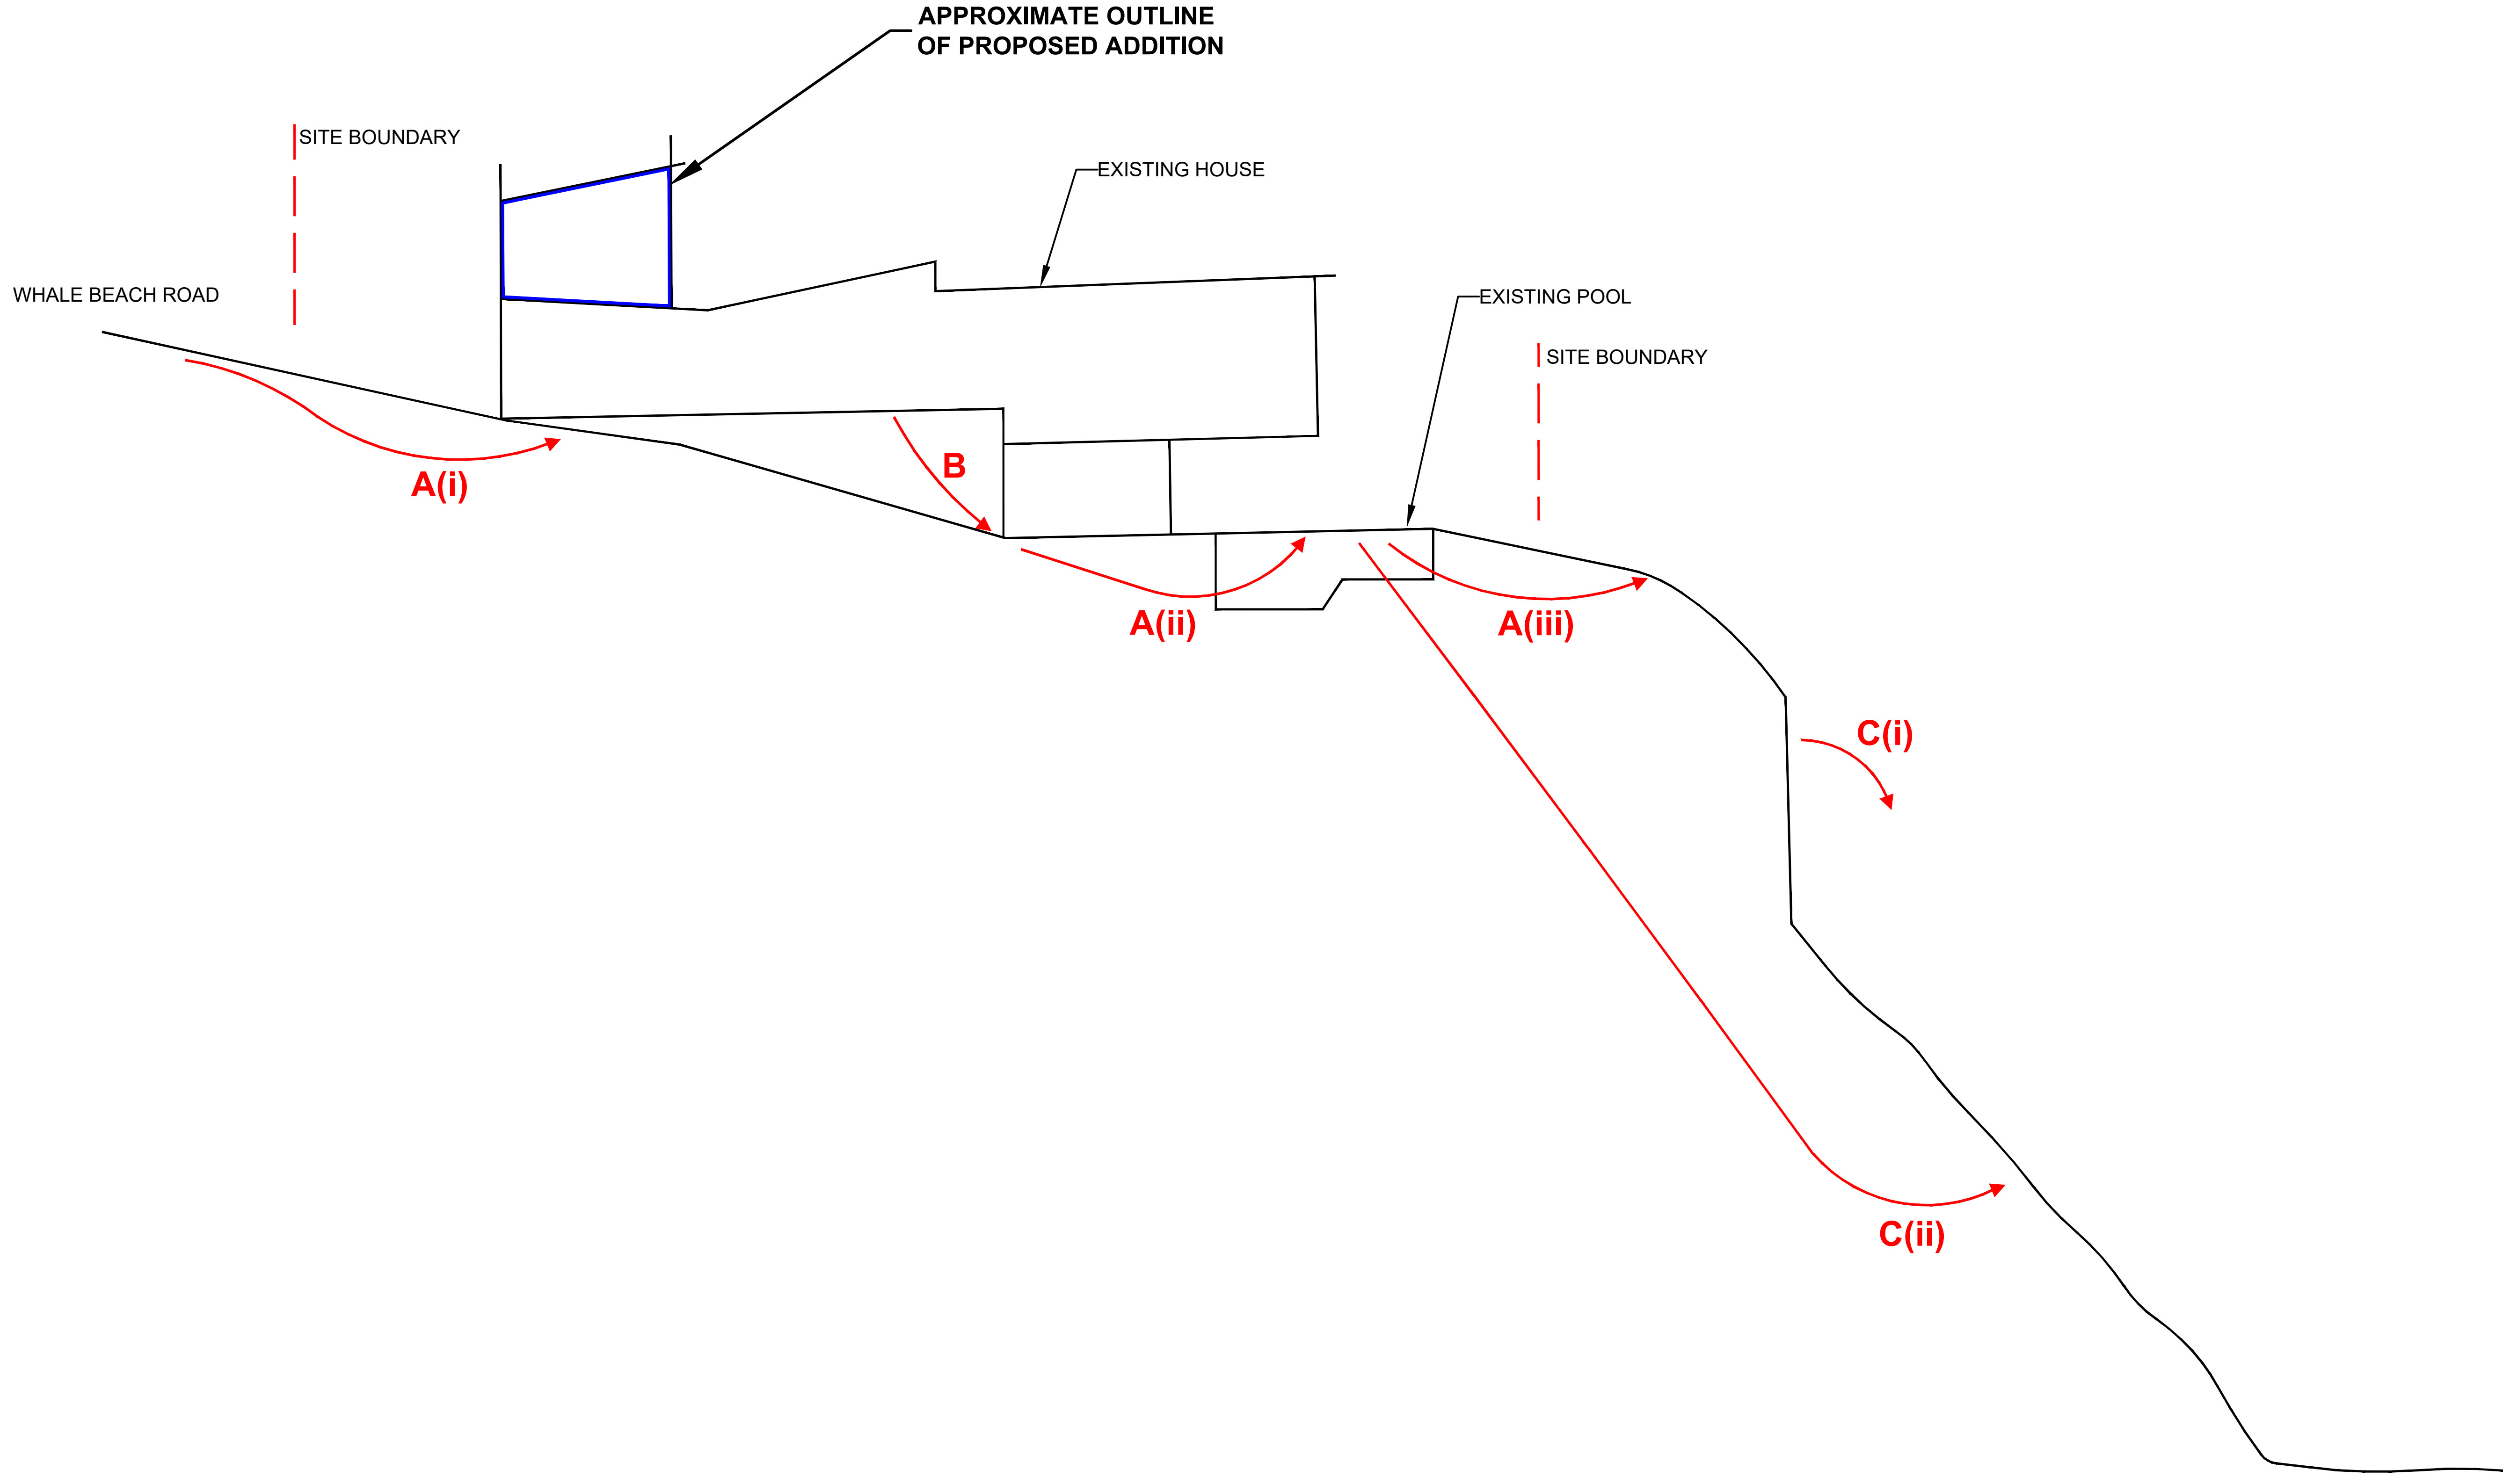
Title: **GEOTECHNICAL SKETCH SECTION SHOWING POTENTIAL HAZARDS**

These potential hazards are indicated in schematic form on the attached Figure 3.
