GEOTECHNICAL RISK MANAGEMENT POLICY FOR PITTWATER
FORM NO. 1 – To be submitted with Development Application

Address of site 44 Bynya Rd, Palm Beach

REPORT

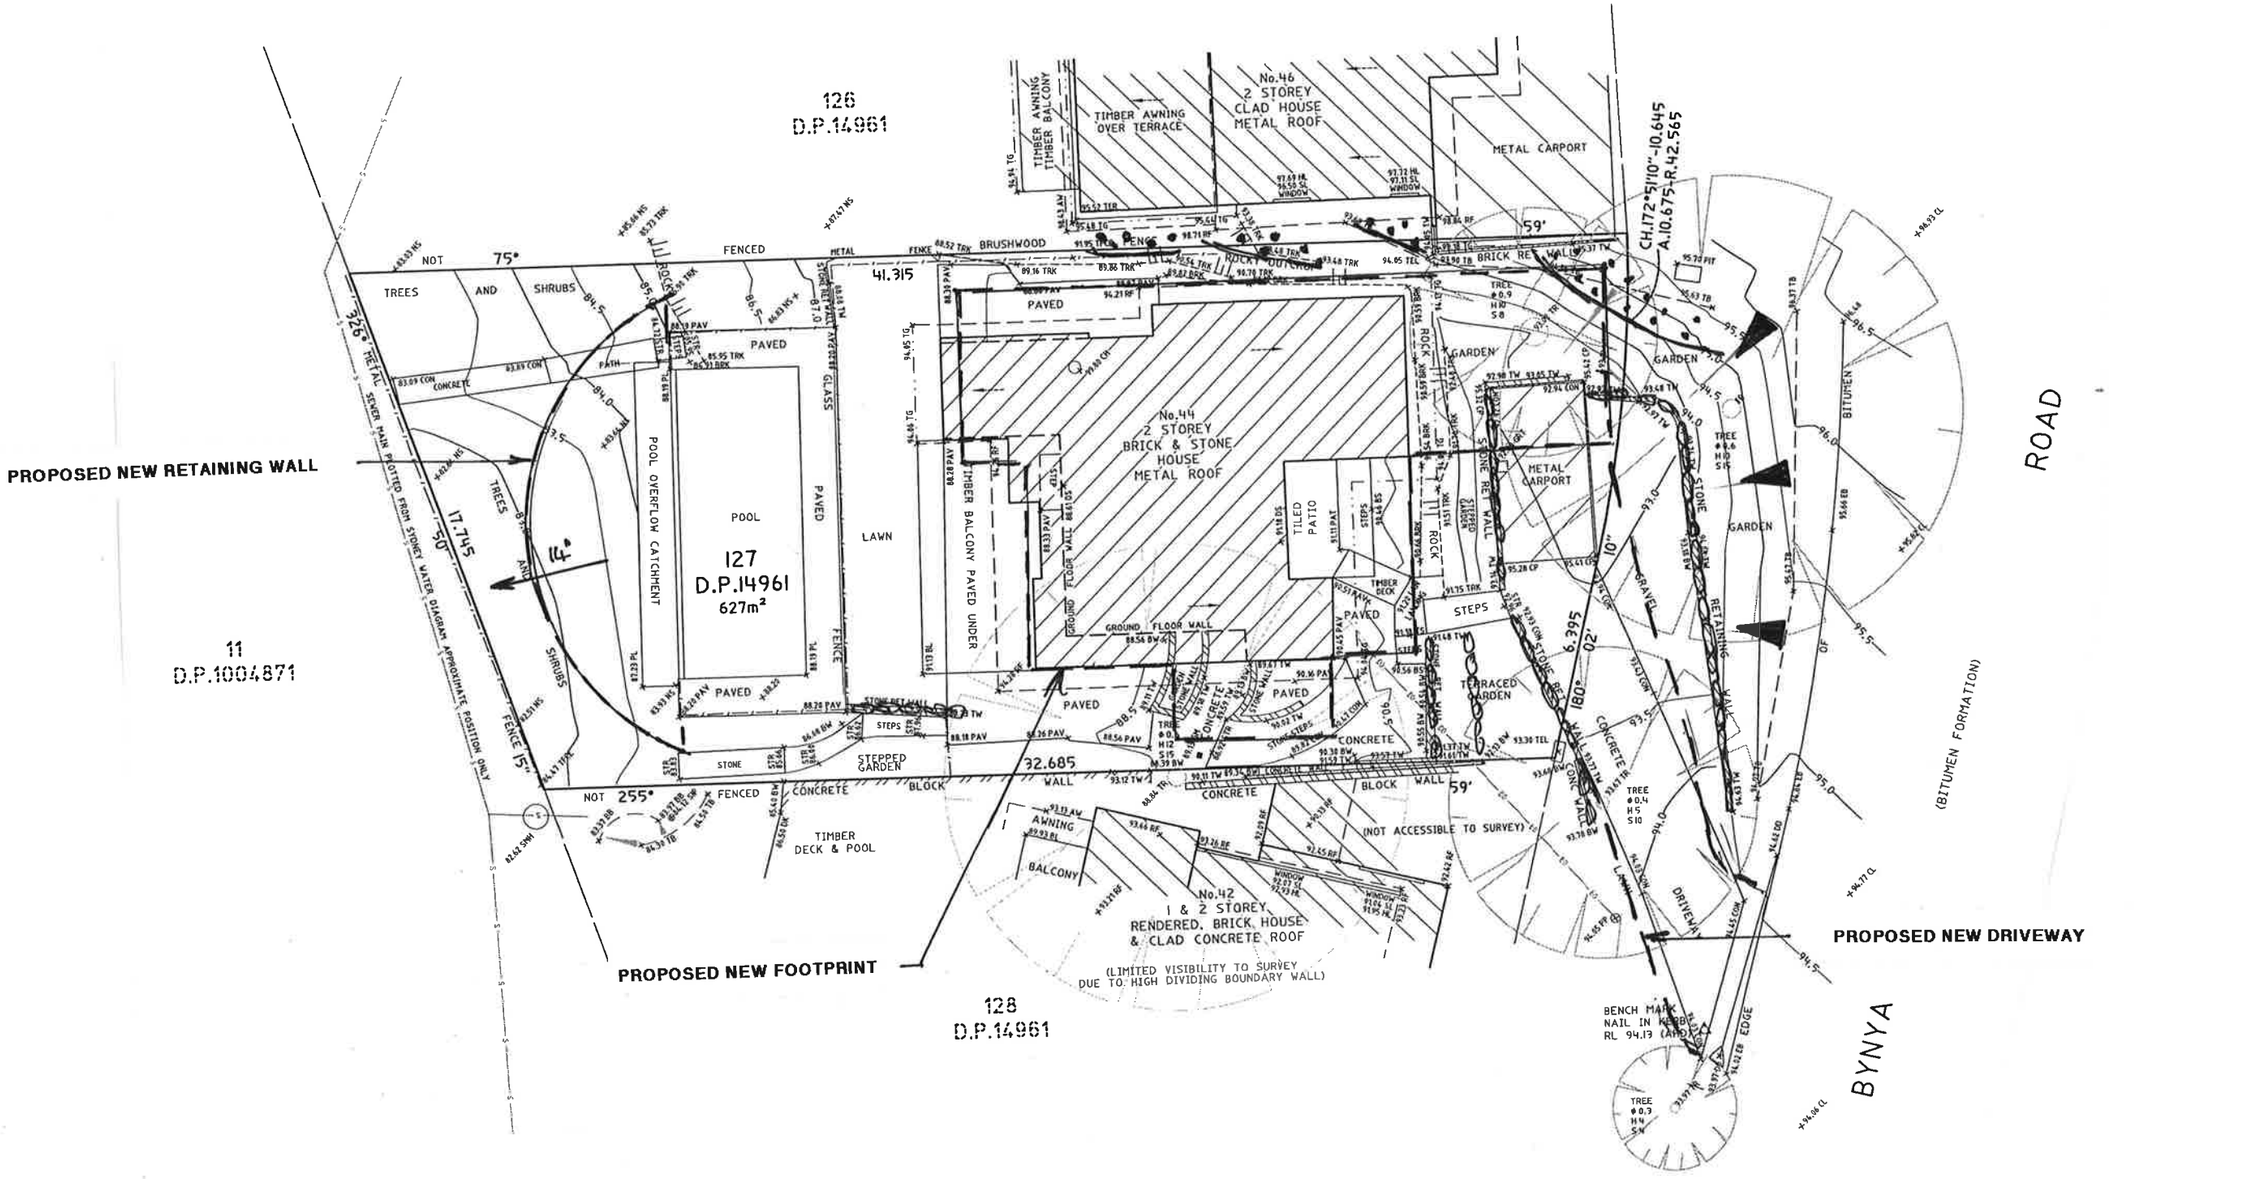
The attached Figure 1 presents a geotechnical sketch plan showing the principal geotechnical features present at the site. Figure 1 is based on the survey plan (Ref 13155, dated 15/06/15) prepared by CMS Surveyors. Additional features on Figure 1 have been measured by hand held inclinometer and tape measure techniques and hence are only approximate. Should any of the features be critical to the proposed development, we recommend they be located more accurately using instrument survey techniques.

The sandstone exposures on site were assessed to be of medium strength and groundwater was noted to be emanating over the bedrock surface and from bedding partings in the rock mass.

6.1.1 All proposed footings must be founded in bedrock. The footings should be designed for an allowable bearing pressure of 600kPa, subject to inspection by a geotechnical engineer prior to pouring.
