GEOTECHNICAL RISK MANAGEMENT POLICY FOR PITTWATER

Address of site 6 Captain Hunter Road, Bayview

0 4 8 12 16 20 SCALE 1:400 @A3 m	Title: **GEOTECHNICAL SITE PLAN**		
	Location: 6 CAPTAIN HUNTER ROAD BAYVIEW, NSW		
	Report No: 30495RH	Figure: 2	
This plan should be read in conjunction with the JK Geotechnics report.	**JKGeotechnics**

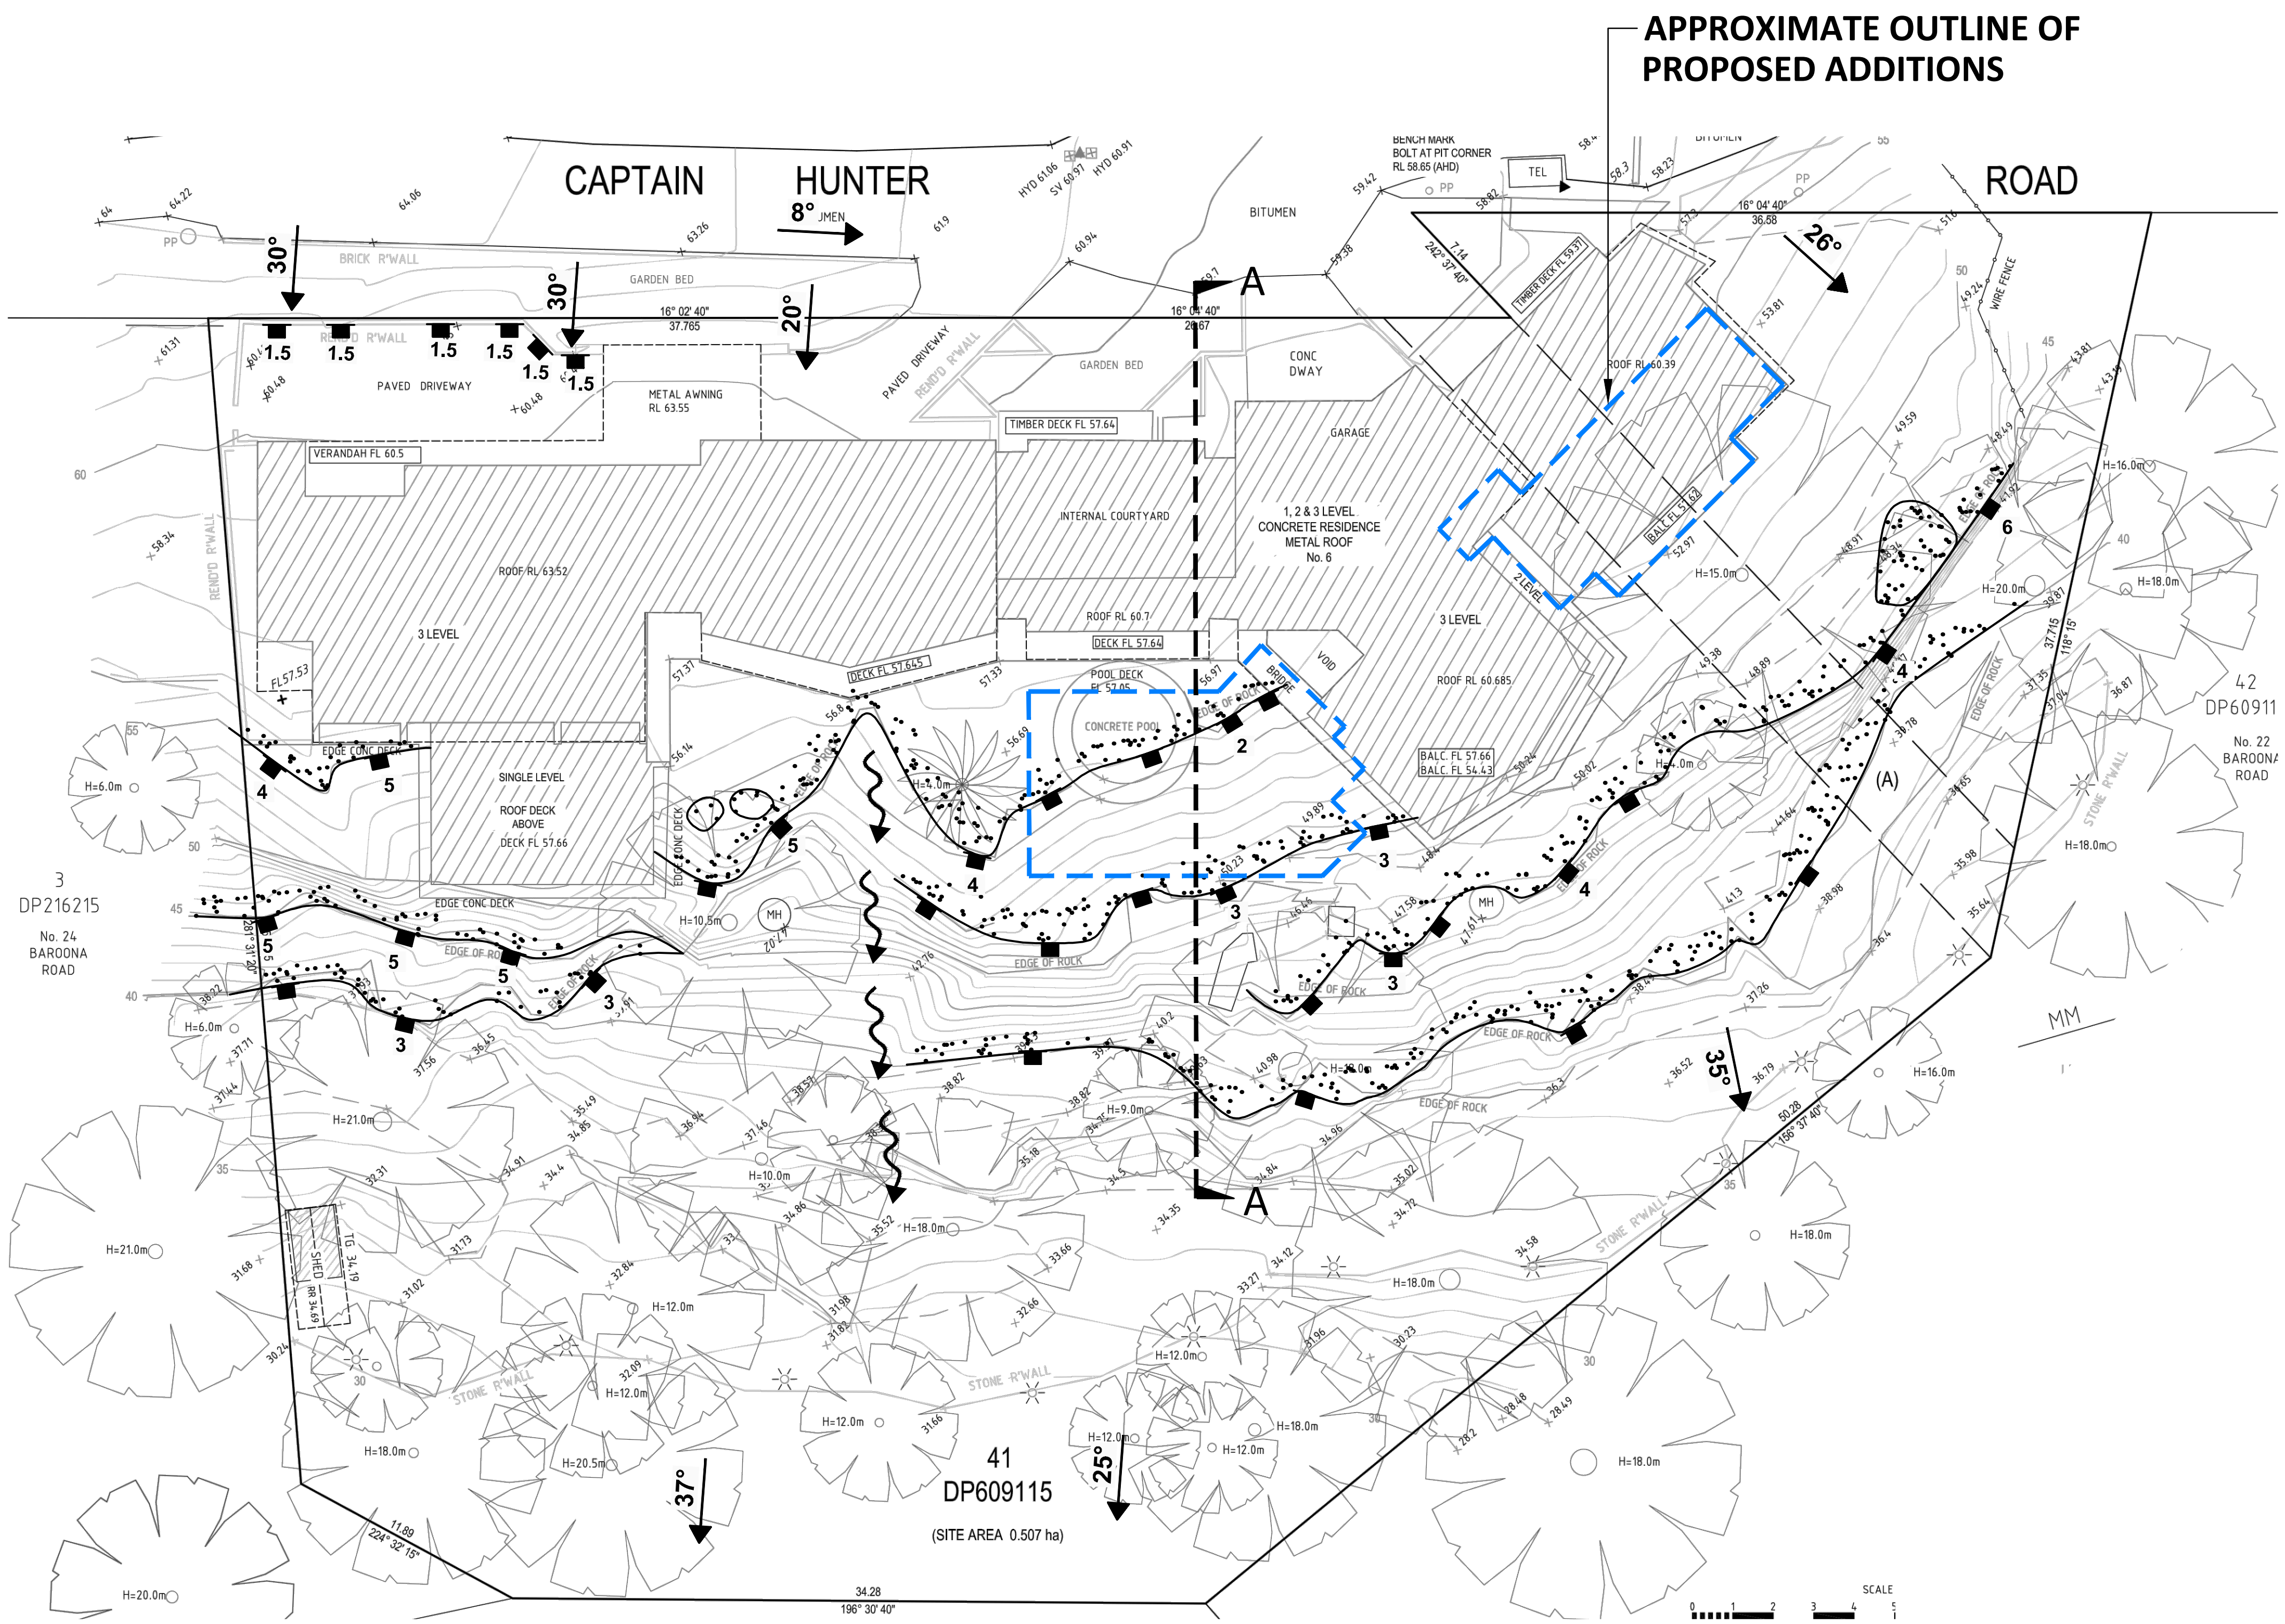
- At the time of our inspections, the upper western portion of the site was occupied by a one, two and three storey concrete house, which appeared in good condition, based on a cursory inspection from within the site.

- Sandstone cliff faces (maximum height of about 6m) stepped down from the eastern side of the house. Several detached sandstone boulders were present in the rear yard. Overhangs were observed within some of the cliff faces and extended back a maximum horizontal distance of about 3m.

- The neighbouring two storey brick house to the north-west of the site (9 Captain Hunter Road) was set back at least 25m from the subject site and appeared to be in good condition based on a cursory inspection from within the site.

Due to the presence of several large detached boulders over the lower eastern portion of the site, our inspection has indicated that rock slope instability has occurred in the past. We infer that the cliff faces immediately to the east of the house have formed along north-south trending joint planes within the rock mass. The likely mechanism for a cliff face collapse would be undercutting along a weathered seam or bedding plane forming an overhang, followed by toppling and/or basal shear. Basal shear could occur due to the surcharge load of the overlying rock mass. A toppling failure would cause the detached mass to rotate forwards and down the hillside. We infer that the above, however, has been occurring over geological time. Such a failure would result in the material collapsing down the hillside.

On the basis of the above, it will be critical for a geotechnical engineer to inspect the excavation progressively for the proposed additions, as well as the bedrock where proposed footings are to be founded, to confirm the suitability of the bedrock for founding, and/or to provide advice on rock face stabilisation measures, such as underpinning of an overhang, if appropriate. The geotechnical engineer will also need to inspect the base of the footing excavations to check for the presence of potential adverse jointing which may impact stability of the existing and/or proposed structure. If potential adverse joints are present, then additional portions of the proposed structure may need to be cantilevered over the defect plane or rock bolt support provided.

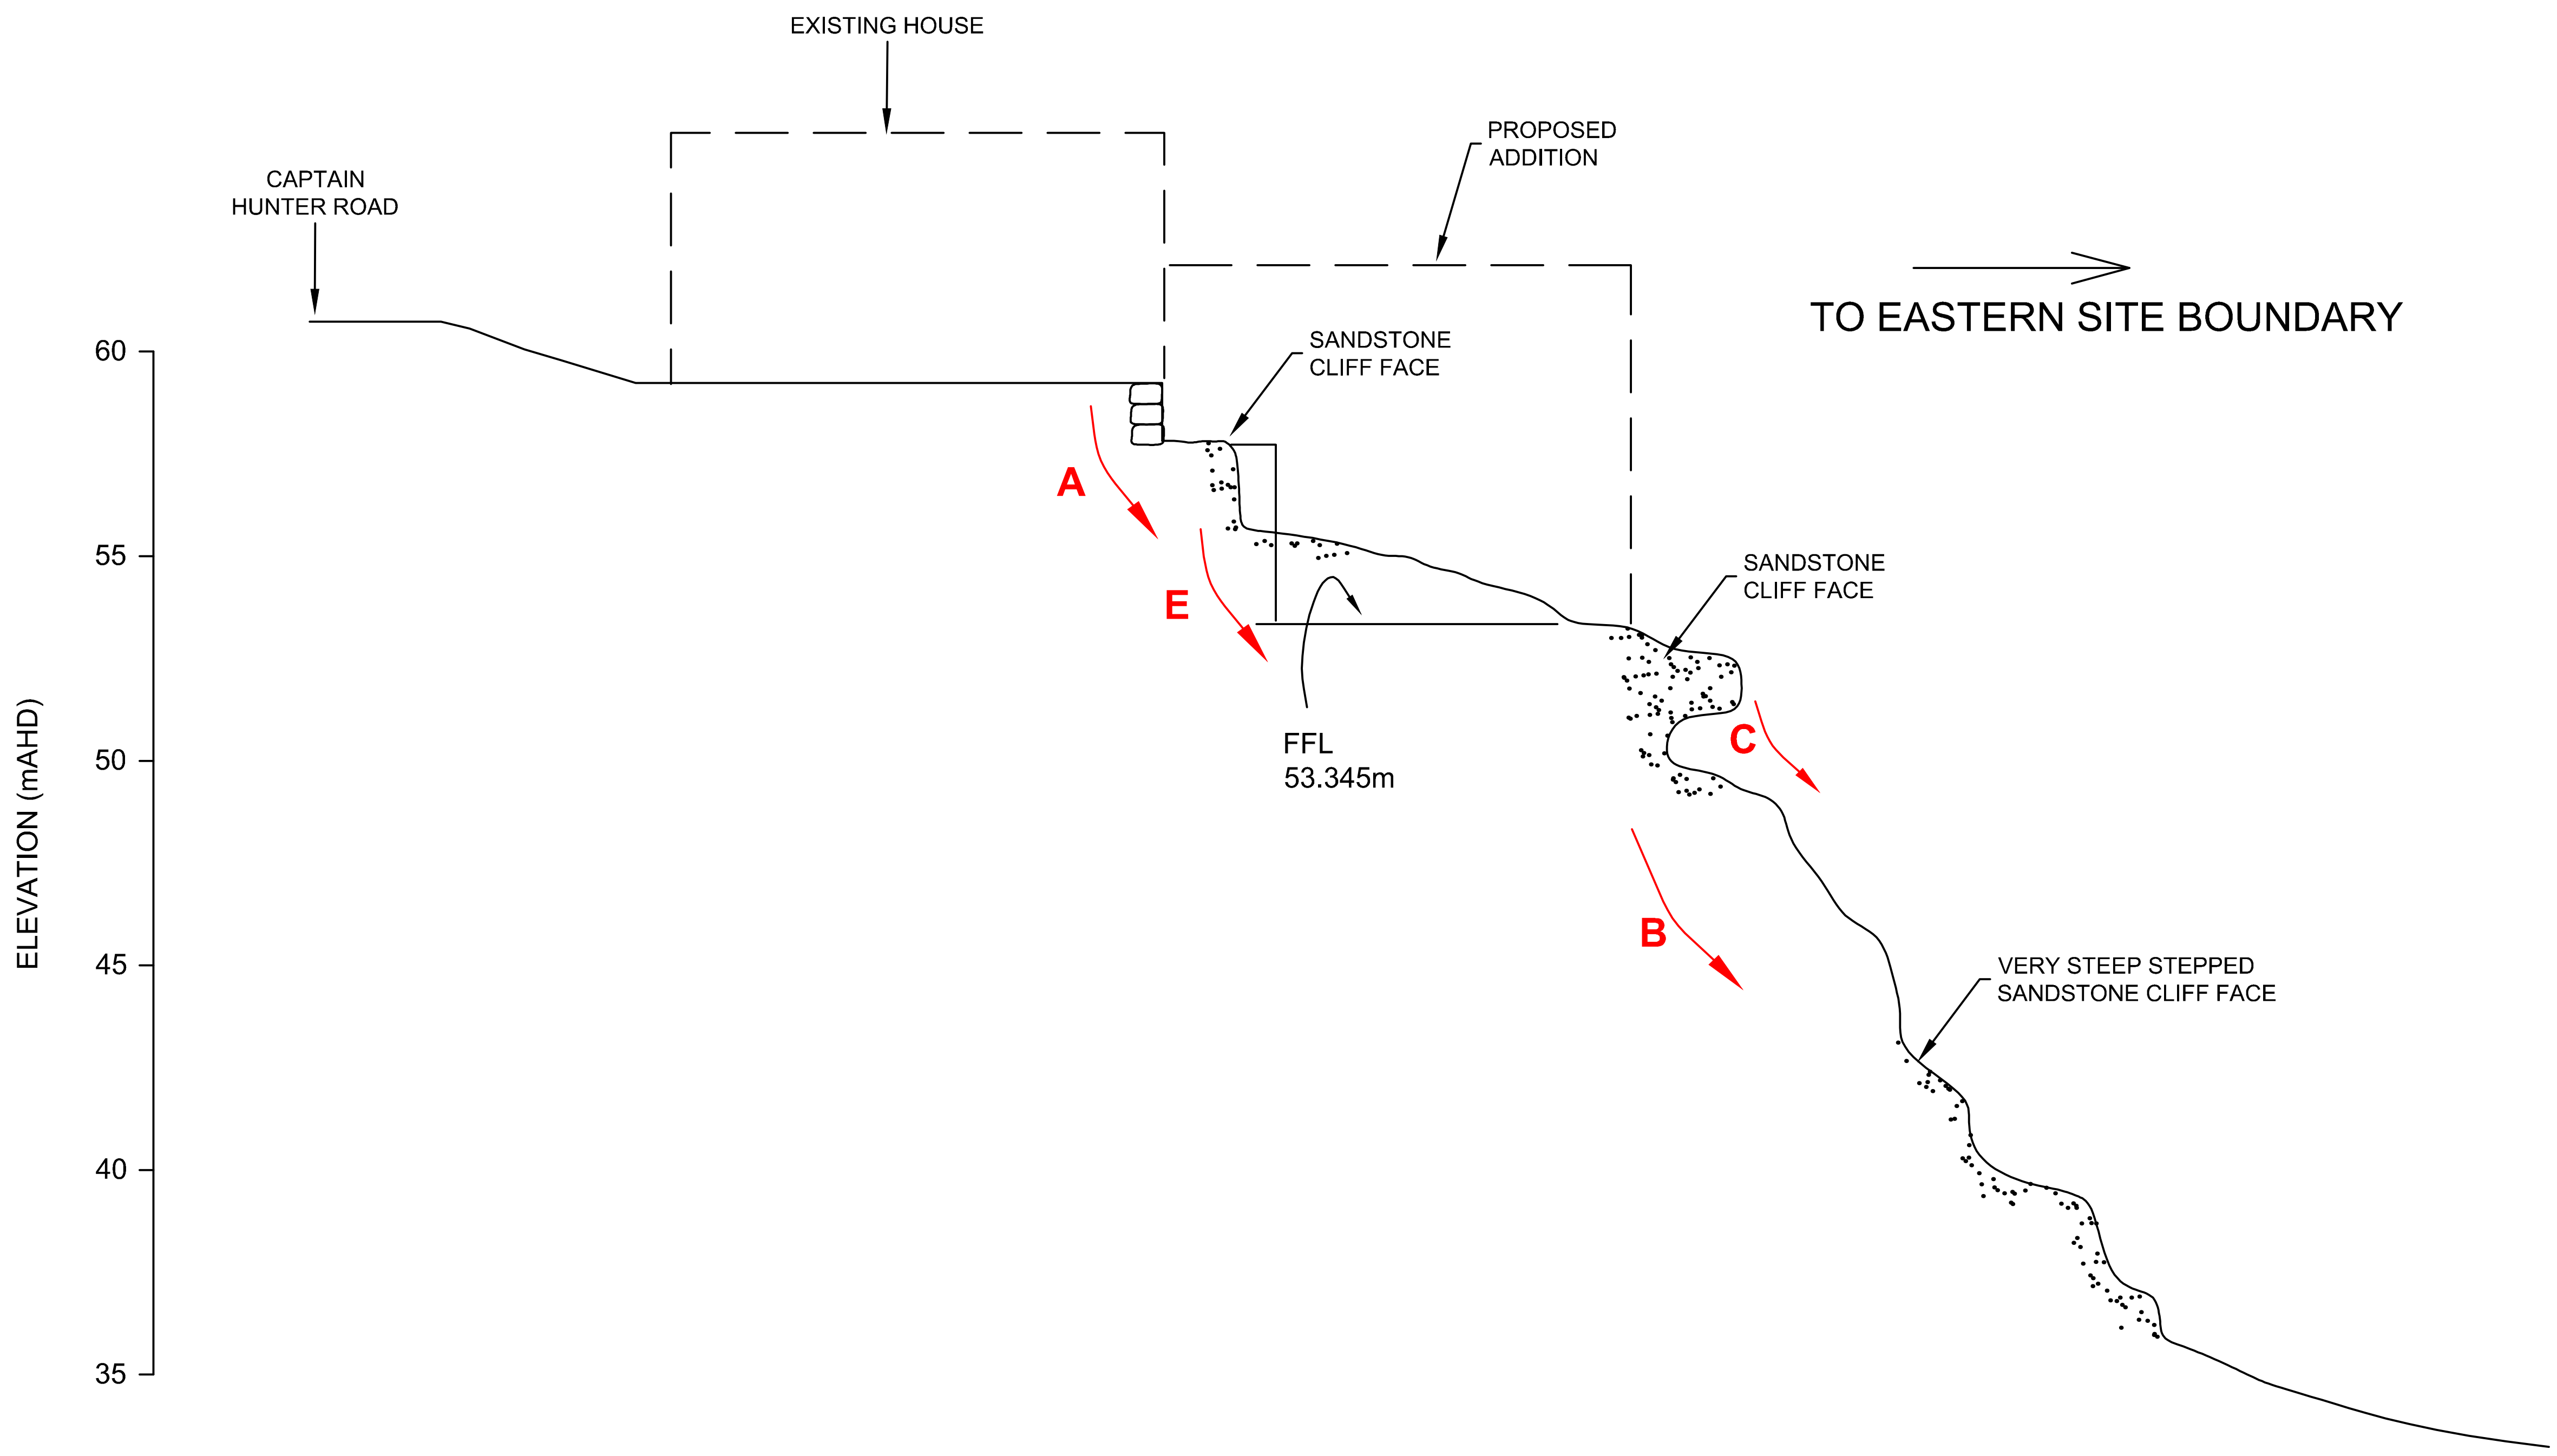
Some of these potential hazards are indicated in schematic form on the attached Figure 3.
