GEOTECHNICAL RISK MANAGEMENT POLICY FOR PITTWATER
FORM NO. 1 – To be submitted with Development Application

Address of site ____90 Hudson Parade, Ckareville, NSW_____

Report Title: Geotechnical Assessment

Report Date: 16 December 2022 Report Ref No: 35686Yrpt
:
Author: Woodie Theunissen

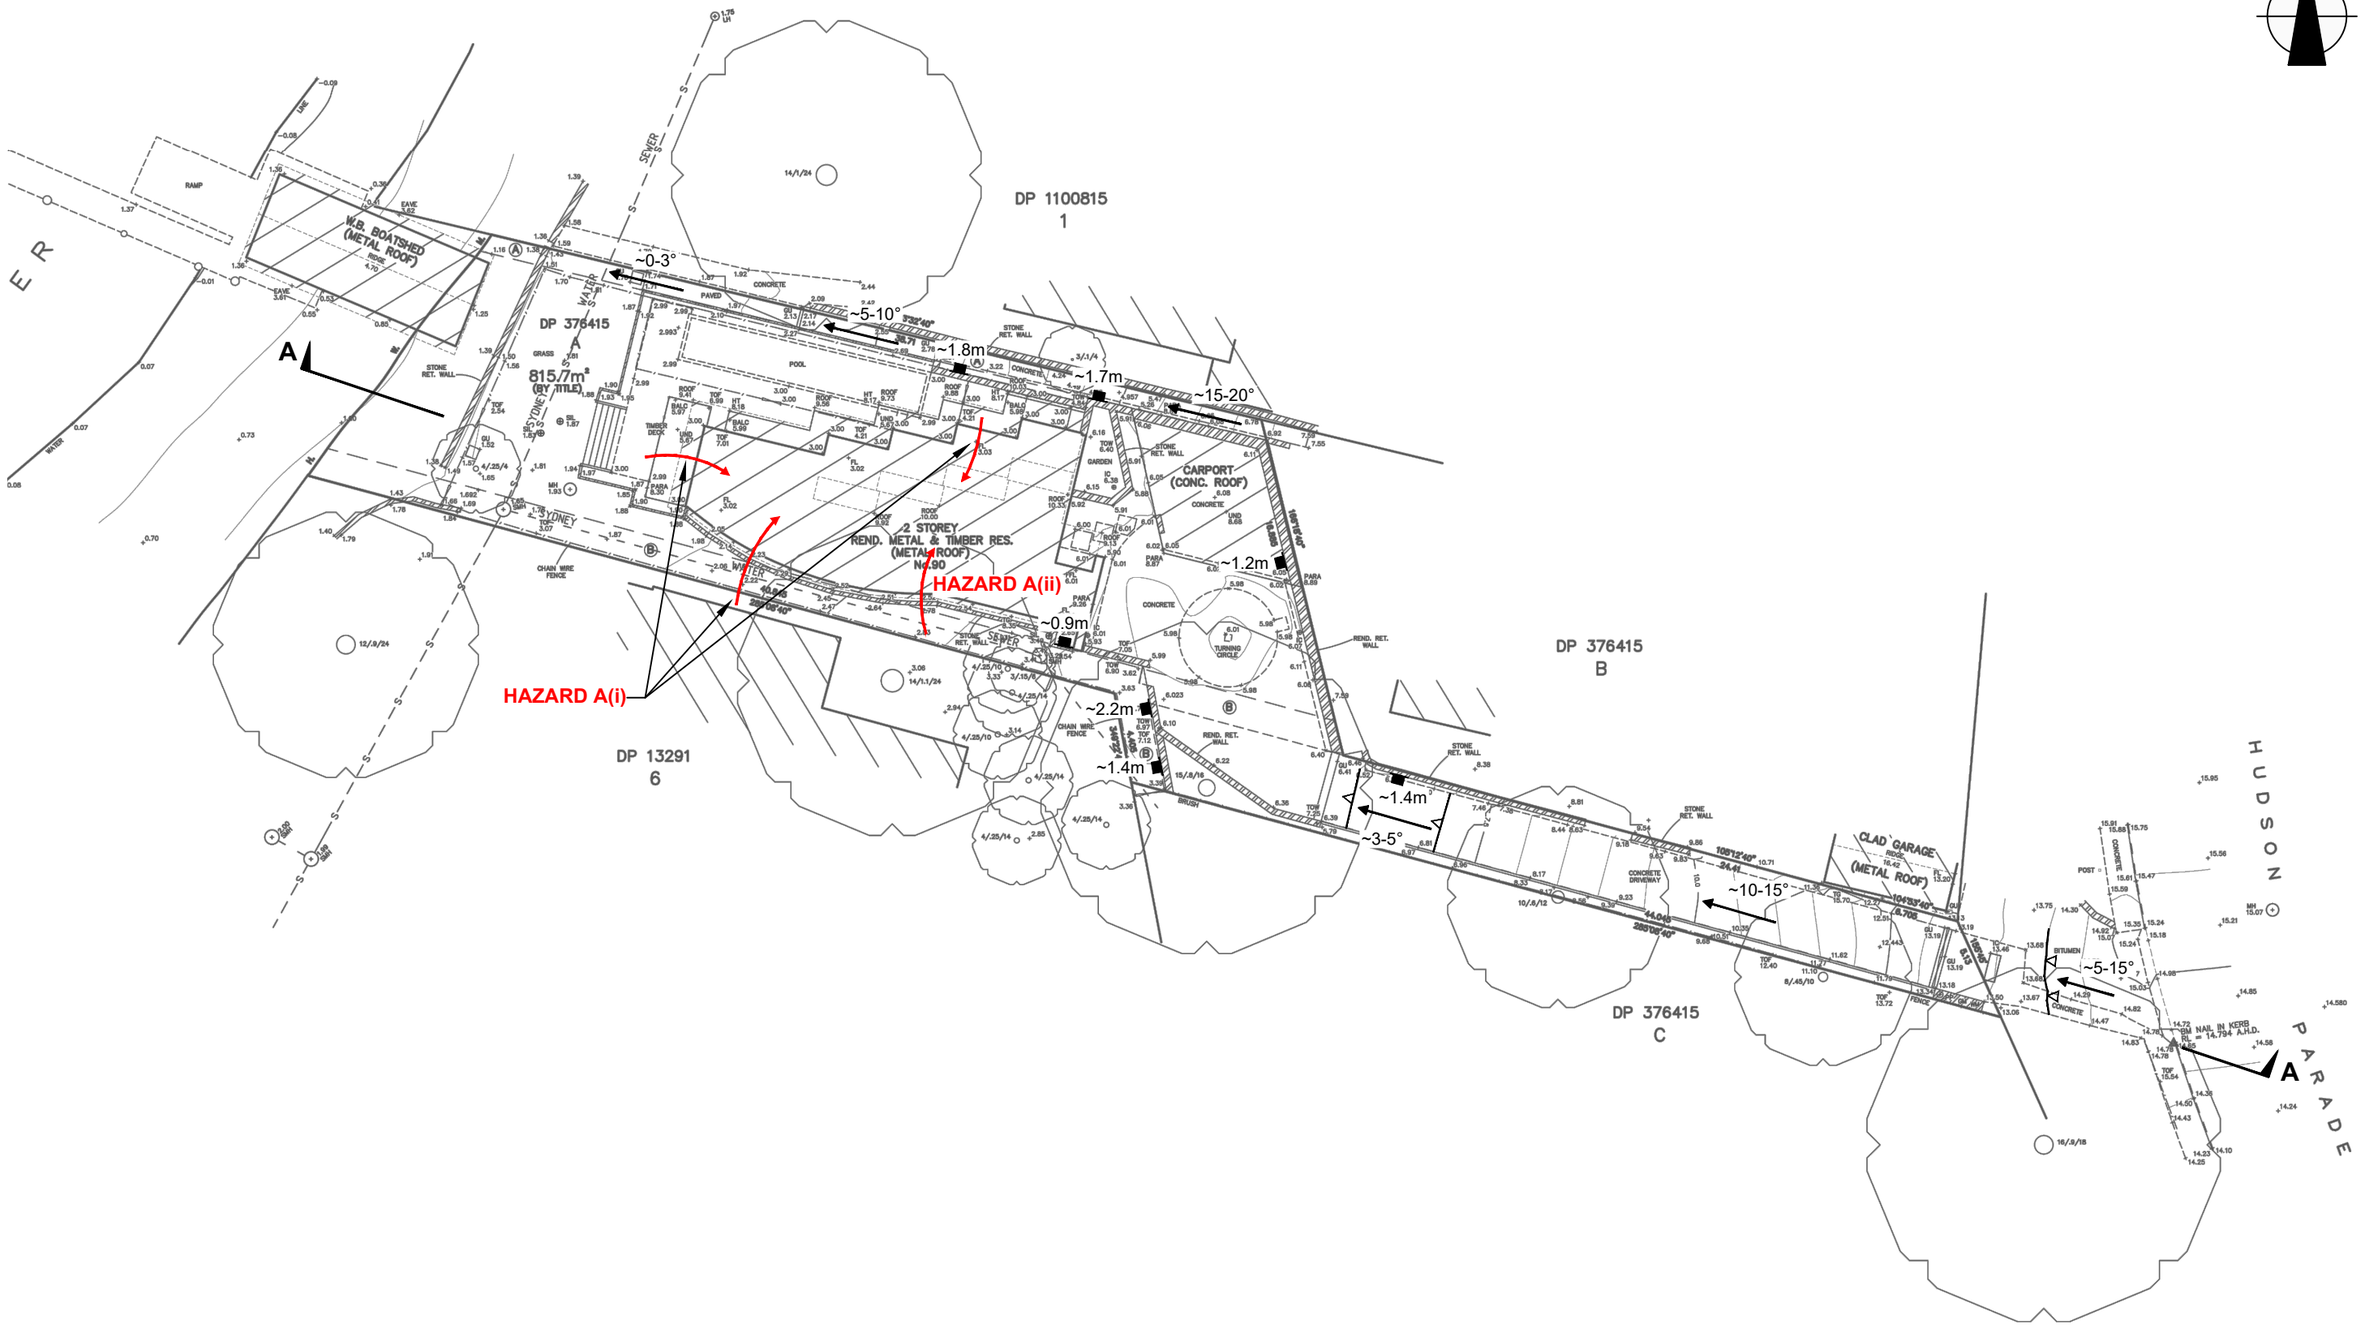
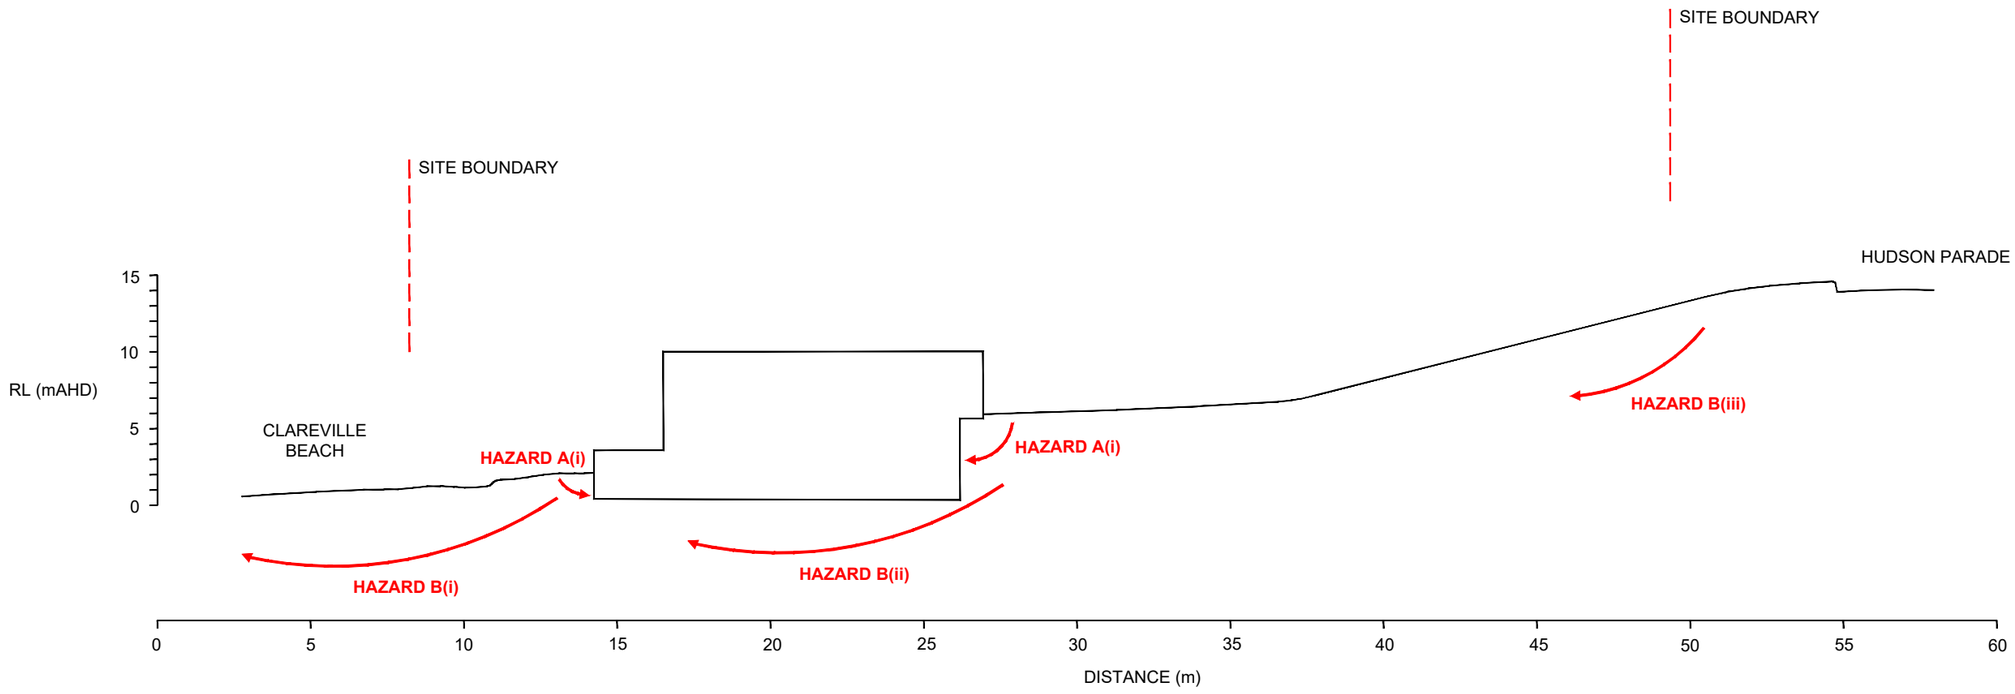
The attached Figure 2 presents a geotechnical sketch plan showing the principal geotechnical features present at the site. Figure 2 is based on the survey plan prepared by Hill and Blume (Drawing No:60279001C dated 24 February 2022). Additional features on Figure 2 have been measured by hand held inclinometer and tape measure techniques and hence are only approximate. Should any of the features be critical to the proposed development, we recommend they be located more accurately using instrument survey techniques. Figure 3 presents a typical cross-section through the site based on the survey data augmented by our mapping observations.

These potential hazards are indicated in schematic form on the attached Figure 2.
