Arboricultural Impact Assessment
Northern Sydney Asset Management Unit
Narrabeen North Public School

23 June 2020

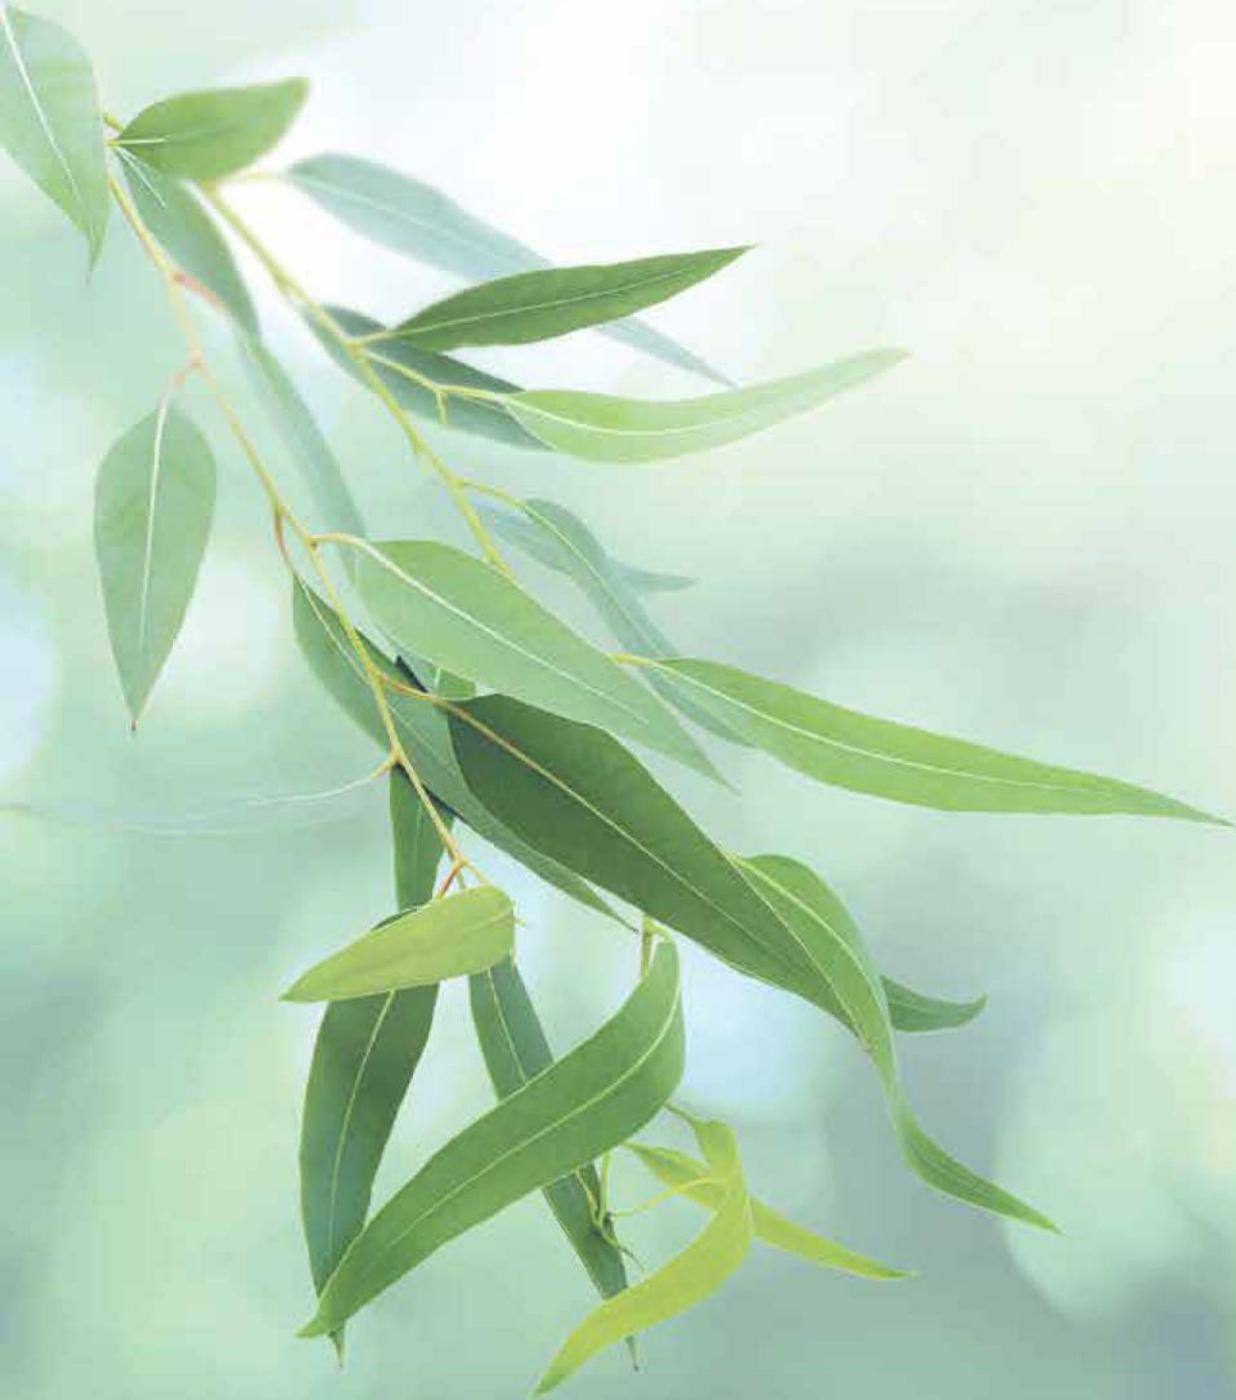
Site Assessment Data

40	<i>Eucalyptus tereticornis</i>	Forest Red Gum	1	24	29	2.9	26.06	2.0	5-10	<5	Good	Fair	Semi-Mature	25-50	Co-dominant stems;Deadwood/stubs < 30mm;Soil compaction;Suppressed;Wound(s);	Amenity value/shade;		- 18-06-2020 : Justin Herbert : Tree assessed. - 27-08-2019 : Alex Austin : Tree assessed.	C	12	Retain tree with generic protection requirements (i.e. protective fencing and restriction of activities within the TPZ).
41	<i>Corymbia citriodora</i>	Lemon-scented Gum	1	104	94	12.5	489.30	3.2	10-15	15-20	Good	Fair	Mature	25-50	Co-dominant stems;Epicormic growth;Mechanical damage to root(s);Previous failure(s);Resin exudation/kino;Soil compaction;Soil grade changes;Wound(s);	Amenity value/shade;Attractive landscape feature;Significant due to age/size;Dominant landscape feature;		- 18-06-2020 : Justin Herbert : Tree assessed. - 18-06-2020 : Justin Herbert : Tree assessed. - 27-08-2019 : Alex Austin : Tree assessed.	A	12	Retain tree with specific protection requirements (i.e. Generic measures plus supervision of works within the TPZ and/or use of root sensitive construction techniques).

- 6.3.1 Trees 38 and 41 were recommended for retention and require specific protection measures during construction to ensure they remain viable following the completion of works. Tree 40 is deemed to be retainable due to its location inside the TPZ of Tree 41.
