Geotechnical Assessment

Project: Alterations & Additions
4 Kunari Place, Mona Vale NSW

Ref: AG 24539
2 December 2024

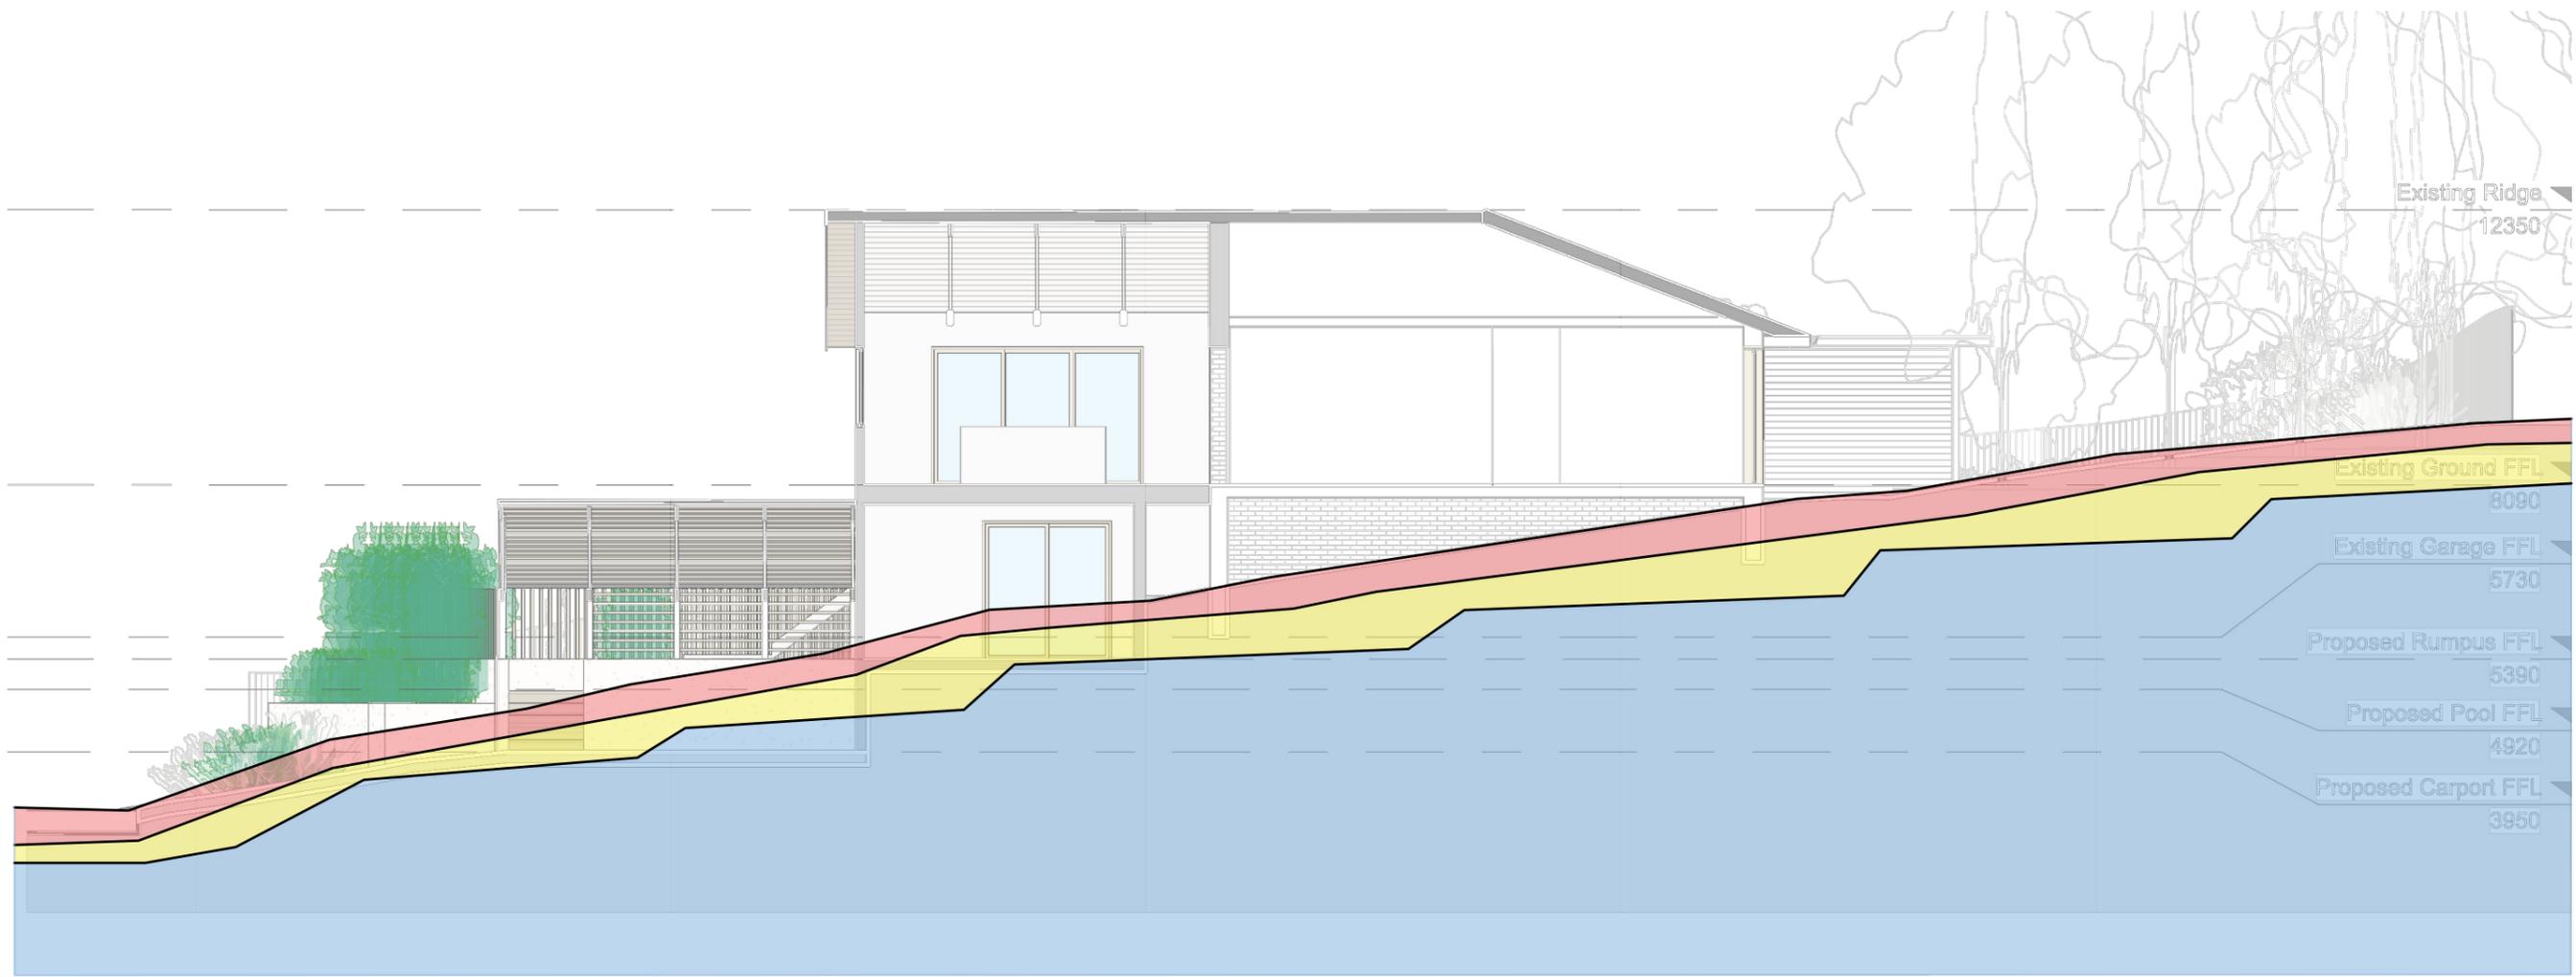
INFERRED GEOLOGICAL SECTION
SCALE NTS

The soil profile consists of shallow uncontrolled silty fill and silty topsoil (O & A Horizons), inferred silty clay (B Horizon) and weathered low strength bedrock (C Horizon). Based on our observations and the results of testing on site, we would expect low strength weathered bedrock to be found within 0.45 to 1.45 metres below current surface levels across the area of the proposed works, potentially deeper where filling has been carried out.
