# **MARINE POLLUTION RESEARCH** PTY LTD

## **AQUATIC ECOLOGY ASSESSMENT FOR THE PERMANENT USE OF THE BERTHING AND PONTOON FACILITIES AT 38 CABARITA RD, AVALON BEACH.**

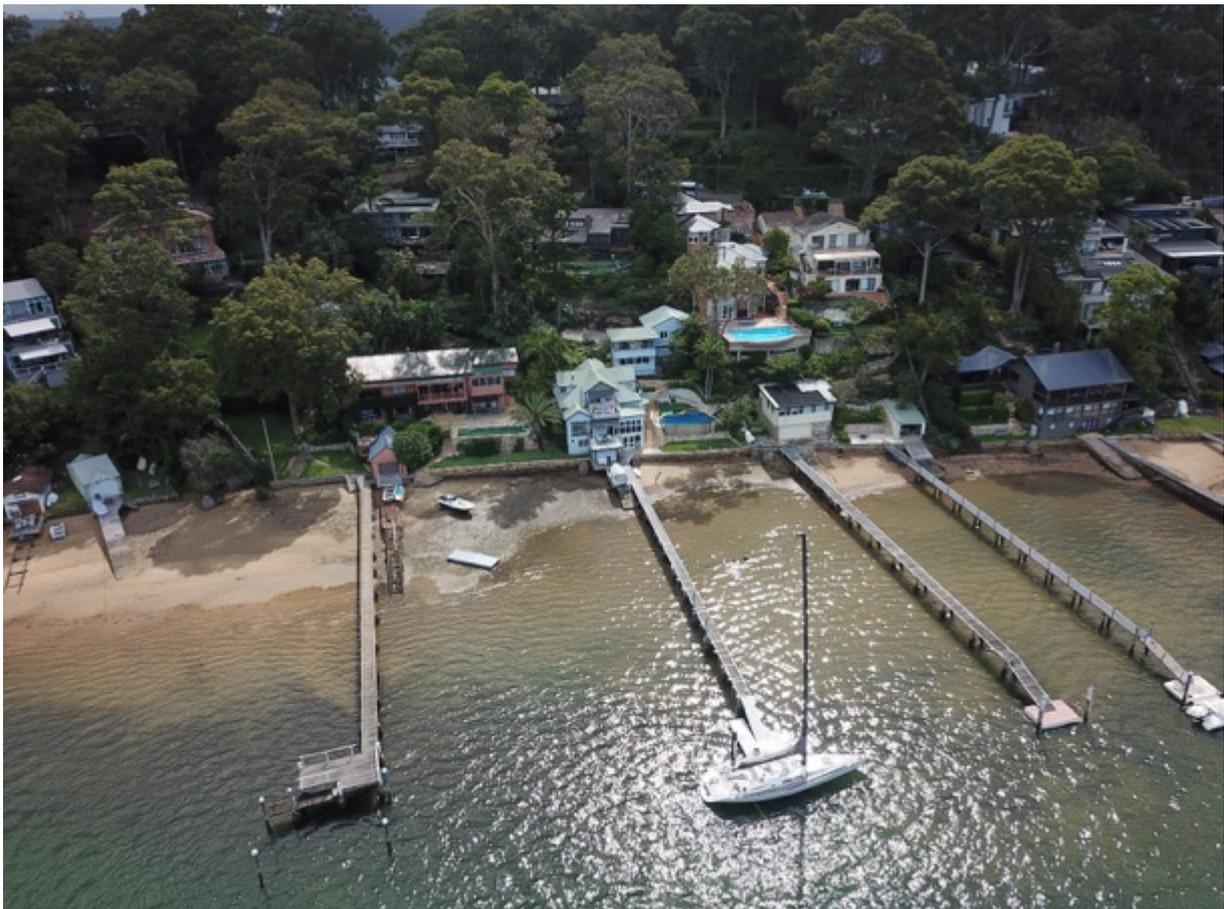
**Figure 1** Oblique drone view of the waterfront facilities and berth at 38 Cabarita Rd, Avalon Beach.

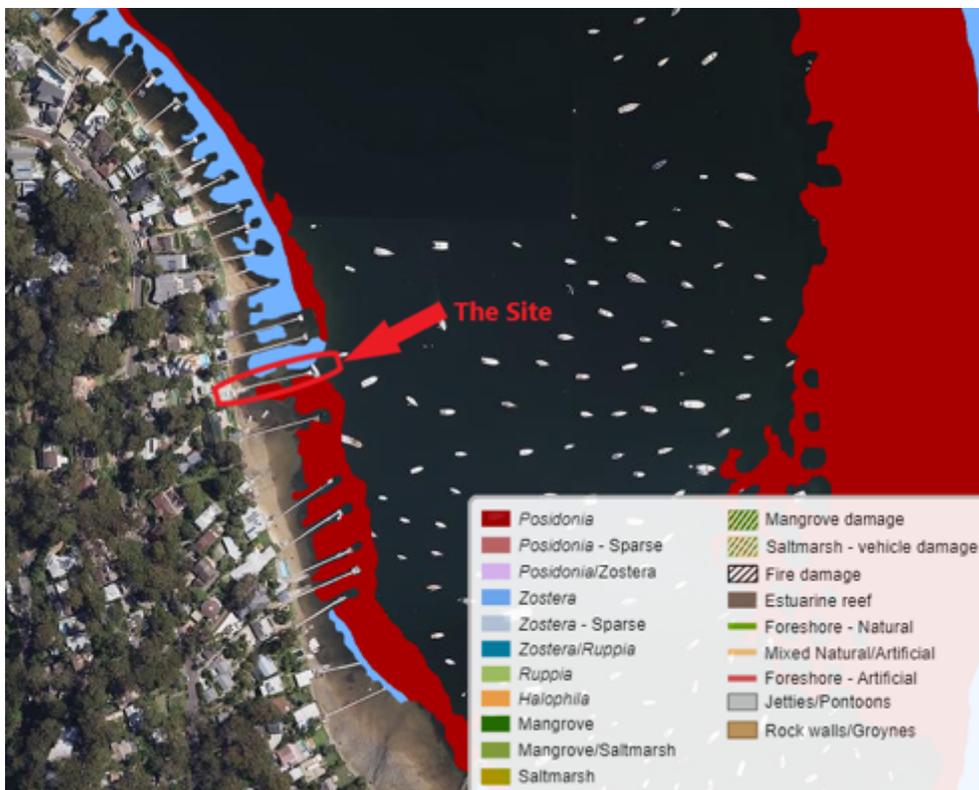
In terms of existing aquatic ecological habitat information, the 2005 DPIRD Fisheries key fish habitat mapping noted an absence of seagrass offshore from the wharf at 38 Cabarita Rd, with inshore shallow water seagrass predominantly *Zostera* to the north of the site and primarily bare sediment plus shallower *Posidonia* seagrass to the south (**Figure 2**).

**Figure 2** Portion of DPIRD Fisheries NSW Marine Vegetation Map 2005 for Pittwater showing *Posidonia* (red) and *Zostera* (Blue) seagrass.

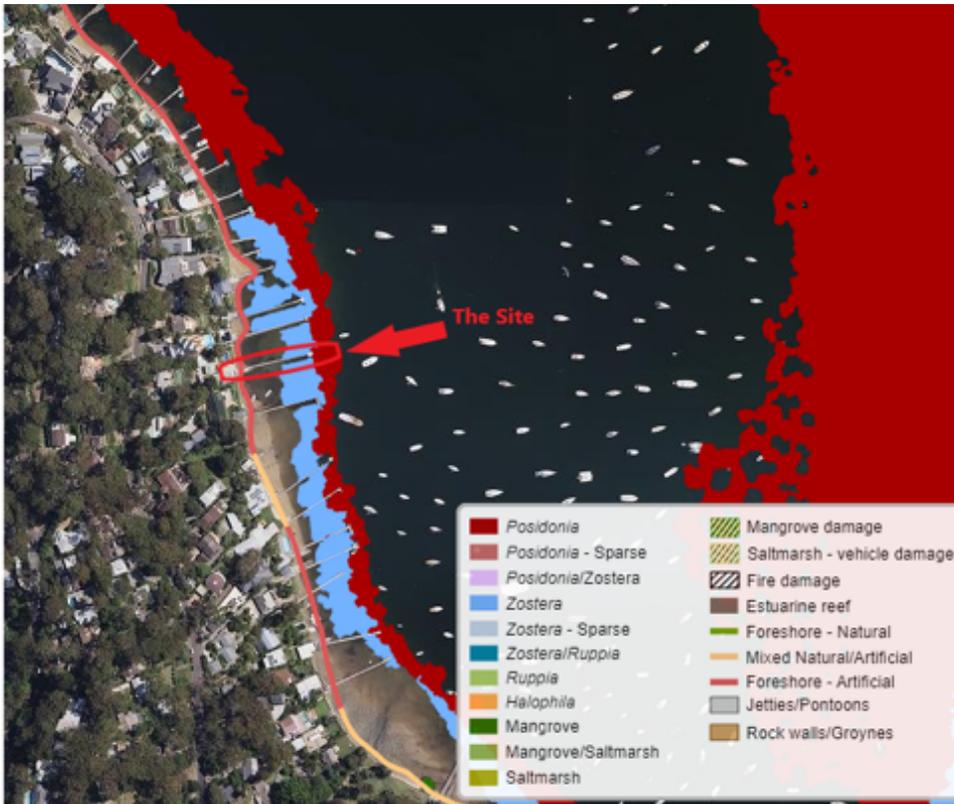
The most recent DPIRD Fisheries NSW marine vegetation habitat map for Pittwater from 2019 indicates a continuous band of *Posidonia* offshore from the waterfront properties with a fragmented band of *Zostera* seagrass inshore (**Figure 3**).

**Figure 3** Portion of DPIRD Fisheries NSW Marine Vegetation Map 2019 for Pittwater showing *Posidonia* (red) and *Zostera* (Blue) seagrass.

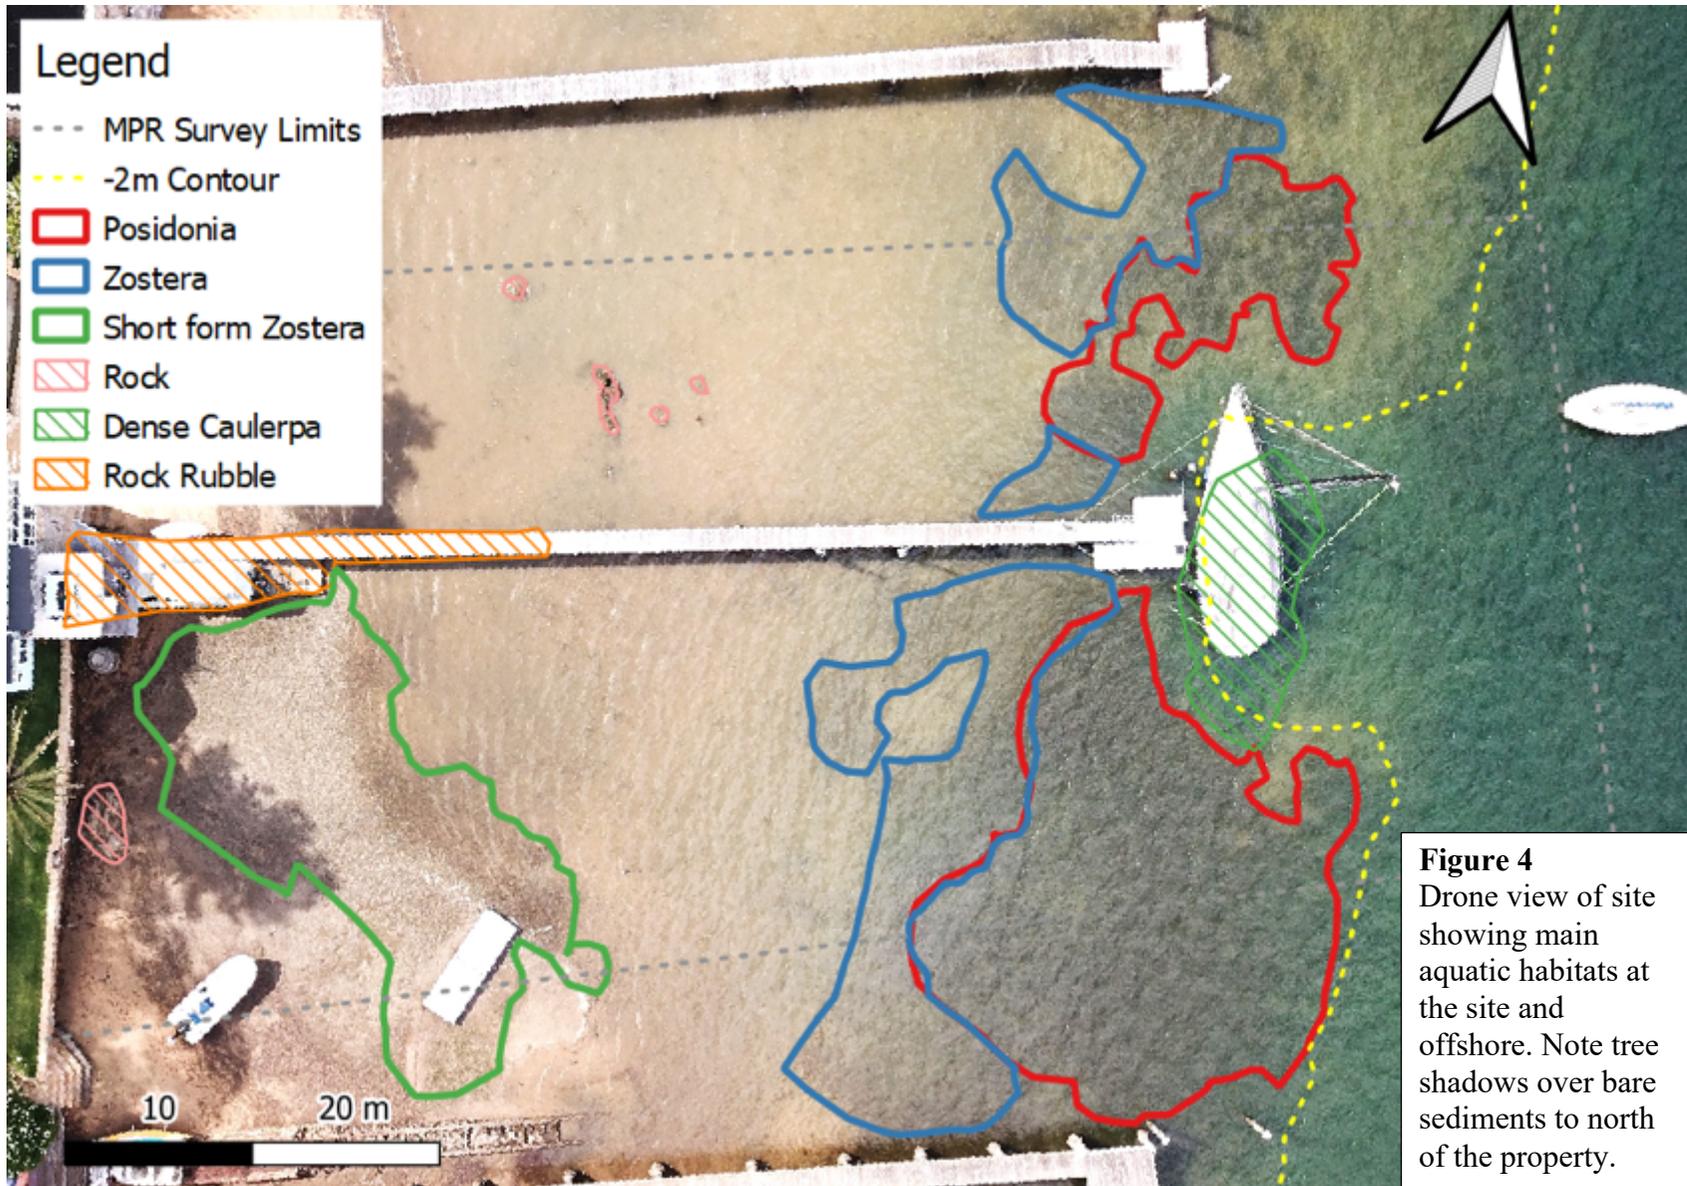
- The riparian zone comprises reclamations with a grassed area and boatshed retained by a sandstone block seawall (**Figures 4 and 5**).
- There is some exposed basement rock under the seawall to the south and there is stacked rock rubble under the ramp and inner portion of the jetty (**Figures 4 to 6**).

- The *Zostera* and *Posidonia* seagrass beds identified for this proposal in **Figure 4** are Type 1 “highly sensitive KFH”.
- The small, exposed rock habitats to the north of the jetty in sub-tidal shallows (may be considered Type 2 “moderately sensitive KFH, due to the presence of some sub-tidal algae.
- The un-vegetated marine silt-sands and the pocket beach sand on the north side of the jetty are Type 3 “minimally sensitive” KFH.
- The intertidal to shallow sub-tidal rock rubble habitat under the inshore deck, ramp and jetty can be considered Type 2 “moderately sensitive KFH, due to the presence of some sub-tidal algae for the outermost shallow rock, and combined with the innermost rock rubble, provide valuable habitat for oyster and crustacean based biotic assemblages, enhanced by the shading protection afforded by the deck, ramp and jetty timber structures.

- The widened southern portions of the inshore deck and timber ramp are both located over shallow tidal rock rubble habitat and provide some additional shading for that habitat in mid-summer whilst not impacting on the short form *Zostera* habitat that abuts the rock rubble on the south side (**Figure 4**).
- As this shading is beneficial for the rock rubble molluscs and crustaceans this impact is considered beneficial for overall aquatic ecology of the site and of Careel Bay.
- The stone seastairs are built onto an intertidal sandy pocket beach and provide some intertidal wetted surfaces for molluscs. The imposition of the sea stairs is not considered to have materially impacted the possible beach invertebrate fauna which would be expected to be minimal in any case due to both its small size and probable instability due wave mediated mobilisation.

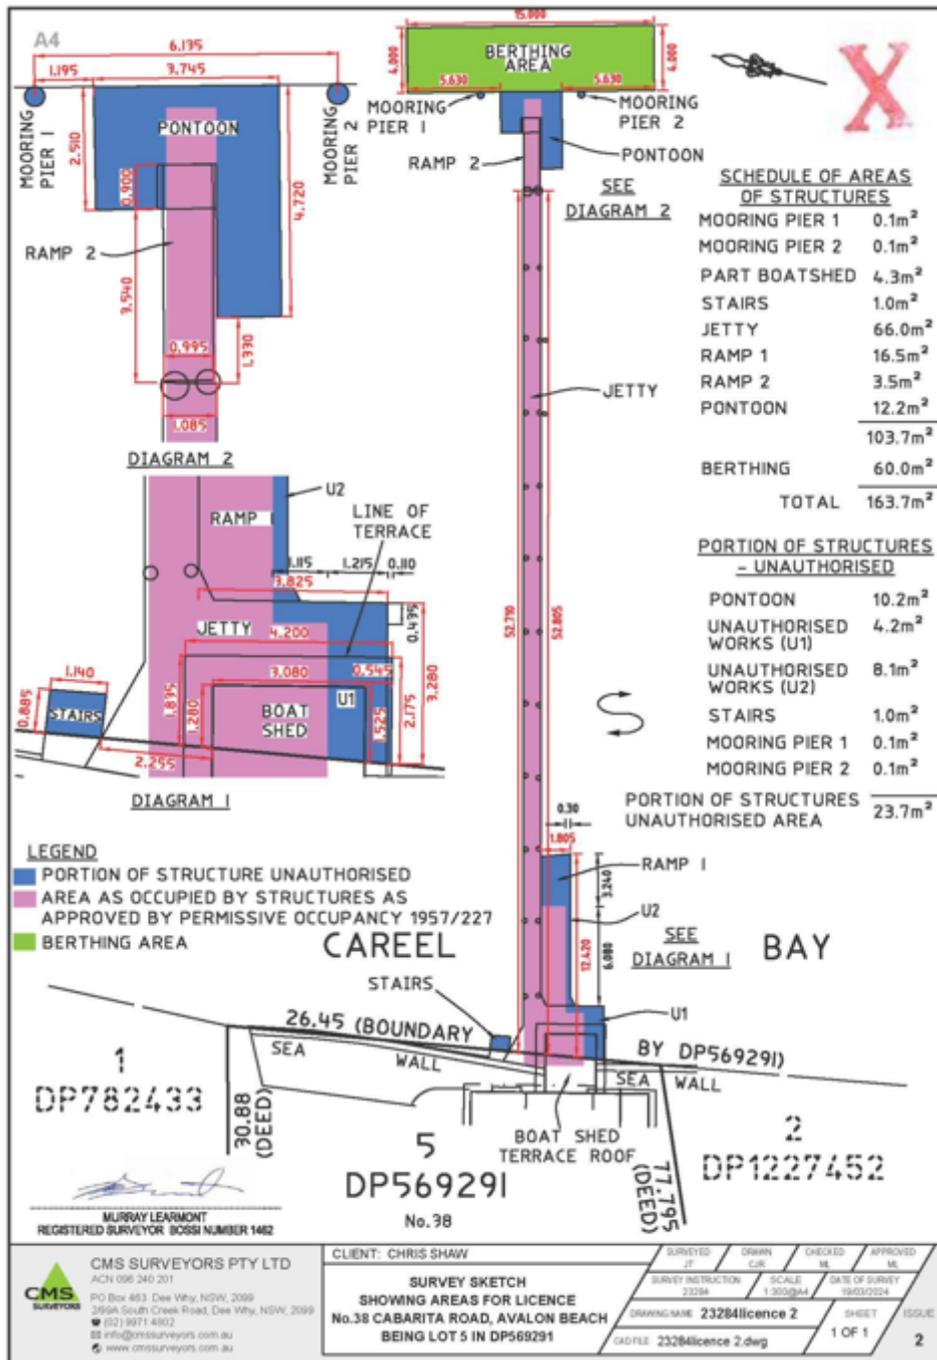
The original 1957 permissive occupancy was for a boatshed, landing, timber slipway and timber jetty, and the present application is for the regularising of unauthorised structures beyond the original 1957 PO via a Building Information Certificate (BIC) plus a Development Application for the existing pontoon facility and an associated mooring pen and mooring piles. (Figures 13).

Figure 13 19 March 2024 Survey detailing approved and unapproved structures the pontoon facility and the proposed berthing pen

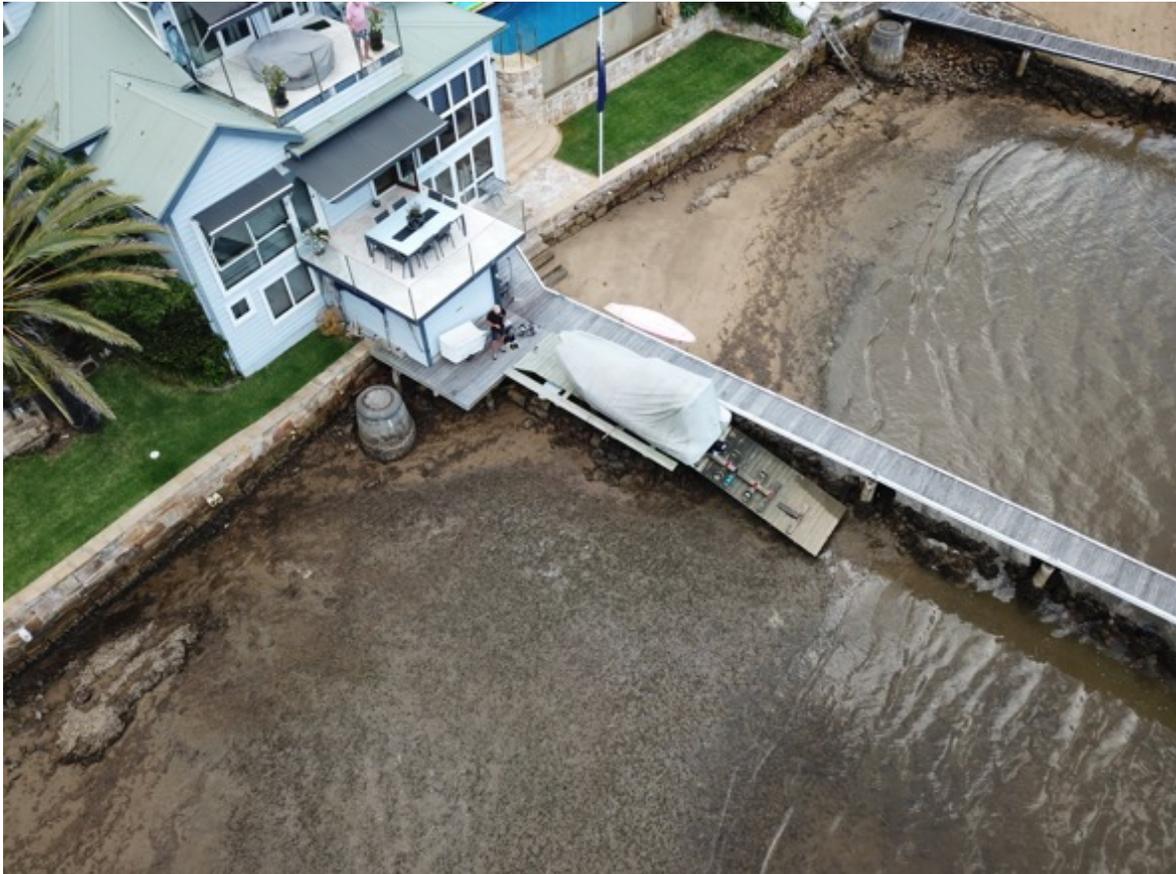
**Figure 14** Drone view of existing boatshed, sea stairs and the intertidal deck plus ramp and jetty facilities in relation to the intertidal rock rubble habitats, the pocket sandy beach to the north and the intertidal to shallow sub-tidal Short Form *Zostera* seagrass bed to the south.

**Figure 14** provides an inshore drone image of the property that includes all the inshore amendment elements. The BIC elements for intertidal structures are the widened section of inshore deck under the approved boatshed and extending out a small distance offshore, the widening of the approved ramp (both to the south of the existing approved structures (see also **Figures 5 and 6**), and sandstone sea stairs immediately north of the approved jetty (also **Figure 7**).

The southern deck widening abuts a concrete sewer inspection structure (**Figure 14**) and there is rock rubble habitat under the approved and extended intertidal structures:
