Report Title: Geotechnical Report <u>16 Cabarita Road, Avalon</u>
Report Date: <u>15/6/20</u>
Author: <u>BEN WHITE</u>
Author's Company/Organisation: <u>WHITE GEOTECHNICAL GROUP PTY LTD</u>

GEOTECHNICAL INVESTIGATION:

New Inclined Lifts at 16 Cabarita Road, Avalon

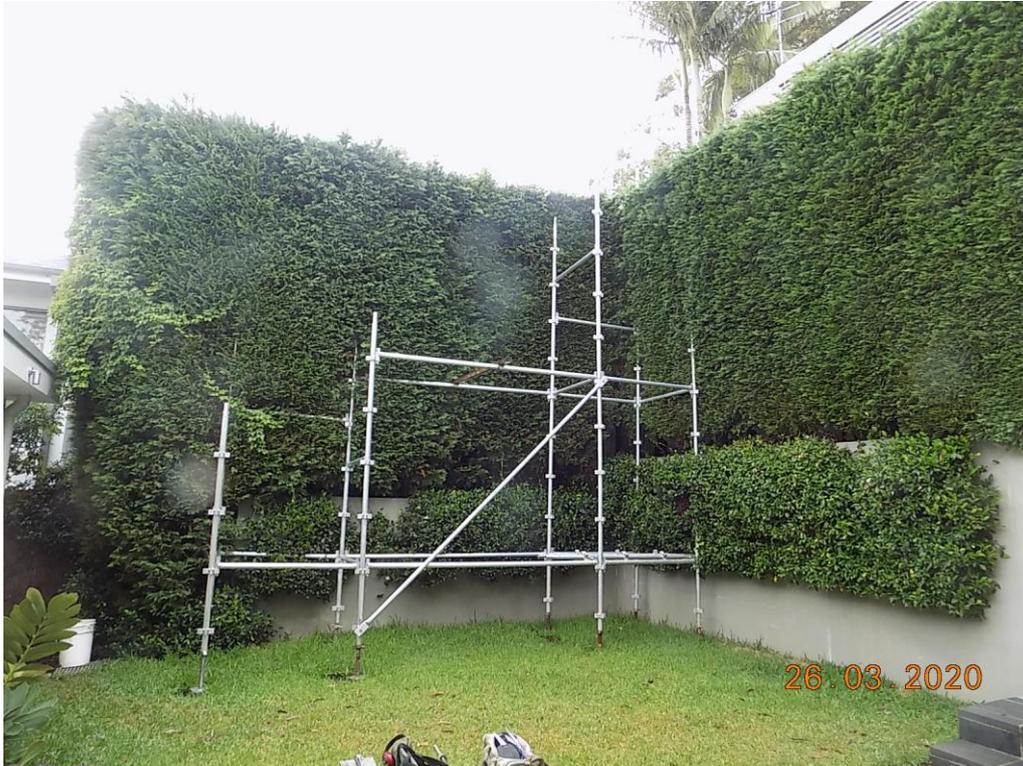
Photo 2

2.3 At the road frontage, a concrete driveway runs to a stable garage along the upper boundary of the property (Photo 1). On the downhill side of the garage, an excavation has been made into the slope for a level lawn above the house (Photo 2). The excavation is supported by rendered masonry retaining walls that appear well constructed (Photo 3). The one and two storey clad house displays no significant signs of movement in the external supporting walls (Photo 4). Construction work was currently underway on the downhill side of the property for a separate DA. This slope contains some embedded boulders (Photo 5). Most of the boulders appear to be sitting in stable positions. One of the boulders immediately above the near
