# Geotechnical Assessment

**Project:** Alterations & Additions  
19 Emma Street, Mona Vale NSW

**Ref:** AG 25405  
22 September 2025

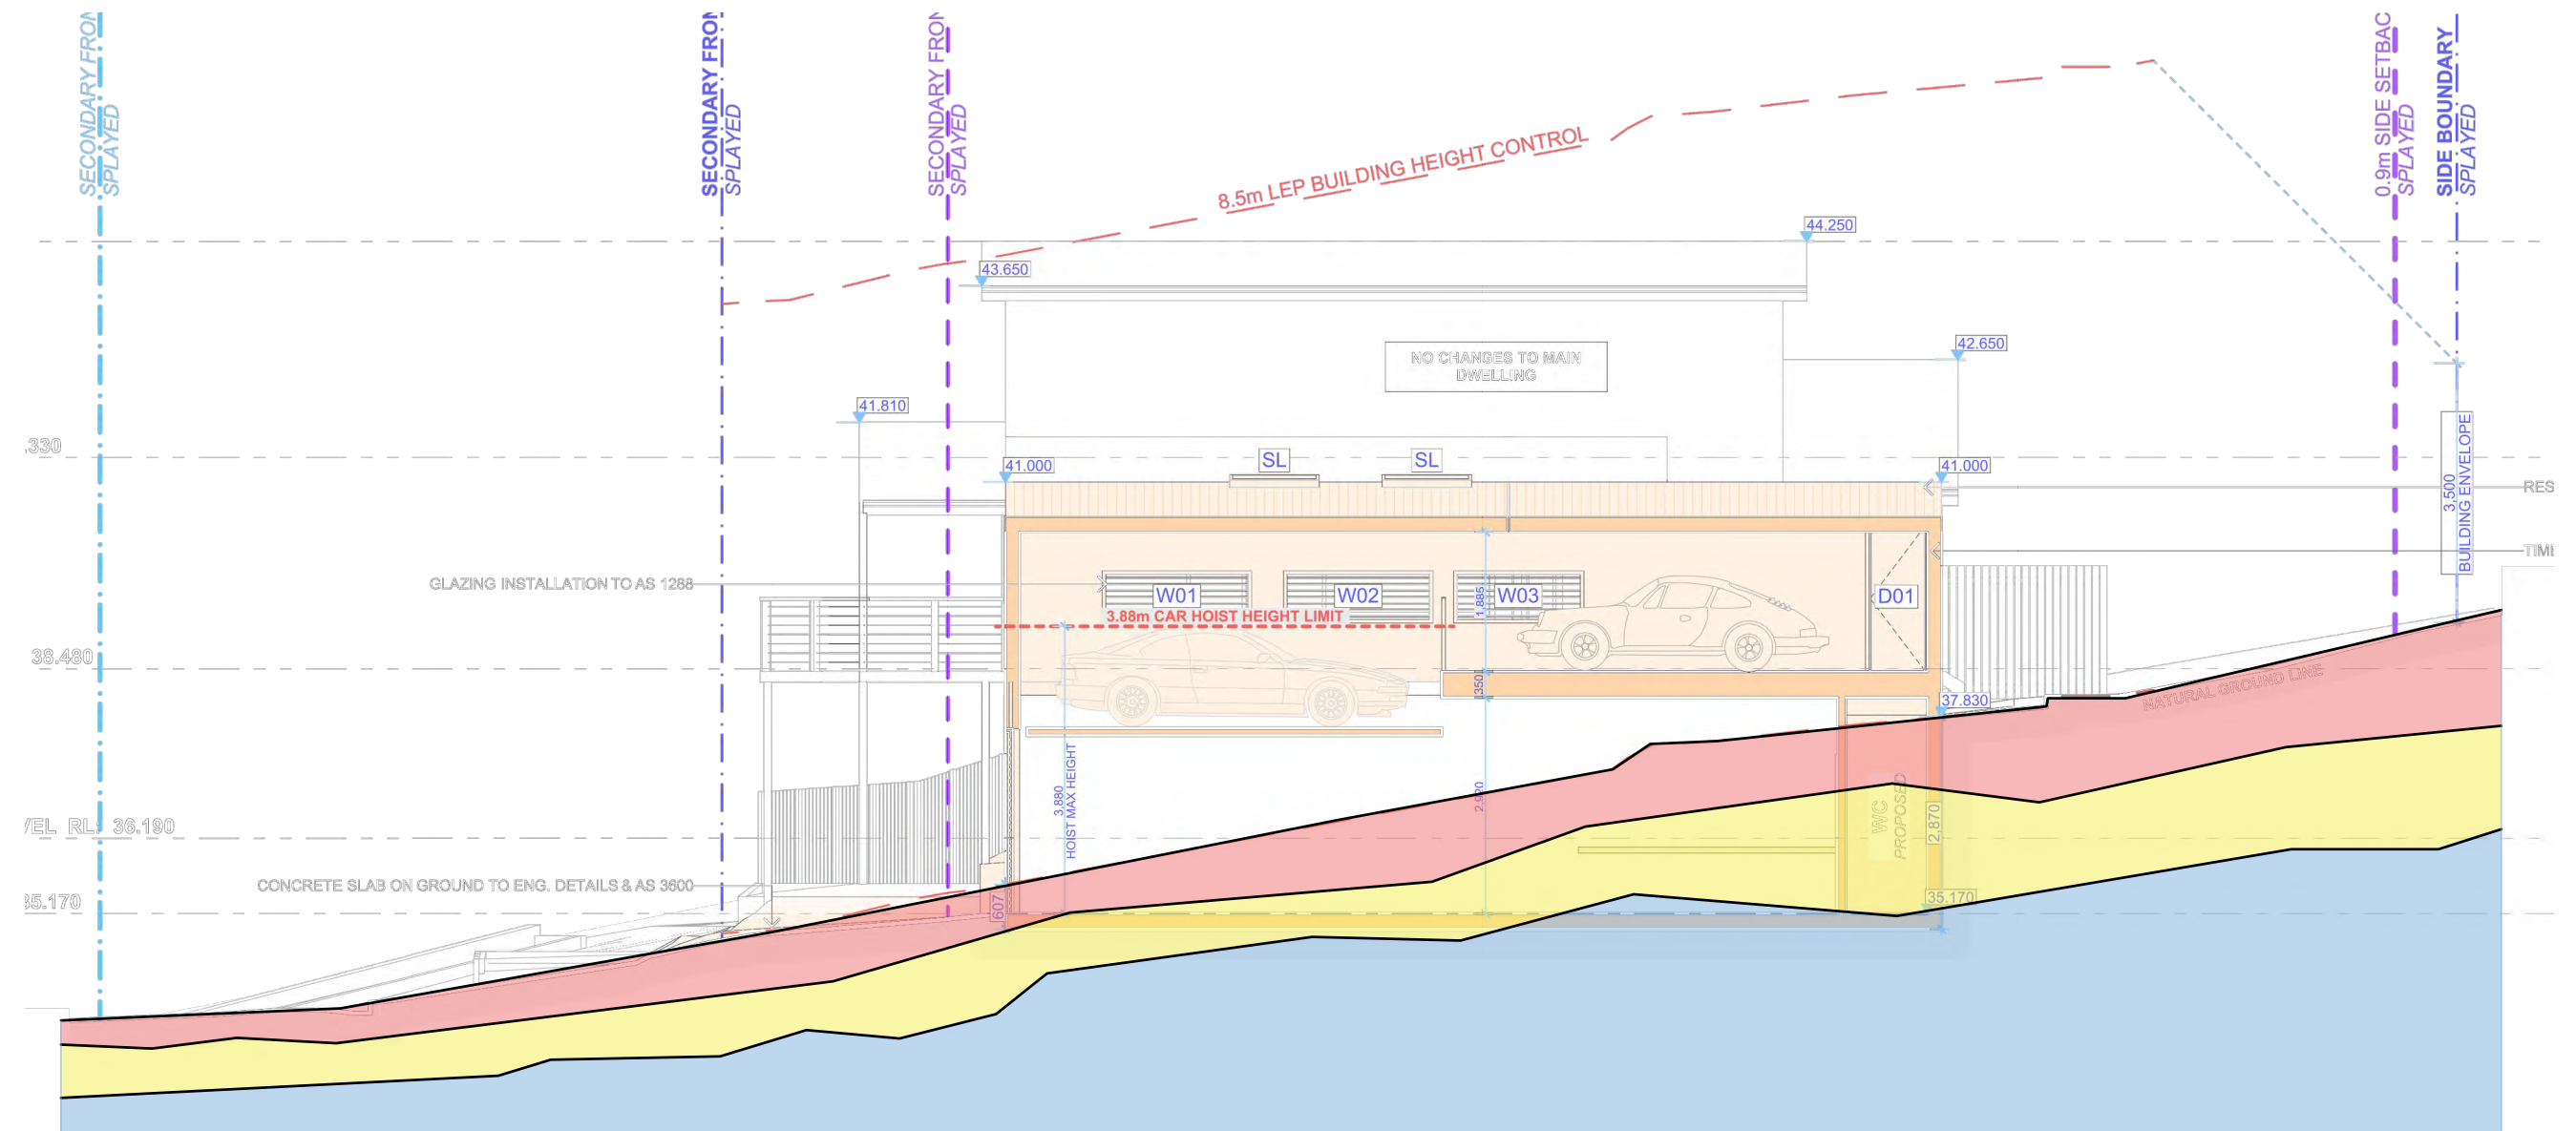
**INFERRED GEOLOGICAL SECTION**  
SCALE NTS

The soil profile consists of shallow uncontrolled sandy fill and silty topsoil (O & A Horizons), silty/sandy CLAY (B Horizon) and weathered low strength bedrock (C Horizon). Based on our observations and the results of testing on site, we would expect weathered low strength weathered bedrock to be found within 1.5 to 2.7 metres below current surface levels across the area of the proposed works and potentially deeper where filling has been carried out.

| Test | Summary |
|---|---|
| DCP 2 | Practical Refusal @ 1.8m DCP unable to penetrate through inferred weathered bedrock. Red brown silty clay on moist to very moist tip. |
