5 Portions, Lovett Bay, Lovett Bay

Geotechnical Investigation and Landslide Risk Assessment

September 2023

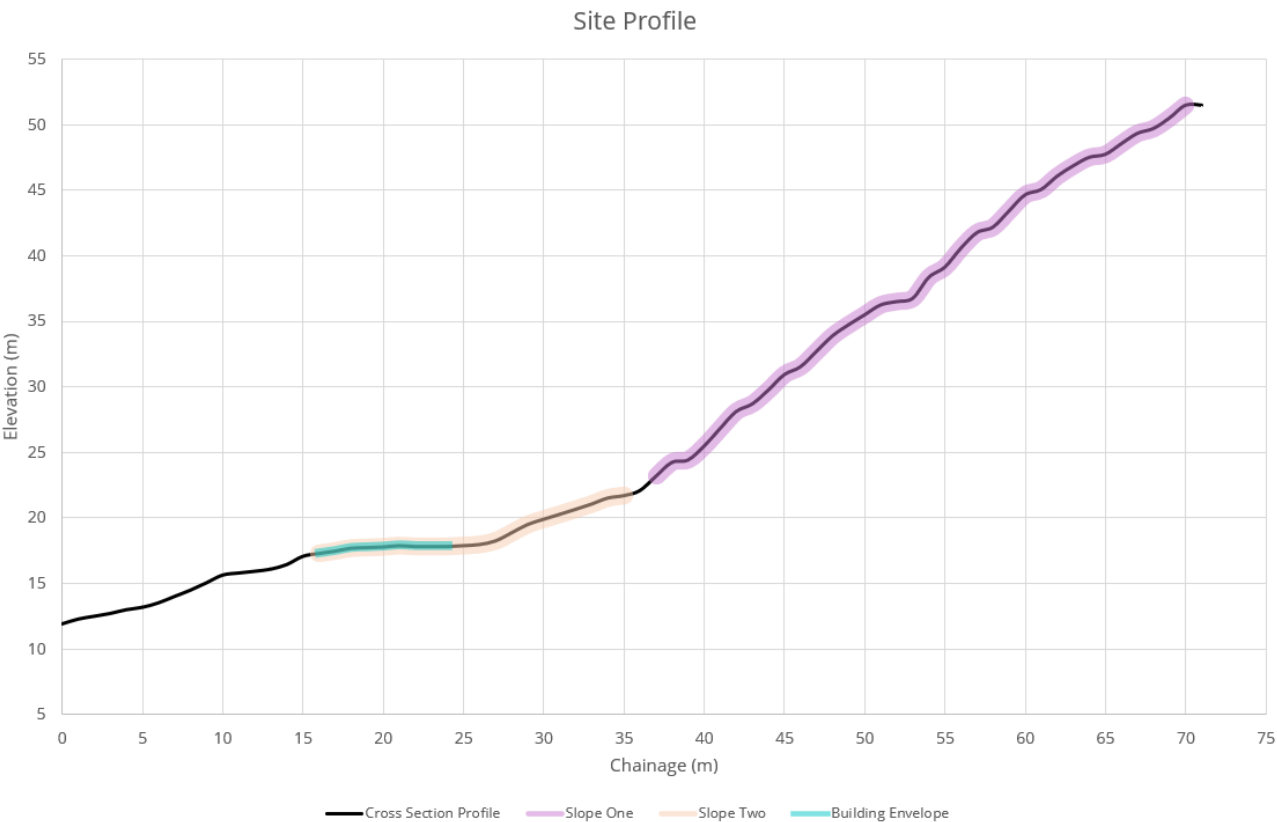
Figure 3.1: Profile Cross-section south to north (site building envelope in blue)

The inclination of a slope is the biggest consideration when determining the type(s) of landslide and likelihood. It is closely related to the landform (Section 3.2). Lidar data with a 1m² resolution has been used for the terrain analysis. The slope profile is based on 3.0m elements which reveals an average slope of 38.6° and a maximum slope of 50.7° above the building envelope. Within the building envelope, the average slope is 4.7°.

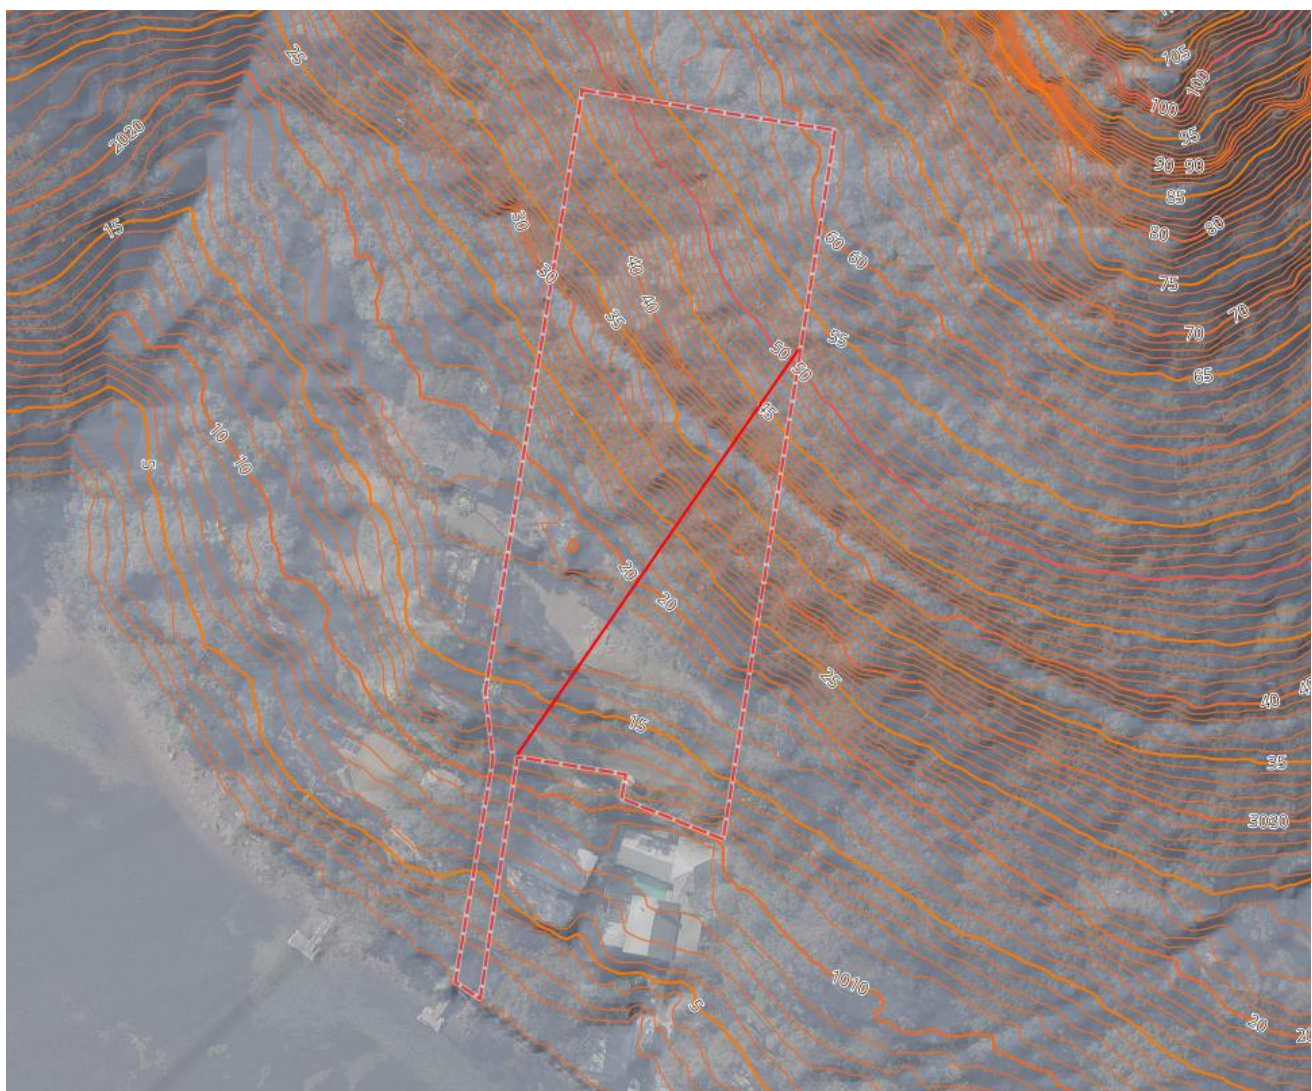
**Figure 3.2:** Site morphology and slope cross section profile (red line)

A general assessment of the likely surface water interaction with the landform is summarised in Table 3.5 below. Figure 3.2 shows the results of the Terra Flow analysis (see Appendix B for the full map). The analysis shows that surface water is most likely to flow south and east of the site.

Figure 3.2: Terraflow analysis of the slope terrain – no significant flow paths identified.
