Report Title: Geotechnical Report 2 Milga Road, Avalon
Report Date: 25/7/24

GEOTECHNICAL INVESTIGATION:

New Retaining Wall at 2 Milga Road, Avalon

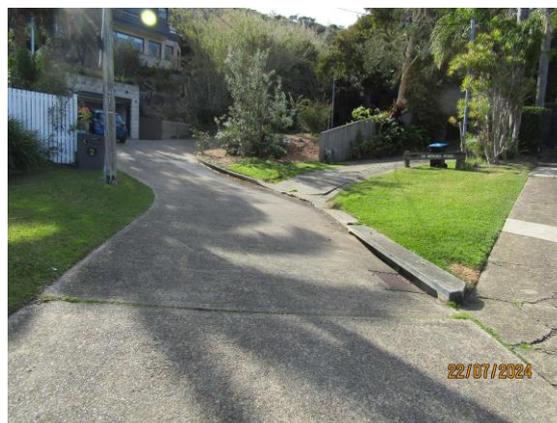
Photo 1

- 2.3** At the road frontage, a concrete Right of Carriageway (ROW) runs up the slope to a concrete driveway and stable concrete block garage at the downhill side of the property (Photos 1 & 2). A rendered masonry retaining wall up to ~1.6m high supports a cut for the driveway and fill for a lawn and garden area above (Photos 2 & 3). The wall is tilting downslope and displays stepped and horizontal cracking. The wall is currently braced with timber. We have been informed by the owner that the wall was damaged by a vehicle. We have also been informed that the wall was tilting downslope significantly prior to being damaged by the vehicle. It is expected that the previous movement has been caused by a palm tree on the uphill side of the wall (Photo 13). These types of plants are supported by a large root ball. As the tree grows and the

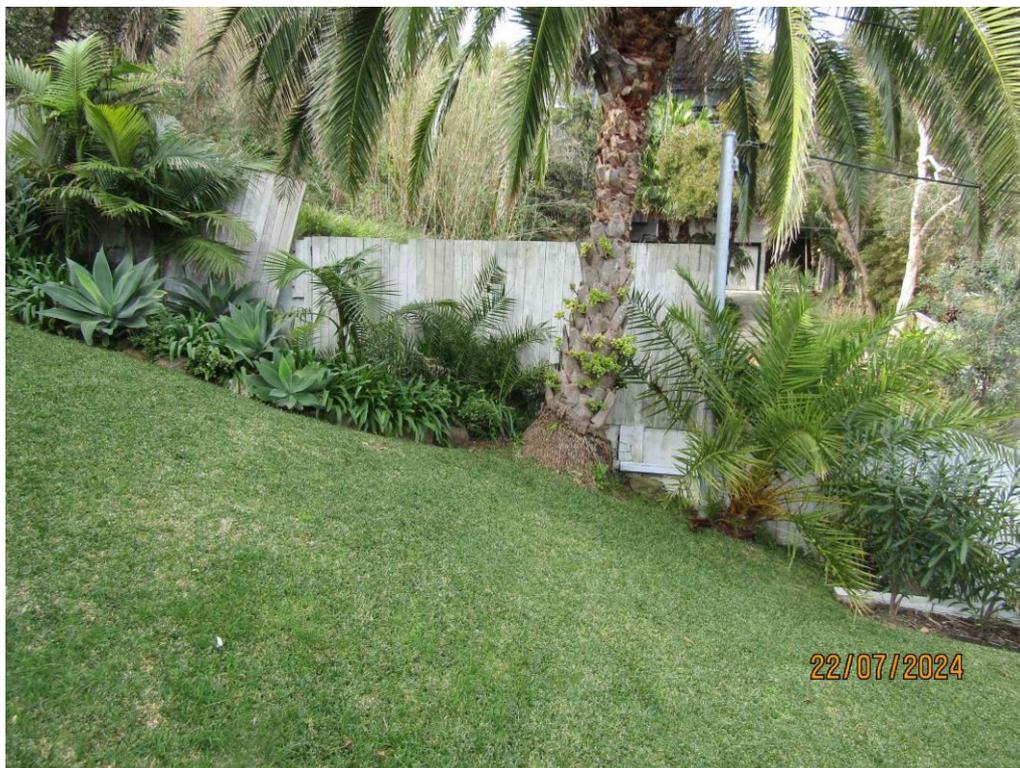
Photo 13

Allowing for backwall drainage, the excavation/demolition comes close to flush with a palm tree (Photo 13), flush with the W common boundary at the downhill side and is set back ~0.7m from the W common boundary at the uphill side. The palm tree and W common boundary will be within the zone of influence of the excavation. In this instance, the zone of influence is the area above a theoretical 30° line (from horizontal) through fill/soil and a 45° line through clay / weathered rock from the base of the excavation towards the surrounding structures and boundaries.

The structural plans indicate there is a plan to batter the excavation if possible. There is insufficient room to batter. In addition, the demolition/excavation comes close to flush with a palm tree (Photo 13). As discussed in **Section 2.3**, it is expected that the previous movement of the existing retaining wall (prior to it being damaged further by a vehicle) has been caused by the lateral loads exerted by the root ball that supports the palm tree. As such, due to the proximity of the proposed excavation to the palm tree and the potential of the lateral loads

from the tree impacting on the new retaining wall, the palm tree (Photo 13) is to be removed prior to the demolition/excavation commencing.
