**GEOTECHNICAL RISK MANAGEMENT POLICY FOR PITTWATER
FORM NO. 1 – To be submitted with Development Application**

Development Application for	<u>Niels and Lenore Walter</u> Name of Applicant
Address of site	<u>10 Taminga Street, Bayview</u>

**RISK ANALYSIS & MANAGEMENT
FOR
PROPOSED ALTERATIONS AND ADDITIONS
AT
10 TAMINGA STREET, BAYVIEW**

Job Number:
QY 00171
15th December, 2020
Page 13

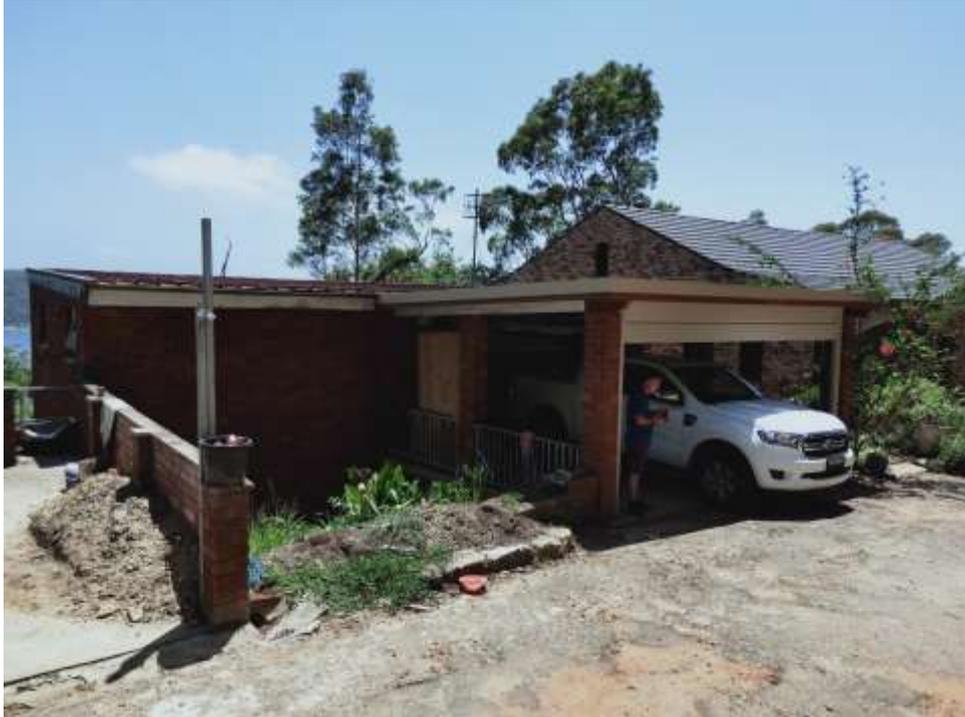
Photo 1

3.3 The site has dual access with vehicular access at the rear of the existing residence from the right of way shared driveway from Ilya Avenue providing access to the existing attached carport and open concrete parking area, Photos 1 & 2. A sandstone block retaining wall is on the southern side of the right of carriage way and appeared stable at the time of our inspection, Photo 3. The main entrance to the existing residence is accessed via the attached carport at the south eastern rear corner. Access to the front of the property is via the landscaped path and stairs on the eastern side of the existing residence, Photo 4. Also, access is via the stairs and decks on the western side of the existing residence, Photo 5. A pathway runs across the southern side of the existing residence under the attached carport suspended concrete slab, Photo 6. A colluvial material batter slopes down from the right of way to the rear of the exiting residence. Exposed sandstone was observed under the suspended concrete slab of the parking area, Photo 7. A talus slope with colluvial material and large sandstone displaced joint blocks was overserved under the western decks, Photo 8. Under the front of the existing residence the natural slope is evident, Photo 9. The batter directly in front to the existing residence where the disused sewerage tank is located was observed to be poor to fair condition, Photo 10. The front of the property is terraced by two sandstone retaining walls of approximately 1.6 metres in height supporting fill material, Photo 11. These retaining walls were observed to be in fair to good condition considering their age. A well vegetated batter slopes down to Taminga Street level with a landscaped pathway and stairs providing access from the street, Photo 12.
