TREE ASSESSMENT AND DEVELOPMENT IMPACT REPORT

DECEMBER 2018

96-104 CABARITA ROAD AVALON BEACH NSW 2107

Meraki Developments Pty Ltd

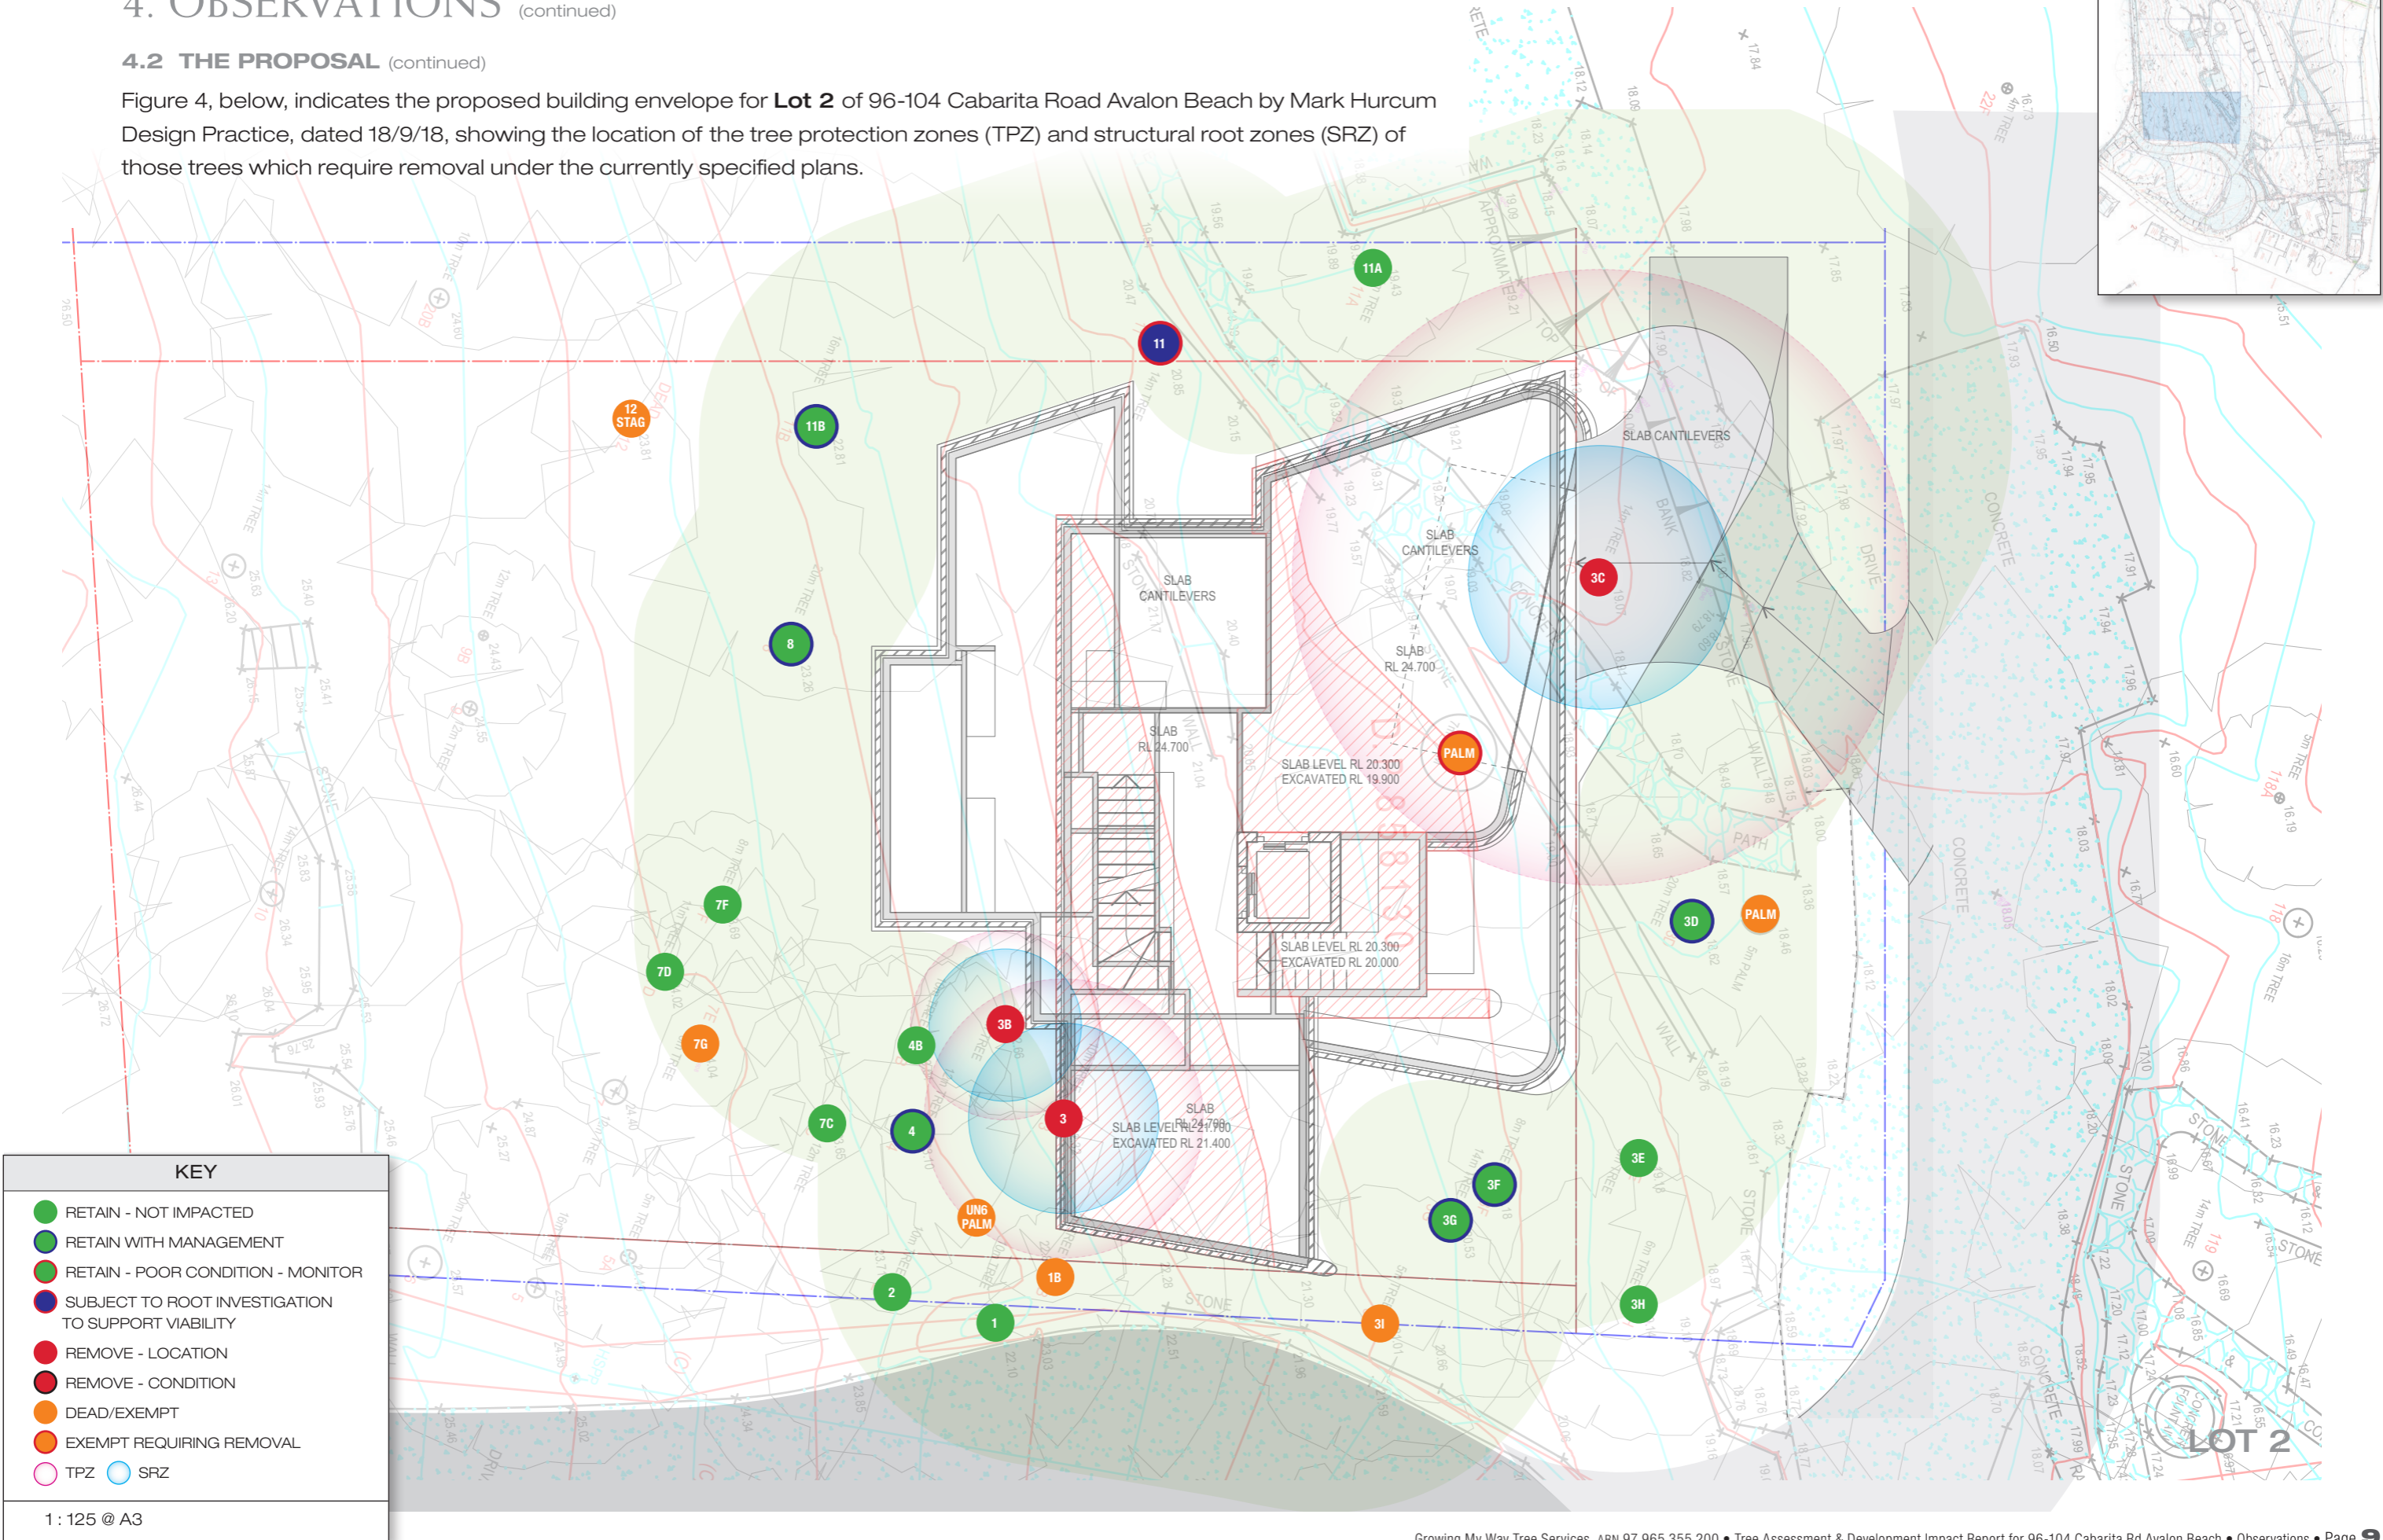
- c) 26 trees (**3, 3B, 3C, 22B, 22C, 22E, 44, 47A, 67A, 67B, 69C, 69D, 71C, 84B, 86, 89F, 90, 92A, 94A, 94B, 95A, 95B, 95C, 118A, 136A and 138**) are deemed unsustainable under the currently specified plans due to their location within, or proximity to, the proposed building such that their SRZs and/or TPZs will be breached by its excavation and construction. These trees are proposed to be removed and replaced, ideally with indigenous species, as a part of a coordinated landscape plan.

Figure 4, below, indicates the proposed building envelope for **Lot 2** of 96-104 Cabarita Road Avalon Beach by Mark Hurcum Design Practice, dated 18/9/18, showing the location of the tree protection zones (TPZ) and structural root zones (SRZ) of those trees which require removal under the currently specified plans.

Trees nominated for removal are on the basis that they are not viable for retention and protection with the development proposal as currently specified. It is recommended that these trees be adequately offset with replacement plantings, ideally indigenous species, as a part of a coordinated landscape plan.

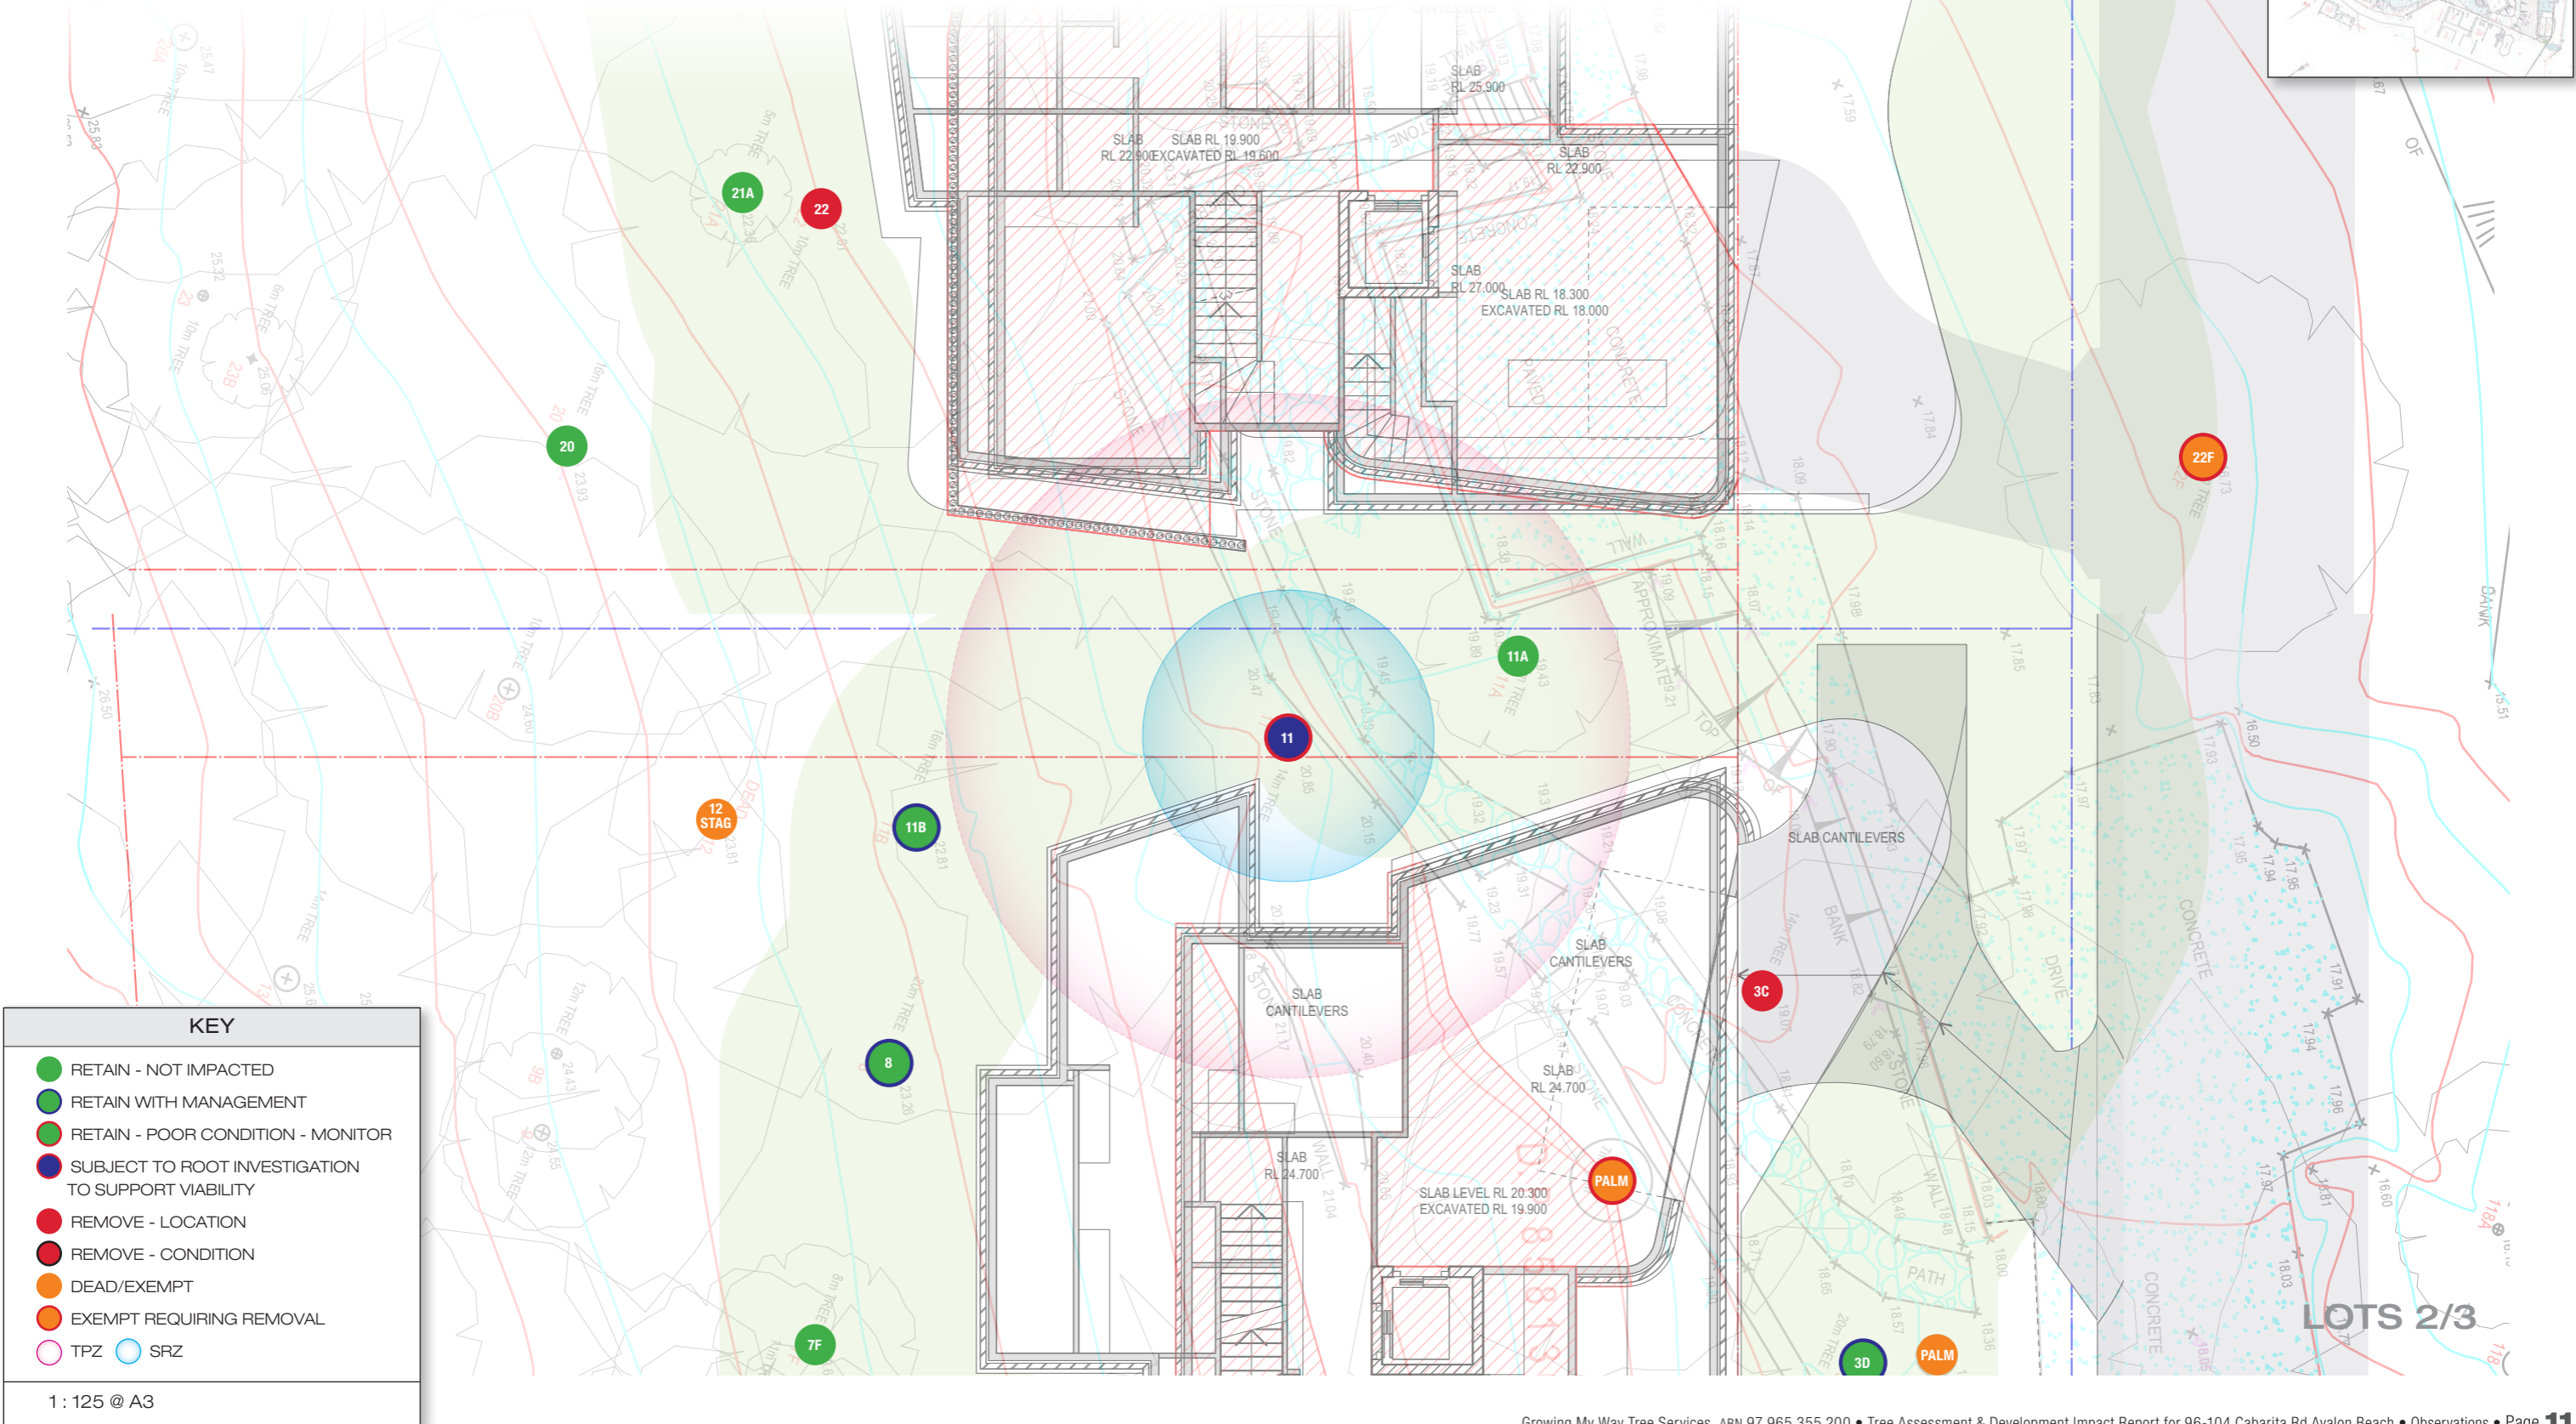
Figure 6, below, indicates the proposed building envelopes for **Lots 2 and 3** of 96-104 Cabarita Road Avalon Beach by Mark Hurcum Design Practice, dated 18/9/18, showing the tree protection zones (TPZ) and structural root zones (SRZ) of Tree 11 (recommended for root investigation to determine viability – refer Discussion and Recommendations).

In order for these trees to be retained, a root investigation under supervision of the site arborist would need to demonstrate that excavation would not cause significant root disturbance within the TPZ, nor adverse impact to tree health. Any roots over 50mm that require severing, are to be severed under the supervision and only with the approval of the site arborist. Tree management strategies for these trees are fully discussed under 'Recommendations'.

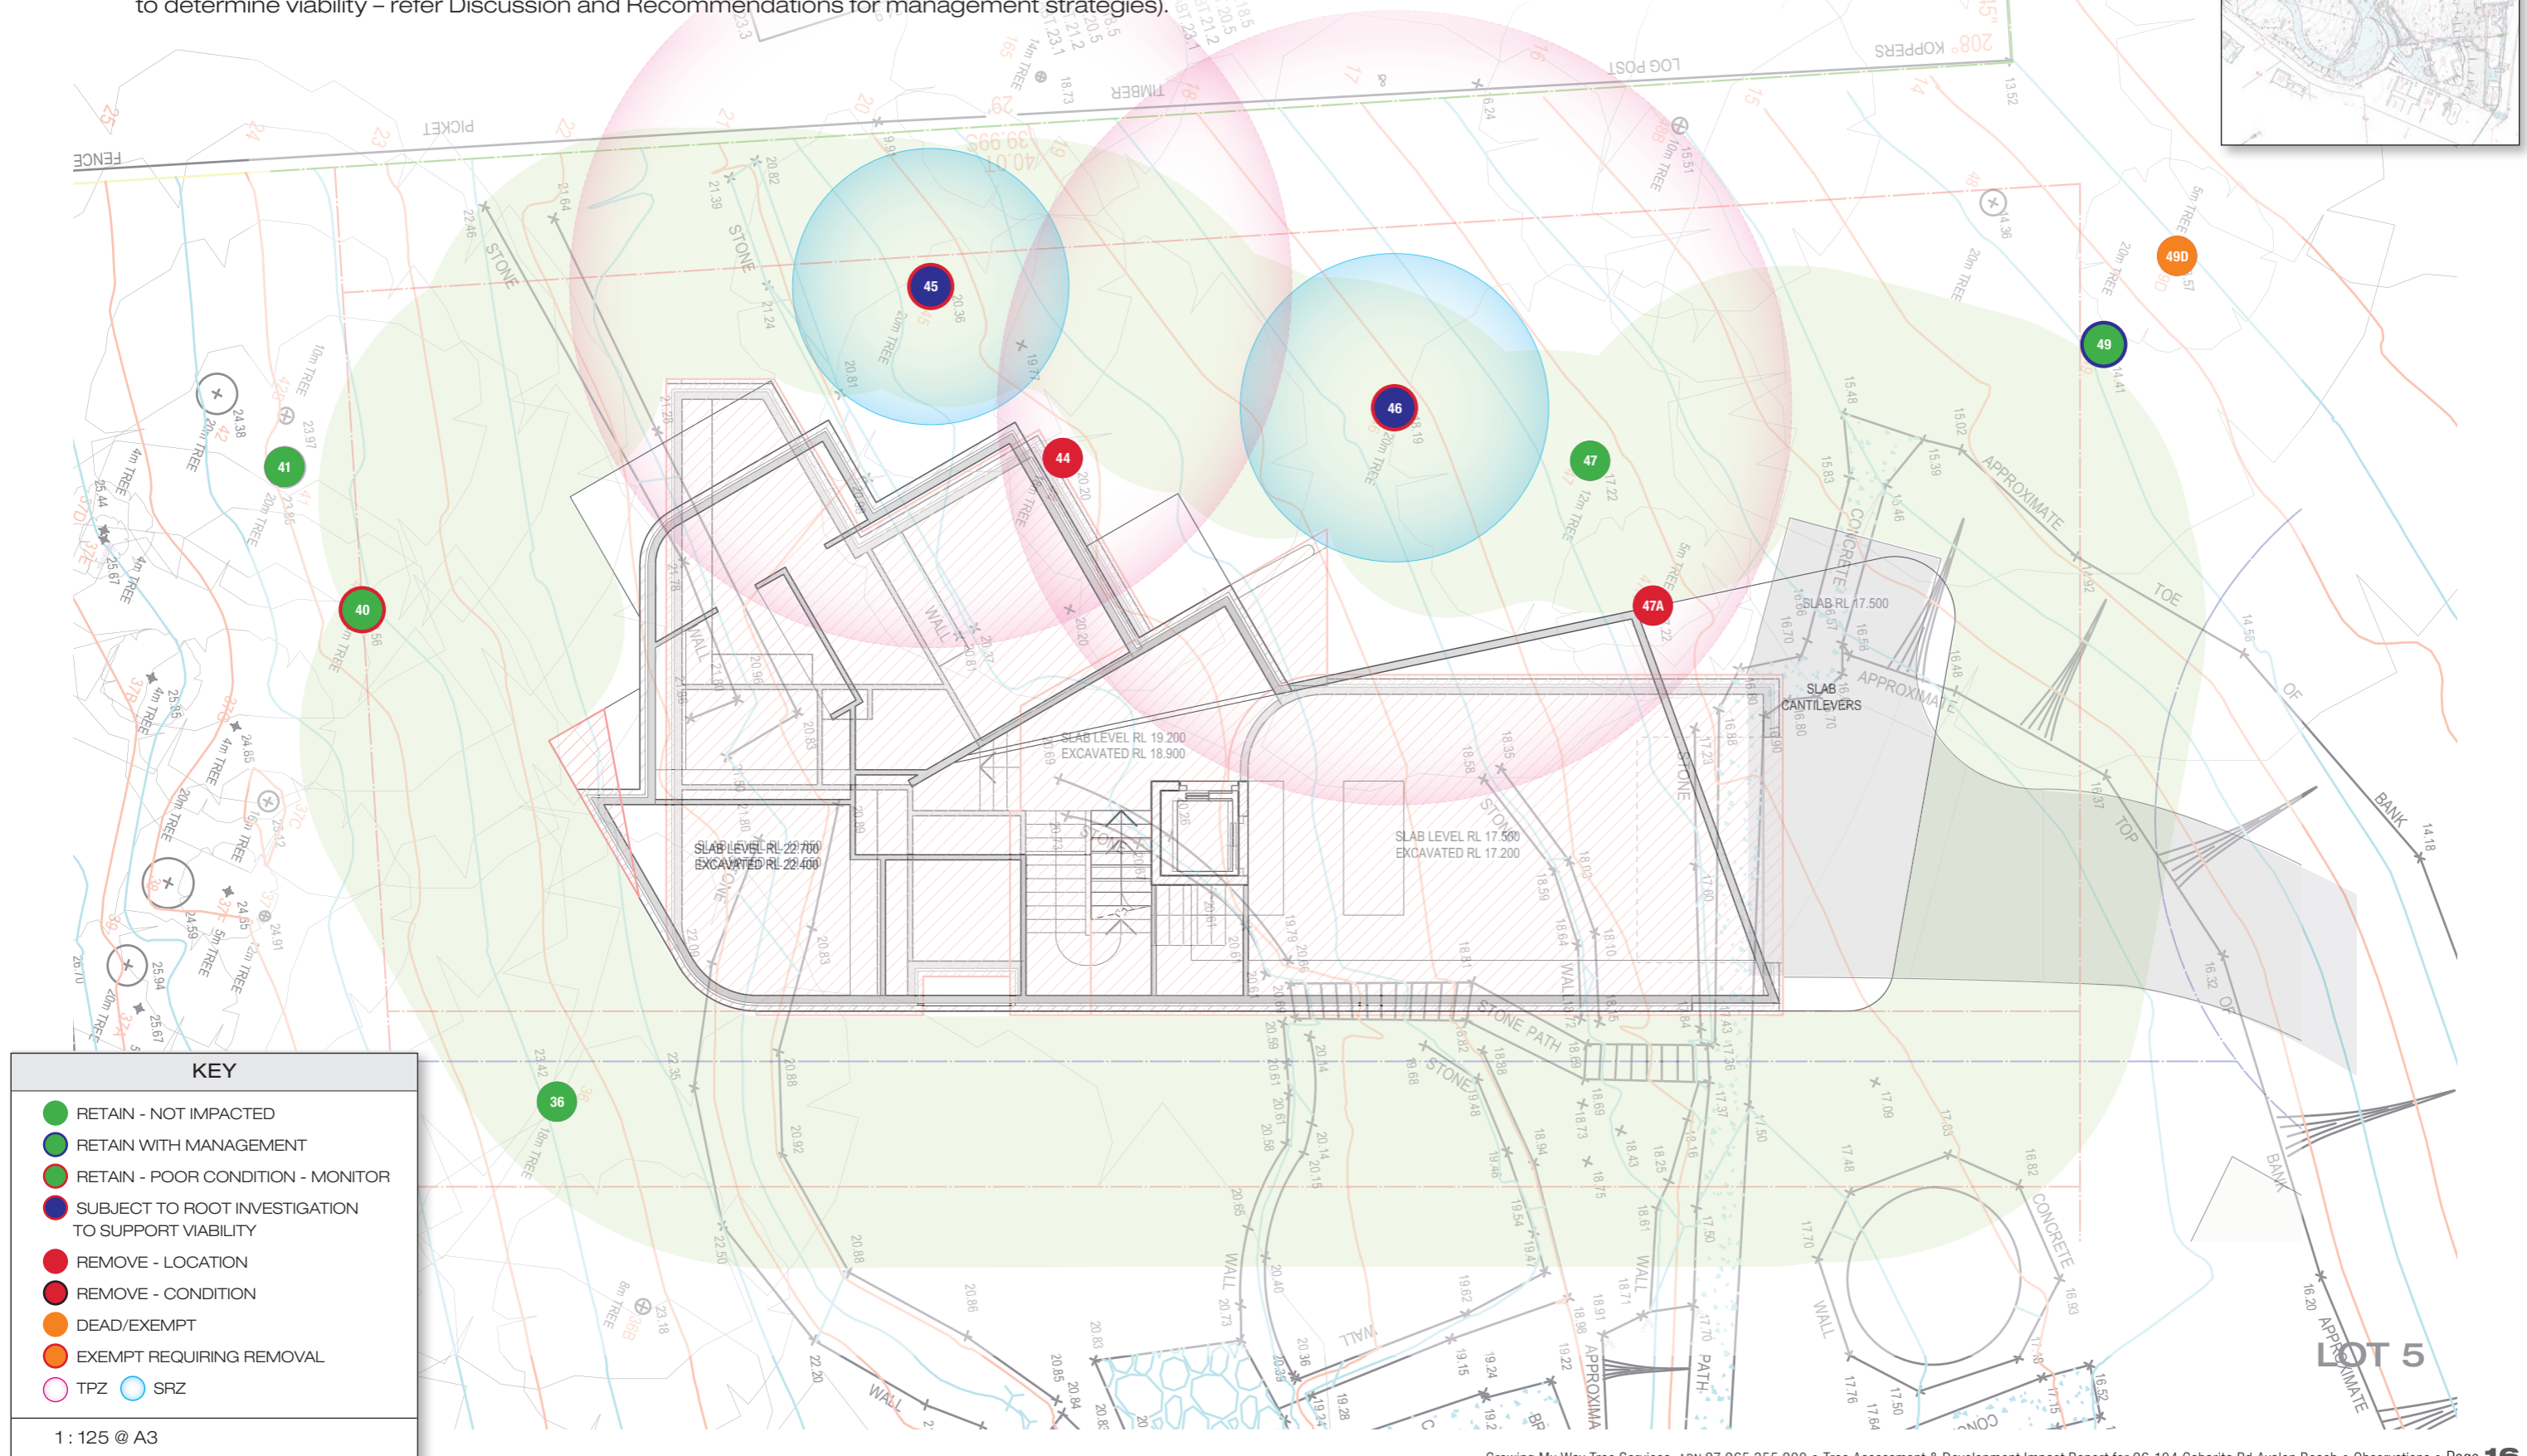
Figure 11, below, indicates the proposed building envelope for **Lot 5** of 96-104 Cabarita Road Avalon Beach by Mark Hurcum Design Practice, dated 13/9/18, showing the tree protection zones (TPZ) and structural root zones (SRZ) of tree 45 and 46 (recommended for root investigation to determine viability – refer Discussion and Recommendations for management strategies).

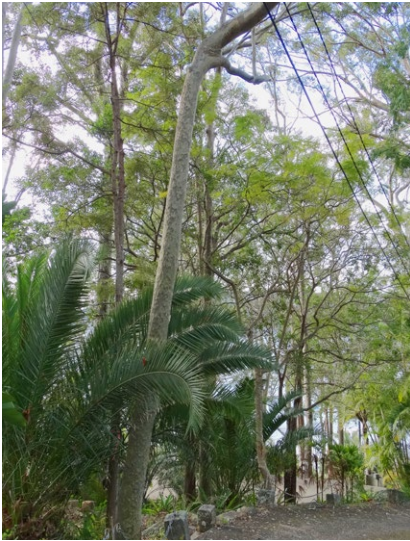
Fig. 23: 1. *Corymbia maculata*

1: *Corymbia maculata* (Spotted gum) is a mature to over-mature specimen in fair to poor health and vigour – see figure 23. It has a thin canopy entirely in the east, generally suppressed due to the overshadowing of neighbouring trees. It has deadwood of up to 40mm in 5% of its canopy. Tree 1 is not directly impacted by the development as currently specified.

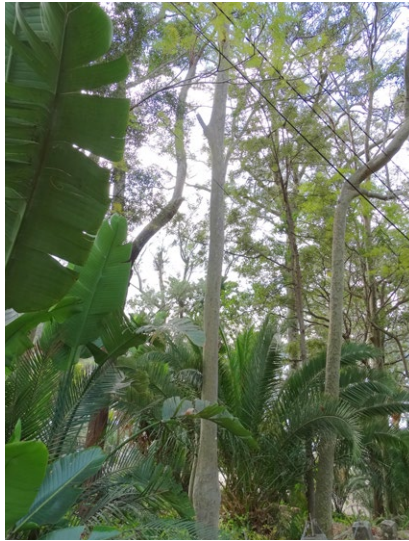
Fig. 24: 2. *Corymbia maculata*

2: *Corymbia maculata* (Spotted gum) is a mature to over-mature specimen in fair to poor health and vigour, suppressed due to the overshadowing of surrounding trees – see figure 24. There is a distinct swelling on the southern side of its trunk at 0.5m, no

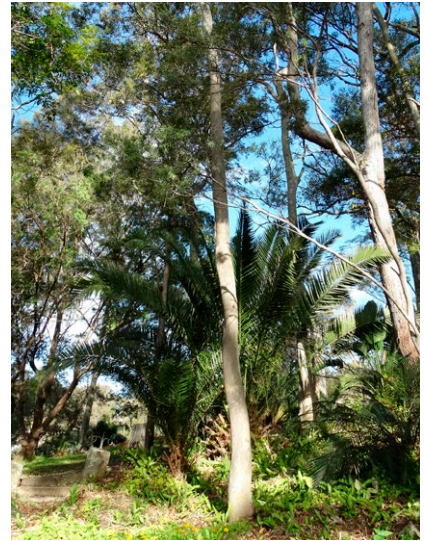
Fig. 25: 3. *Corymbia maculata*

3: *Corymbia maculata* (Spotted gum) is a mature to over-mature specimen in poor health and vigour – see figure 25. It has an asymmetric crown to the north and a leggy habit consistent with being heavily overshadowed by neighbouring trees. There are no branches below 8m and it is nearing the end of its useful life expectancy. Tree 3 is located at the edge of the footprint for the proposed dwelling on Lot 2, and as such is deemed unsustainable under the currently specified plans.

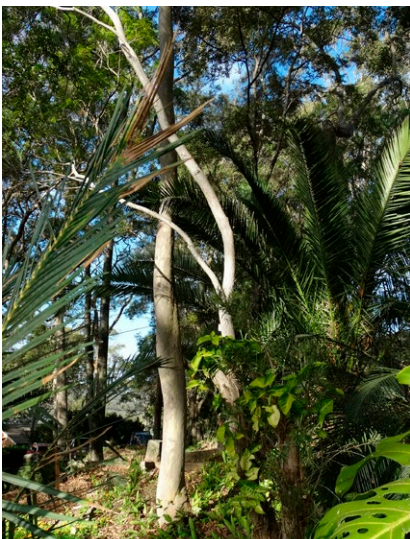
Fig. 26: 3B. *Callistemon* spp. (R)

3B: *Callistemon* spp. (Bottlebrush) is a mature to over-mature tree in poor health and vigour – see figure 26. It has been planted in a raised garden bed and has co-dominant stems, with the south-western stem lopped at 1m. The tree is growing to the north east, with a sparse, leggy canopy whose habit and growth is consistent with overshadowing of surrounding trees. There is a fleshy climber growing up both stems to a height of 1m. Tree 3B is located adjacent to the building footprint of the proposed dwelling, such that its SRZ and TPZ are breached. As such it is deemed unsustainable under the currently specified plans.

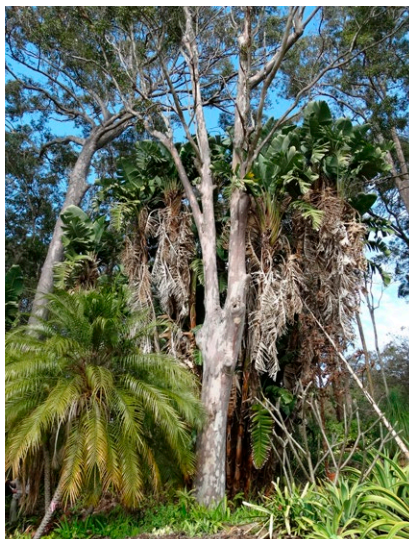
Fig. 27: 3C. *Corymbia maculata*

3C: *Corymbia maculata* (Spotted gum) is an over-mature specimen in poor health and vigour – see figure 27. It has co-dominant stems at 4m consistent with regrowth from being lopped at 4m and 8m, with old pruning stubs and a failed central stem. There is significant epicormic growth and deadwood up to 100mm in diameter in over 10% of its canopy. It is nearing the end of its useful life expectancy and warrants consideration for removal due to poor health and declining structure. Tree 3C is located in the driveway and under a cantilevered mid-level slab of the dwelling on Lot 2, and is deemed unsustainable under the currently specified plans.

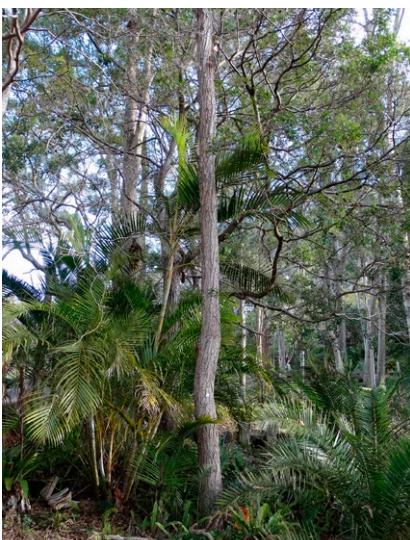
Fig. 29: 3E. *Eucalyptus paniculata*

3E: *Eucalyptus paniculata* (Grey ironbark) is a mature to over-mature specimen showing fair to poor health and poor vigour – see figure 29. Its canopy is sparse and lacking vigour and grows predominantly in the north-east. There are no branches below 7m and it is nearing the end of its useful life expectancy. Tree 3E is not directly impacted by the development as currently specified.

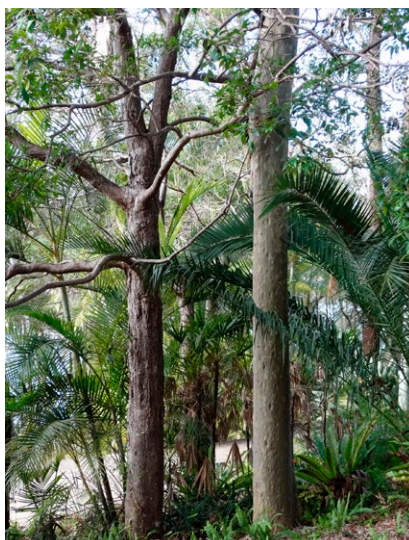
Fig. 30: 3F (L) *Syzygium paniculatum*
3G (R) *Corymbia maculata*

3F: *Syzygium paniculatum* (Magenta Lillypilly) is a mature to over-mature specimen in fair health and vigour – see figure 30 (left). It has a thin and leggy habit due to the phototropic effect of overshadowing of neighbouring trees. It is significant as a listed endangered species in NSW under the *Biodiversity Conservation Act 2016*. The proposed lower level of dwelling on Lot 2 requires negligible excavation (2.1%) in the TPZ, while the mid-level slab floats above ground in a further 15.5% of the zone. While not envisaged, should any pier supports be required, they must be located flexibly to ensure the SRZ is not breached, and to avoid any significant root disturbance within the TPZ. On this basis, and with due care, Tree 3F is considered not directly impacted by the development as currently specified.

3G: *Corymbia maculata* (Spotted gum) is a mature to over-mature specimen in fair to poor health and vigour – see figure 30 (right). It has co-dominant stems at 6m and a thin and leggy habit due to the overshadowing of surrounding trees. There is a large *Phellinus* fruiting body emerging from a wound site 4m about ground on the north side of the trunk indicating possible substantial internal decay – see detail figure 31. The proposed lower level of dwelling on Lot 2 requires negligible excavation (1.3%) in the TPZ, while the mid-level slab floats above ground in a further 15.3% of the zone. While not envisaged, should any pier supports be required, they must be located flexibly to avoid any significant root disturbance within the TPZ. On this basis, and with due care, Tree 3G is considered not directly impacted by the development as currently specified.

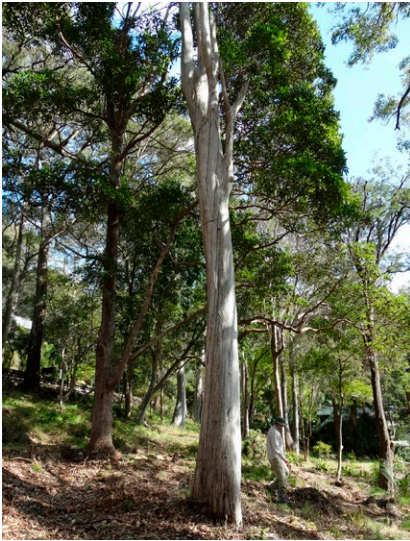
Fig. 41: **12.** Dead stag

12: is a dead stag, potentially providing wildlife habitat – see figure 41. It is not directly impacted by the development as currently specified.

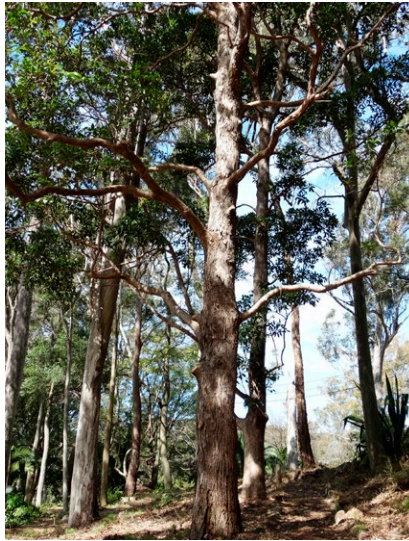
Fig. 42: **20.** *Lophostemon confertus*

20: *Lophostemon confertus* (Brush box) is a mature specimen showing fair to good health and vigour – see figure 42. It has been crown lifted to a height of 3m, as evidenced by multiple pruning stubs/scars. Its canopy grows predominantly to the north due to the phototropic effect of surrounding trees. Tree 20 is not directly impacted by the development as currently specified.

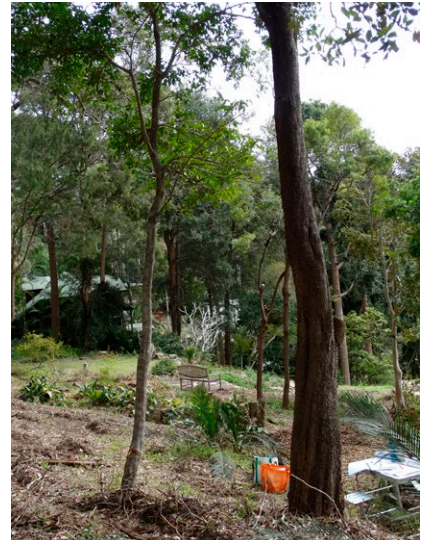
Fig. 43: (L - R) **21A.** *Glochidion ferdinandi*; **22.** *Allocasuarina torulosa*

21A: *Glochidion ferdinandi* (Cheese tree) is a mature specimen showing fair to poor health and vigour – see figure 43 (left). It leans to the north and has been crown lifted to a height of 3.5m with a 60mm diameter pruning stub at 1.5m and a small machinery scar on its southern side. Tree 21A's canopy grows predominantly in the north due to the overshadowing of neighbouring trees. It is not directly impacted by the development as currently specified.

22: *Allocasuarina torulosa* (Forest she-oak) is an over-mature specimen in poor health and vigour – see figure 43 (right). Its canopy is sparse and grows predominantly in the north due to overshadowing, with up to 10% deadwood of up to 40mm diameter. There is a pruning stub in the north-west at 2m and a large wound extending from below ground level to 1.5m, with significant central decay, seriously compromising the tree's structure. It is at the end of its useful life expectancy and is considered potentially hazardous. Its TPZ is breached by the proposed excavation for Lot 4's dwelling and taking into account its poor health and declining structure Tree 22 is recommended for removal and replacement.

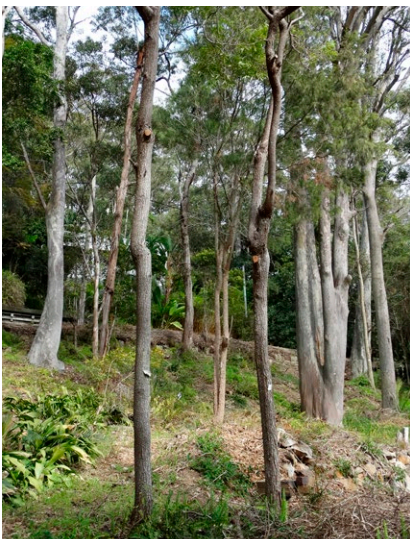
Fig. 44: **22B.** (L); **22C** (R)
Ceratopetalum gummiferum

22B: *Ceratopetalum gummiferum* (NSW Christmas Bush) is a mature to over-mature specimen showing fair to poor health and vigour – see figure 44 (left). It has been crown lifted to 4m and its canopy grows predominantly to the east due to overshadowing. Tree 22B's SRZ and TPZ are breached by excavation for the proposed dwelling on Lot 4 and as such is deemed unsustainable under the currently specified plans.

22C: *Ceratopetalum gummiferum* (NSW Christmas Bush) is a mature to over-mature specimen in poor health and vigour – see figure 44 (right). It has been crown lifted to 4m, with numerous pruning stubs and its canopy favours north and north-east. Tree 22C is located at the edge of the building footprint of the proposed dwelling on Lot 4 such that its SRZ and TPZ are breached by excavation. As such it is deemed unsustainable under the currently specified plans.

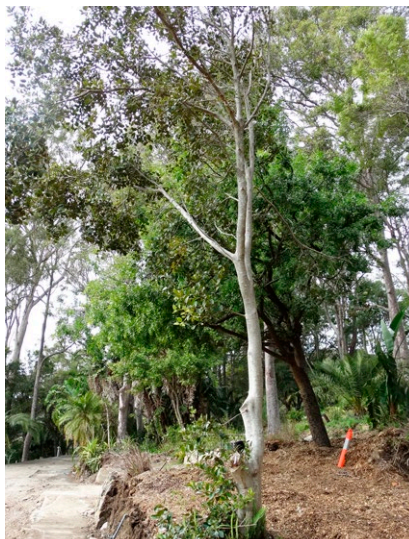
Fig. 45: **22E.** *Ficus rubiginosa*

22E: *Ficus rubiginosa* (Port Jackson fig) is a mature specimen in fair health and vigour – see figure 45. It was previously a pot plant, as evidenced by the remnant of its original plastic planter pot embedded at its base – see figure 46. On its north side it has a 200mm diameter remnant stub at 900mm above ground and a 100mm diameter branch pruned at 1.6m. Its canopy grows predominantly to the north due to overshadowing and there is epicormic growth at its base. Tree 22E is located within the building footprint of the proposed dwelling on Lot 4 and as such is deemed unsustainable under the currently specified plans.

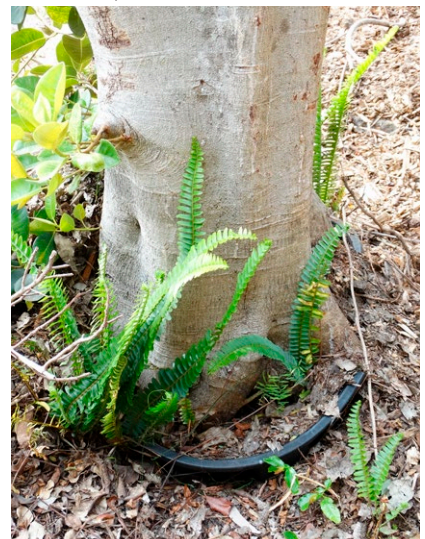
Fig. 46: **22E.** Detail of remnant planter pot

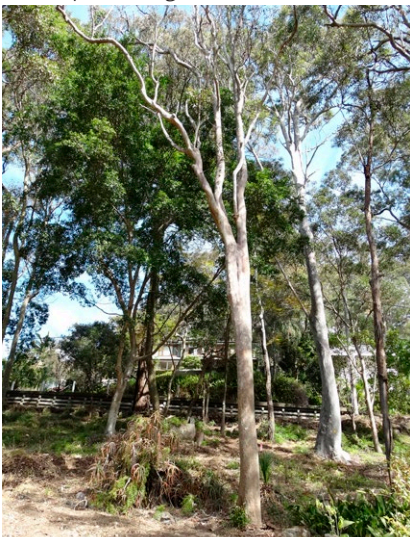
Fig. 47: **27.** *Corymbia maculata*

27: *Corymbia maculata* (Spotted gum) is an over-mature specimen showing very poor health and vigour – see figure 47. It has co-dominant stems at 6m and significant deadwood up to 100mm diameter in up to 60% of its canopy. Its canopy is sparse with significant epicormic growth. It is nearing the end of its useful life. Tree 27 is not directly impacted by the development as currently specified.

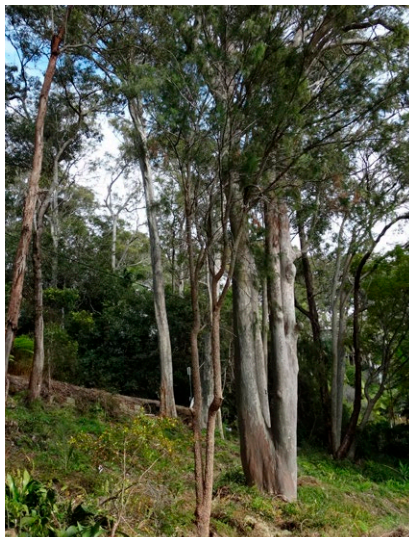
Fig. 48: **27A.** (front centre)
Allocasuarina torulosa

27A: *Allocasuarina torulosa* (Forest she-oak) is an over-mature specimen showing fair to poor health and vigour – see figure 48. It has co-dominant stems at 60mm above ground and a thin canopy growing predominantly to the north due to the phototropic effect of surrounding trees. Tree 27A is not directly impacted by the development as currently specified.

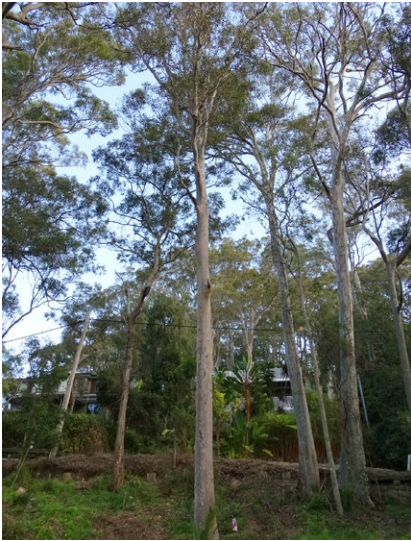
Fig. 50: **36.** *Corymbia maculata*

- 36:** *Corymbia maculata* (Spotted gum) is a mature to over-mature specimen showing poor health and vigour – see figure 50. It has a thin and leggy canopy, growing predominantly in the north due to the overshadowing of neighbouring trees. There is evidence of deadwood up to 150mm diameter in up to 10% of the canopy. Tree 36's TPZ is breached by the proposed excavation by 7.5%, and as such, with due care, is considered not directly impacted by the development as currently specified.

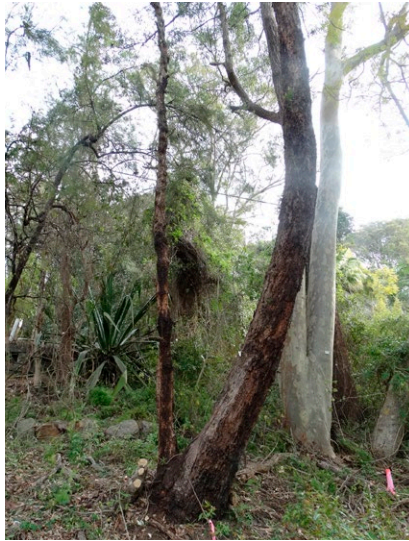
Fig. 51: **40.** *Eucalyptus paniculata*

- 40:** *Eucalyptus paniculata* (Grey ironbark) is an over-mature to senescent specimen in very poor health and vigour – see figure 51. It has co-dominant stems with a decay site at its base where it forks. Its canopy is very sparse with up to 60% deadwood up to 150mm in diameter. While Tree 40 is not directly impacted by the development, it is nearing the end of its useful life expectancy. As such its ongoing condition should be monitored with consideration of removal should its declining structure become hazardous.

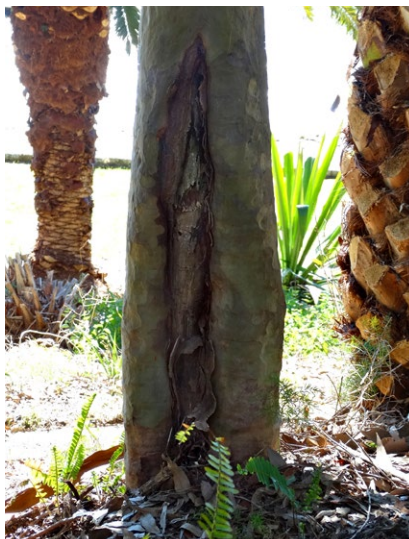
Fig. 81: **95C.** detail of basal wound

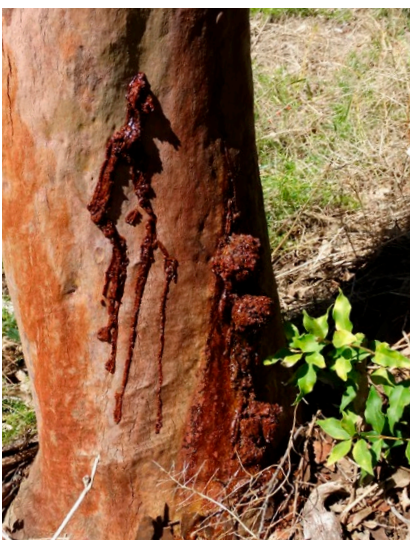
Fig. 83: **97.** detail of kino - evidence of likely insect attack

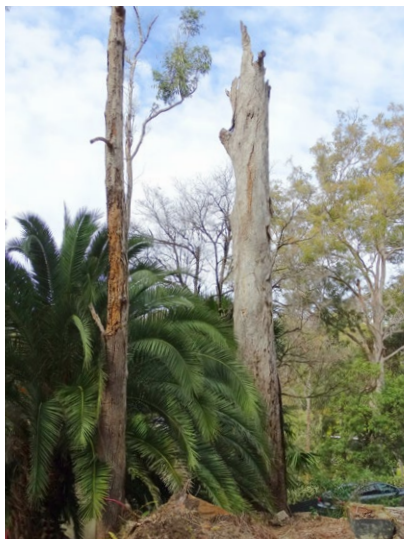
Fig. 108: (L-R) **139** - dead tree; **Stag1**

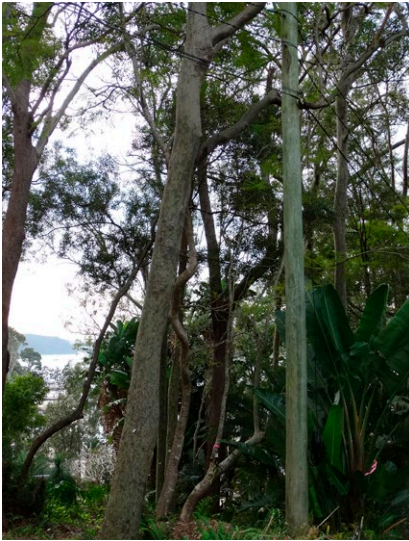
Fig. 113: **5.** *Corymbia maculata*

5: *Corymbia maculata* (Spotted gum) is a mature to over-mature specimen showing fair to poor health and vigour – see figure 113. It has a slight lean and an asymmetric canopy to the east due to overshadowing and it exhibits deadwood up to 80mm diameter in up to 5% of its canopy. The proposed below-ground services infrastructure requires negligible excavation (1.3%) within Tree 5's TPZ. As such it is considered not directly impacted by the development as currently specified.

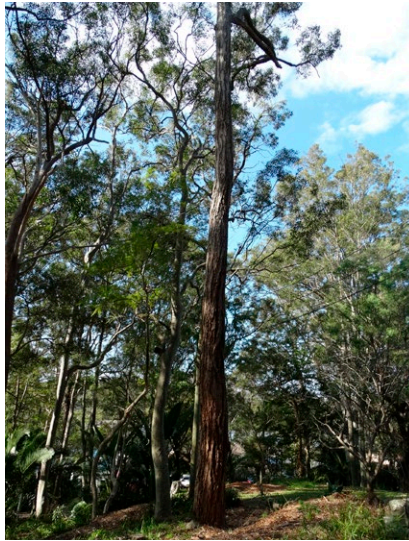
Fig. 114: **6.** *Eucalyptus paniculata*

6: *Eucalyptus paniculata* (Grey ironbark) is a mature specimen showing fair to good health and vigour - see figure 114. It has no branches below 12m and exhibits deadwood of up to 100mm diameter in up to 5% of its canopy. The proposed services conduit intrudes into 5.5% of Tree 6's TPZ. Subject to engineering and construction specification, Tree 6 is considered sustainable given careful management.

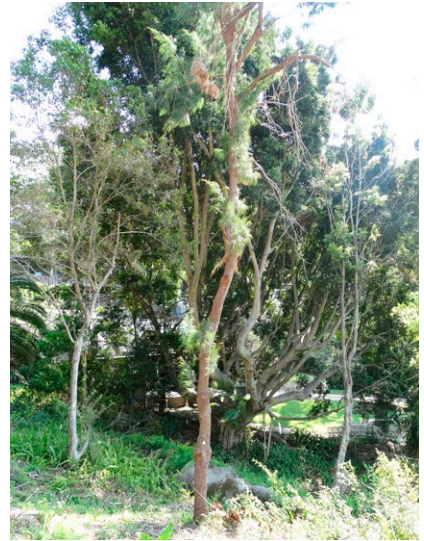
Fig. 115: **54.** *Allocasuarina torulosa*

54: *Allocasuarina torulosa* (Forest she-oak) is a mature specimen showing fair health and vigour – see figure 115. It has multiple pruning stubs to 7m and deadwood of up to 70mm diameter in more than 20% of its canopy. The parking bay of the driveway access intrudes into Tree 54's TPZ by 4.2% and piers should be flexibly located to avoid any intrusion into the SRZ. On this basis Tree 54 is considered not directly impacted by the development as currently specified.

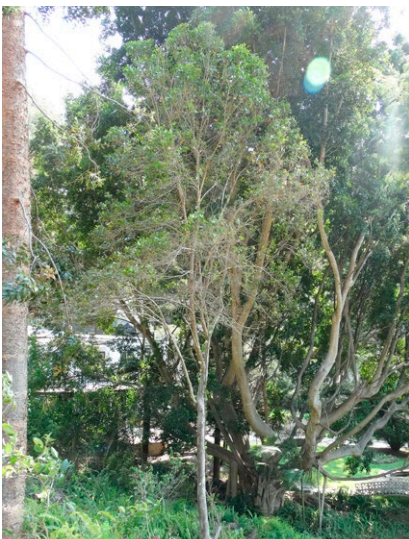
Fig. 116: **55.** *Glochidion ferdinandi*

55: *Glochidion ferdinandi* (Cheese tree) is a mature specimen showing good health and vigour – see figure 116. It has co-dominant stems at its base, with the northern stem lopped at 600mm. The canopy is thin and suppressed due to previous over-

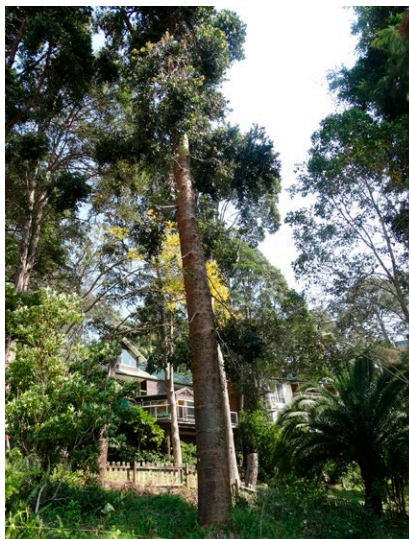
Fig. 117: **56.** *Agathis robusta*

56: *Agathis robusta* (Queensland Kauri) is a mature specimen in good health and vigour – see figure 117. Tree 56's TPZ appears to be impacted by up to 10.8% by excavation for the proposed bio-retention ponds. Additionally the parking bay for Lot 6's driveway sits above ground in 1.9% of the zone, potentially requiring pier support. Any excavation for the ponds or flexibly-located piers for the driveway should be undertaken with care to avoid any significant root disturbance within the TPZ. As such Tree 56 is considered not significantly impacted by the development as currently specified.

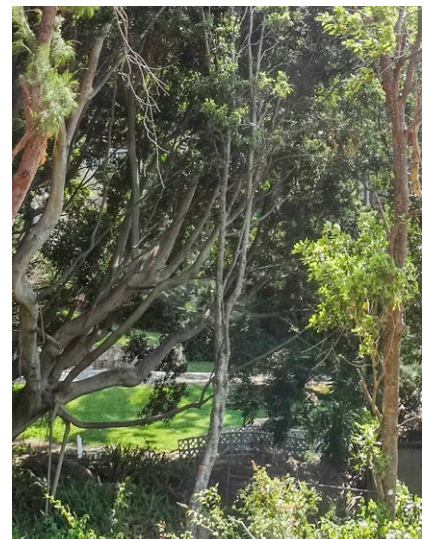
Fig. 118: **62C.** *Pittosporum undulatum*

62C: *Pittosporum undulatum* (Native Daphne) is a mature specimen showing poor health and vigour - see figure 118. Tree 62C is not directly impacted by the development as currently specified.

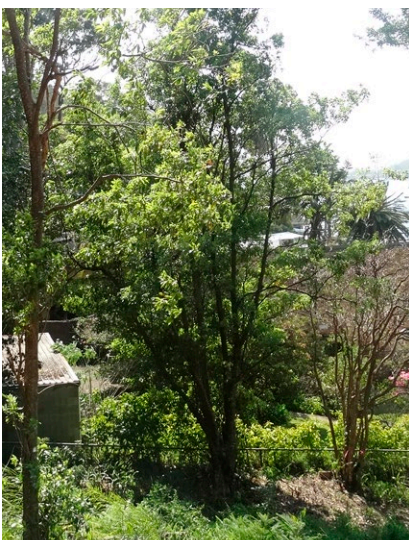
Fig. 119: **66.** *Pittosporum undulatum*

66: *Pittosporum undulatum* (Native Daphne) is a mature specimen with multiple stems, showing good health and vigour – see figure 119. The proposed stormwater infrastructure requires excavation in up to 15% of Tree 66's TPZ. Excavation should be undertaken with the advice and supervision of the site arborist to ensure there is no significant root disturbance within the zone. On this basis, given careful management, Tree 66 is considered sustainable under the current plans.

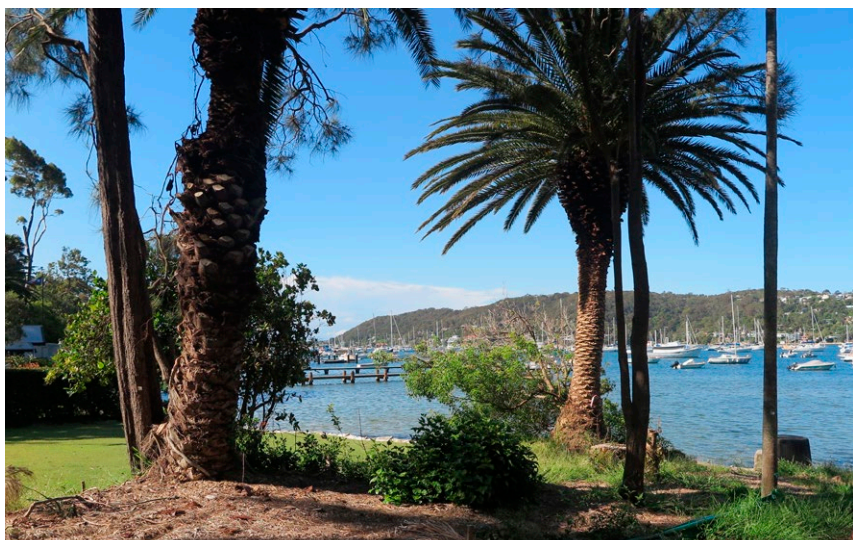
Fig. 120 (L-R) **71C** *C. glauca*, **71 & 71B** *P. canariensis*, **70A** *C. glauca*, **70B** *A. cunninghamiana*

70A: *Casuarina glauca* (Grey she-oak) is a mature specimen, with two stems, showing fair health and vigour – see figure 120. It is located directly above the existing drainage pipe, which is proposed to be utilised for stormwater. As such, no further excavation is required and Tree 70A is not impacted by the development as currently specified.

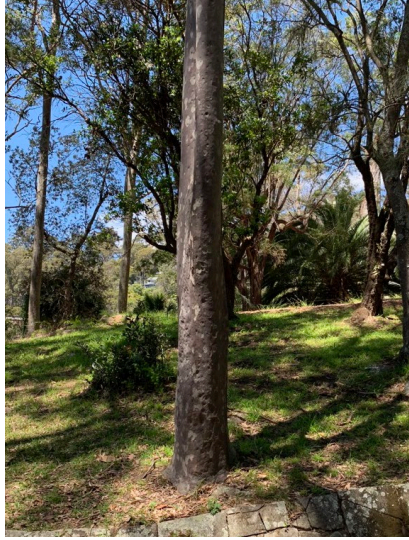
Fig. 122: **128B.** *Corymbia maculata*

128B: *Corymbia maculata* (Spotted gum) is a mature specimen in good health and vigour – see figure 122. The proposed services infrastructure intrudes into 7.2% of its TPZ.

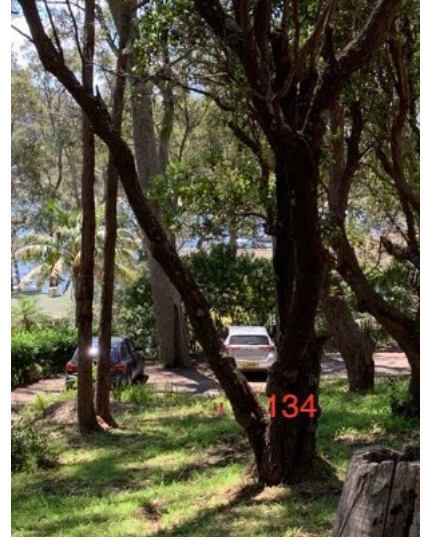
Fig. 123: **134.** *Agonis flexuosa*

134: *Agonis flexuosa* (Willow Myrtle). Native to Western Australia, Tree 134 is a mature specimen showing fair to good health and vigour – see figure 123. It is not directly impacted by the development as currently specified.
