TREE ASSESSMENT AND DEVELOPMENT IMPACT REPORT

DECEMBER 2018

96-104 CABARITA ROAD AVALON BEACH NSW 2107

Meraki Developments Pty Ltd

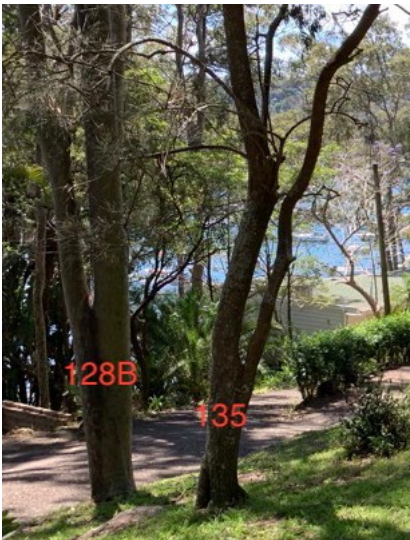
Fig. 124:(R) **135** *Casuarina glauca*

135: *Casuarina glauca* (Grey she-oak) is a mature specimen showing fair to good health and vigour – see figure 124. It is not directly impacted by the development as currently specified.

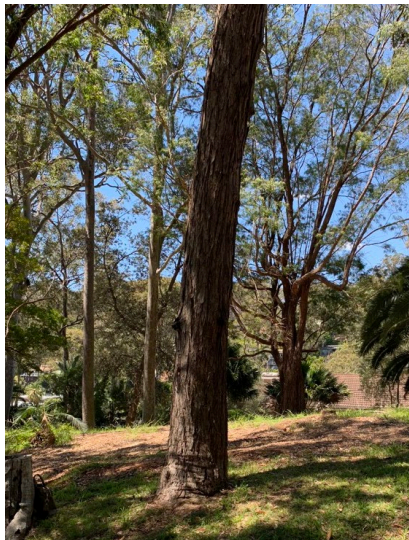
Fig. 125: **136.** *Eucalyptus umbra*

136: *Eucalyptus umbra* (Broad-leaved white mahogany) is a mature specimen in good health and vigour - see figure 125. The proposed services infrastructure may impact Tree 136's TPZ by up to 9.3%. Subject to engineering and construction specification, Tree 136 is considered sustainable given careful management.

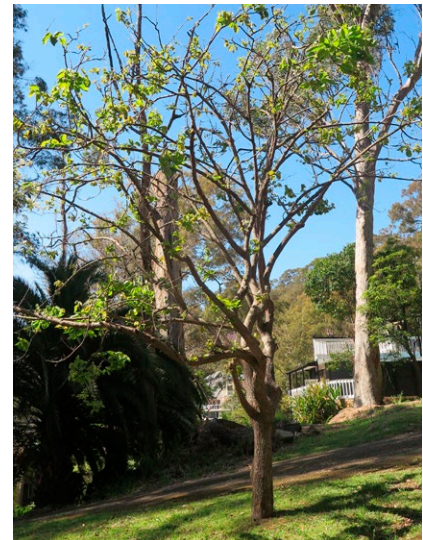
Fig. 126: **136A.** *Bauhinia divaricata*

136A: *Bauhinia divaricata* (Orchid tree) is a mature specimen showing good health and vigour - see figure 126. It is a planted introduced species and is located within the footprint of its proposed driveway access to the dwelling on Lot 10. As such is Tree 136A is deemed unsustainable under the currently specified plans.

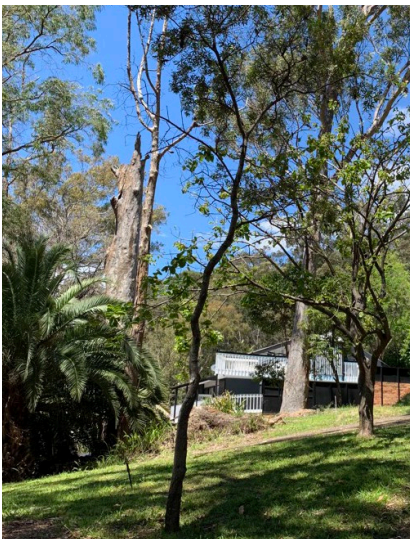
Fig. 127: **136B.** *C. gummiferum*

136B: *Ceratopetalum gummiiferum* (NSW Christmas Bush) is a mature specimen in good health and vigour – see figure 127. It is not directly impacted by the development as currently specified.
