## **73 Marine Parade, Avalon**

### Geotechnical Comments for Section 4.55

## **GEOTECHNICAL INVESTIGATION:**

### **New House and Pool at 73 Marine Parade, Avalon**

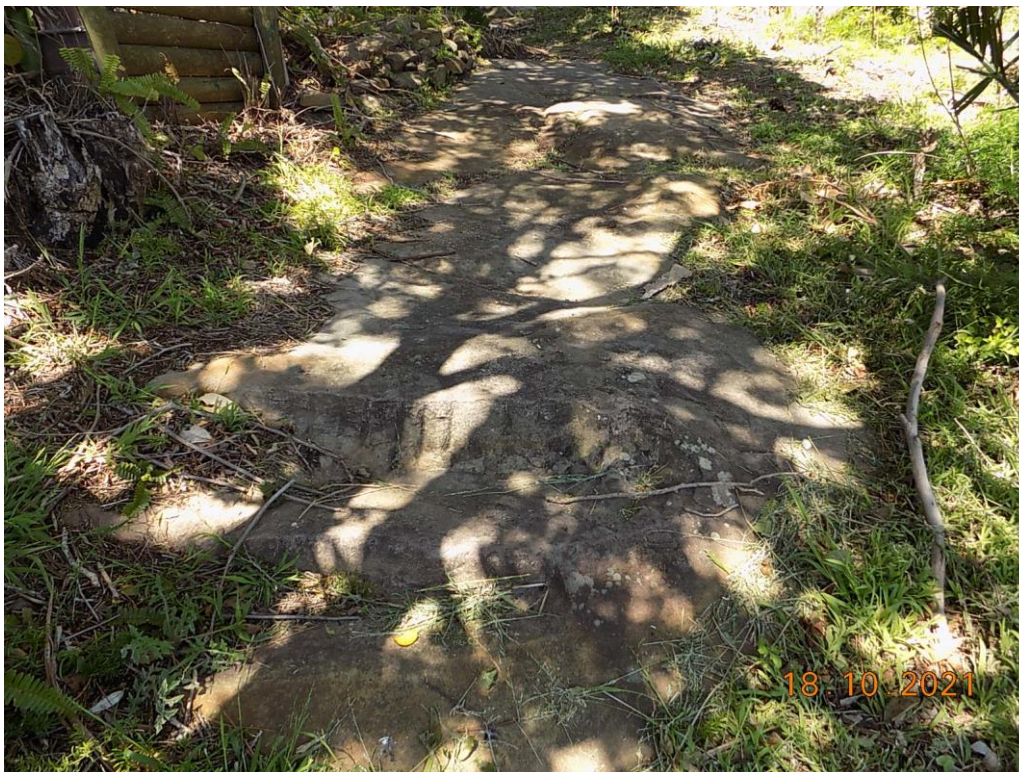
Photo 7

supported directly onto outcropping sandstone bedrock and will be demolished as part of the proposed works (Photos 5 & 6). A gentle to moderately-sloping garden area extends off the uphill side of the house (Photo 7). Sandstone bedrock was observed to be outcropping through the slope in multiple places (Photo 8). A near-level brick-paved fill has been placed at the top of the property (Photo 9). The fill is battered to stable angles and the fill batter is lined with large sandstone boulders (Photo 10). A ~50m high sea cliff falls from the top of the property. The sea cliff was observed from the rock platform below (Photo 11). It consists mainly of massive competent Medium Strength Sandstone with some, alternating thinly bedded shale/laminite layers. The cliff face below the property displays no significant undercutting or other significant geological defects that could affect its stability. The rock platform has a covering of dislodged sandstone boulders at the cliff base.
