17 October 2022

Arboricultural Impact Assessment Report regarding four (4) trees located within the vicinity of the proposed new eastern deck at St Luke's Grammar School, 1977 Pittwater Road, Bayview

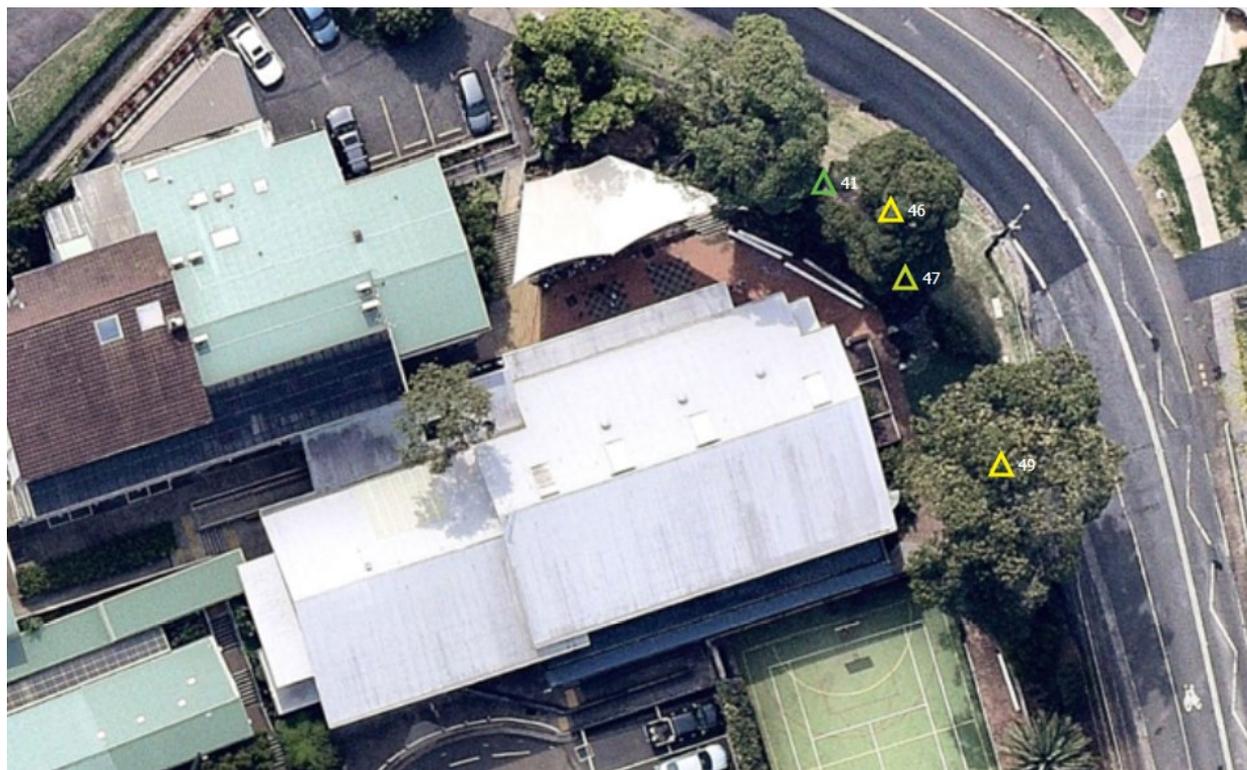
- 5.2.3 Trees 46 and 49 (Category A trees) are mature trees which form part of the dominant species (*Lophostemon confertus*) running along Pittwater Road. These trees make significant contributions to the landscape and cannot be readily replaced within 20 years.

- 5.2.4 Trees 41 and 47 (Category C trees) are juvenile specimens planted (relatively) recently within the amenity. The trees contribute limited value to the amenity due to their age and size and can be easily replaced.

Figure 3. Site map showing subject trees. Note that icon colour indicates trees current risk rating (not Retention Value). Tree attributes are to be obtained from Appendix E – Tree Assessment Data. (ArborSite, October 2022).
