316 Hudson Parade, Clareville

GEOTECHNICAL INVESTIGATION:

Alterations and Additions at 316 Hudson Parade, Clareville

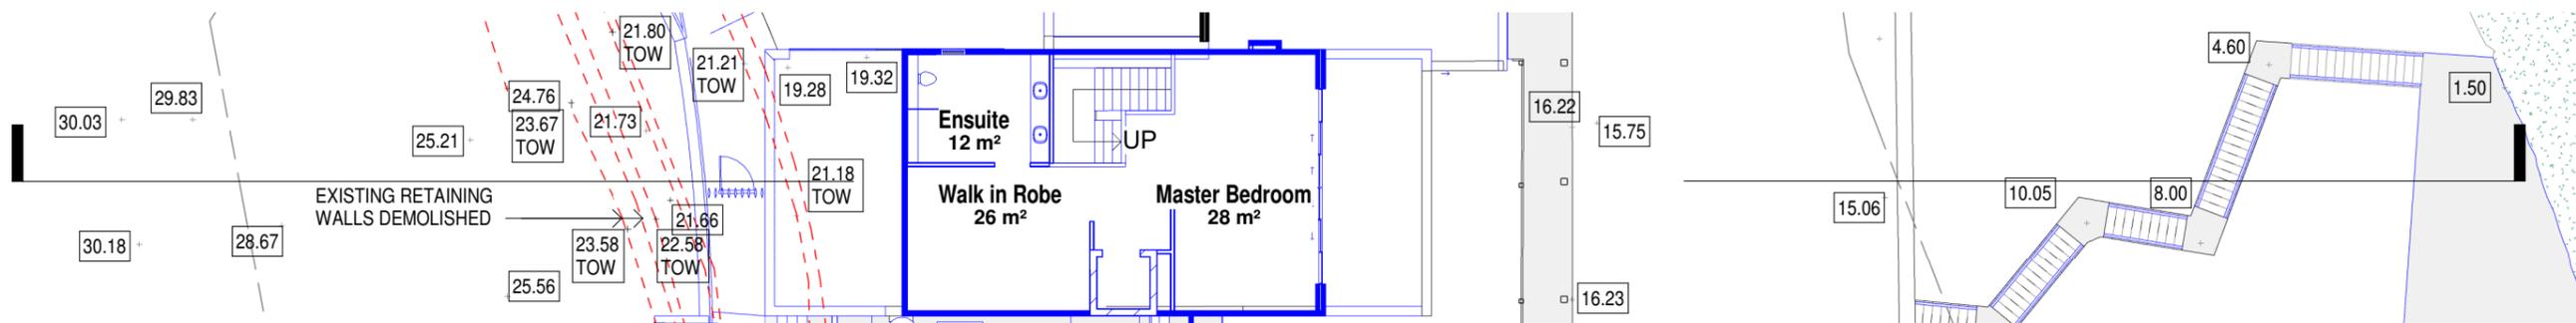
Long Site Section Survey Points

We have reviewed the assumed natural ground line shown by a dashed line on the plan by Baster and Jacobson, drawing number DA 30.05, issue 3, and dated 3/3/21. In our opinion the interpreted natural ground line shown on the plans is a very close approximation of where the natural ground surface was and is suitable as a base to measure the “8.5 meter building height limit” from.

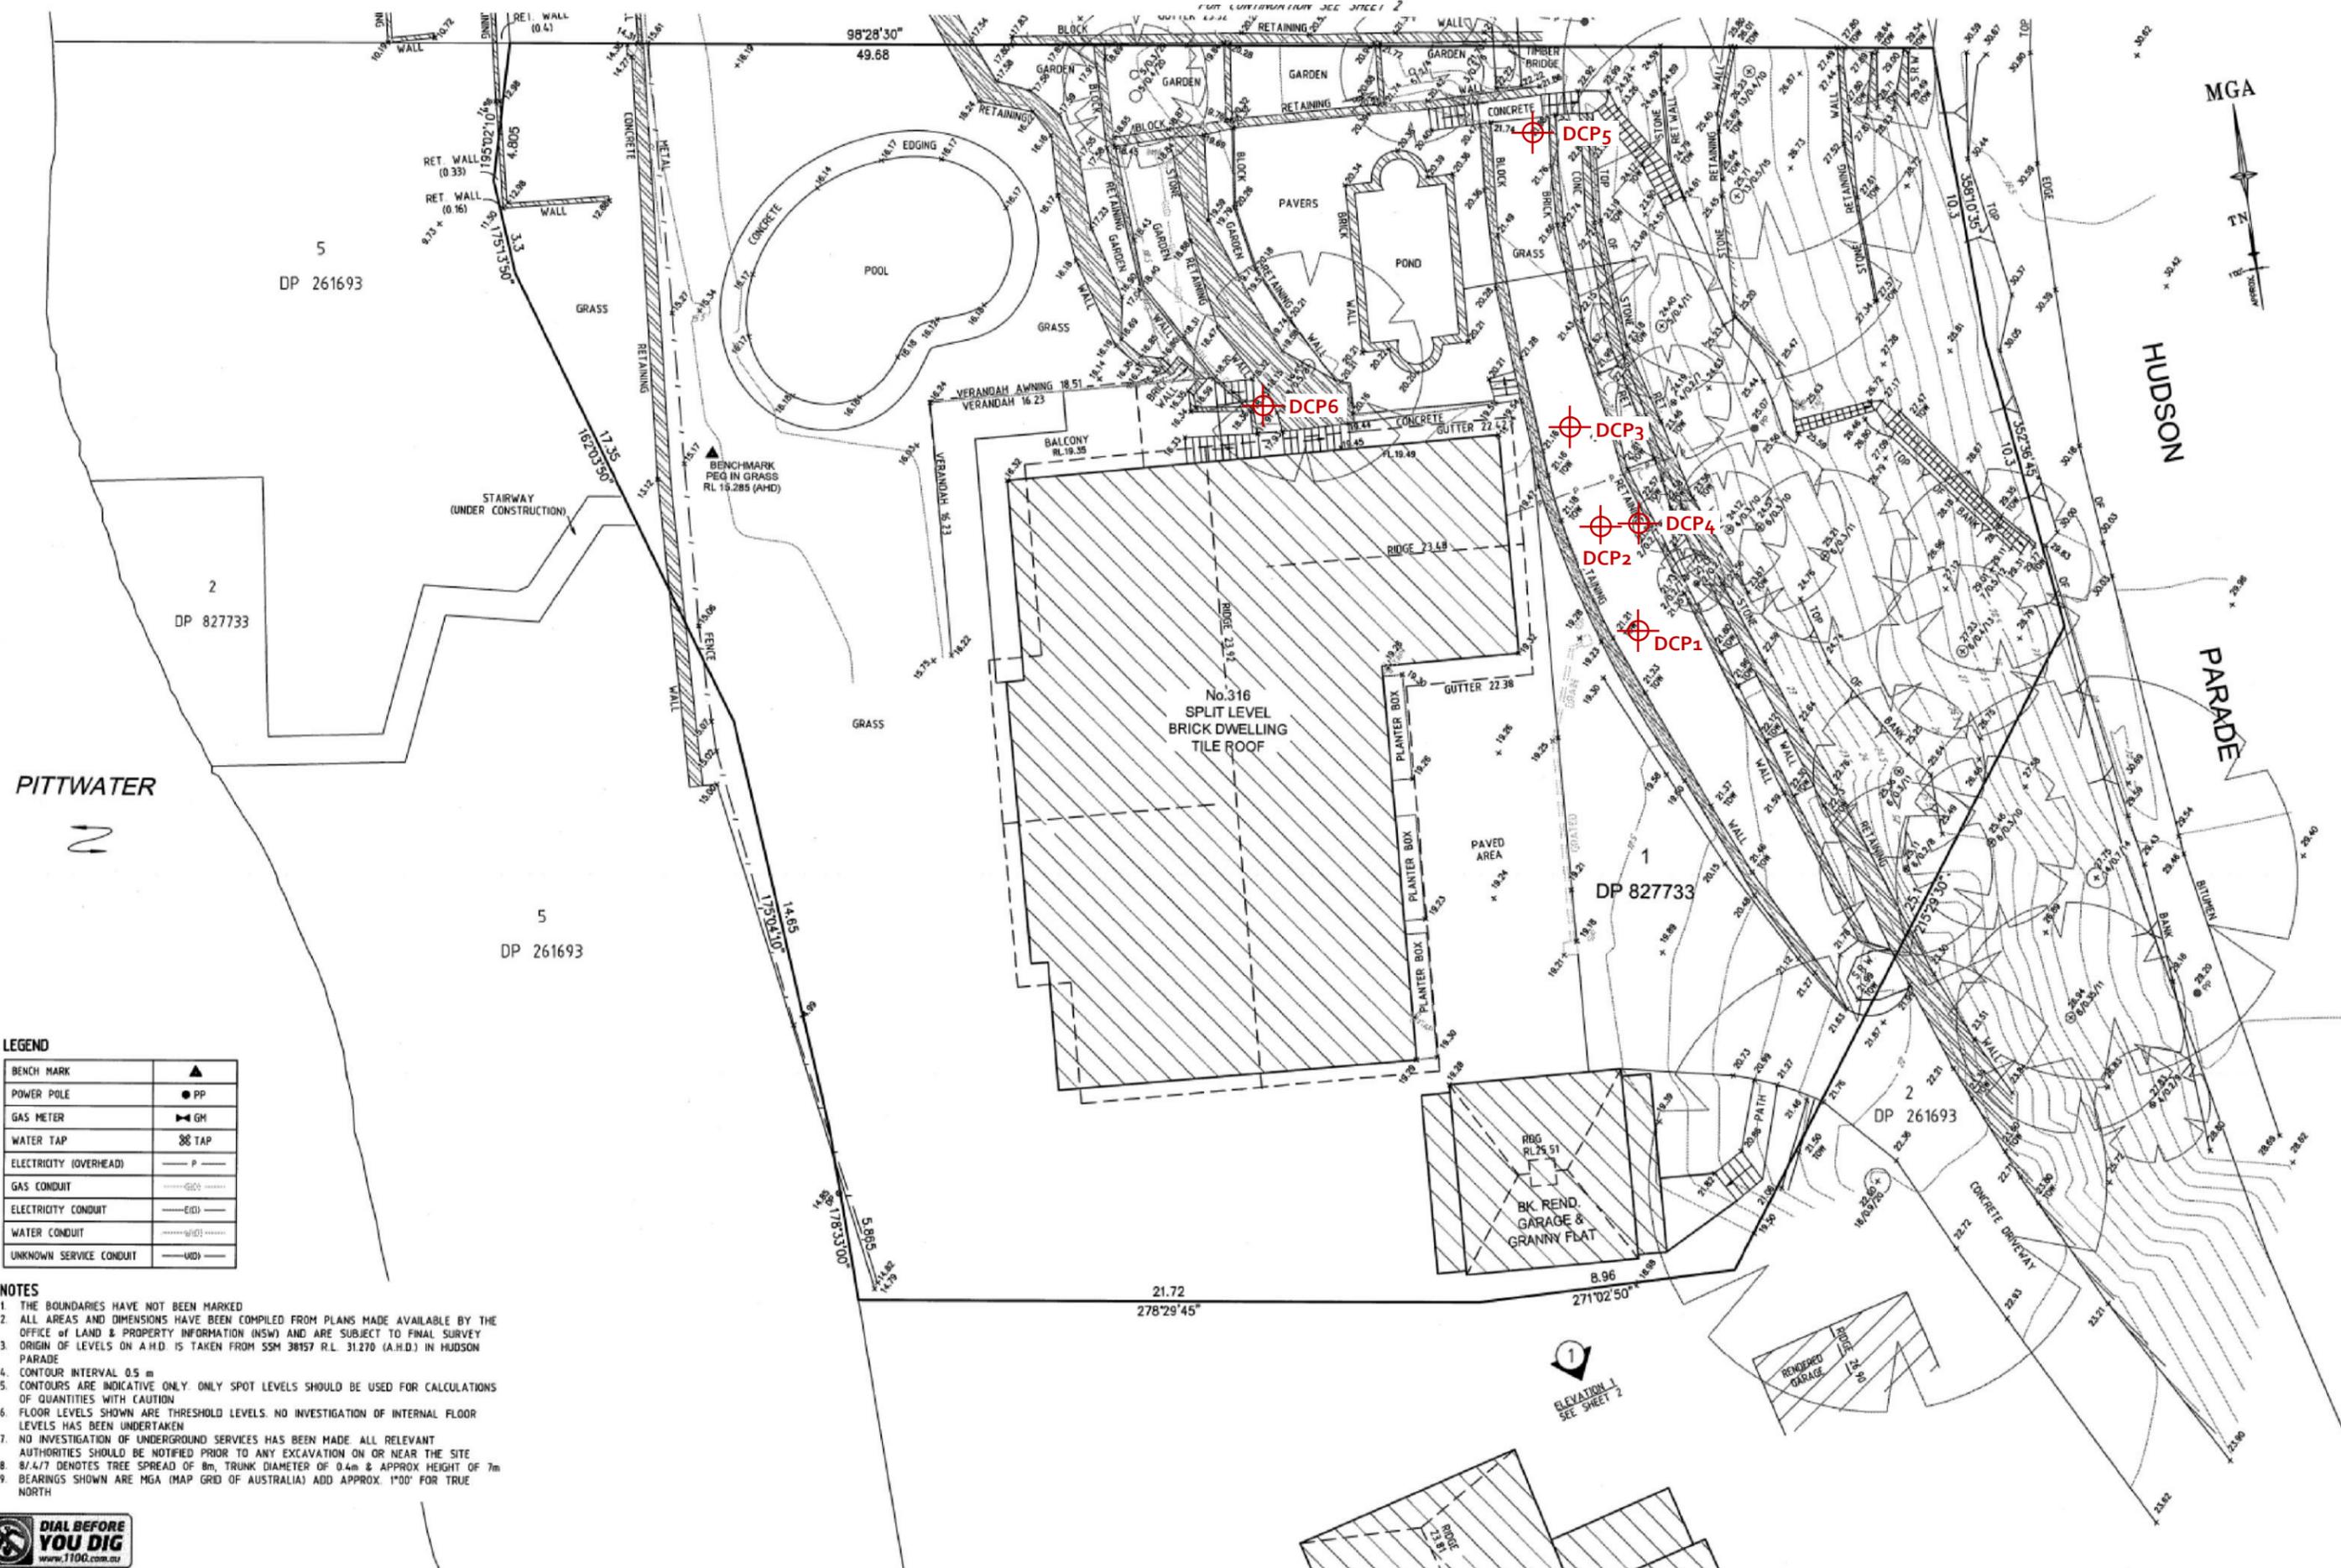
SITE PLAN – showing test locations

Six Dynamic Cone Penetrometer (DCP) tests were put down to determine the relative density of the overlying soil and the depth to weathered rock. The location of the tests are shown on the site plan. It should be noted that a level of caution should be applied when interpreting DCP test results. The test will not pass through hard buried objects so in some instances it can be difficult to determine whether refusal has occurred on an obstruction in the profile or on the natural rock surface. This is not expected to be an issue for the testing on this site. But due to the possibility that the actual ground conditions vary from our interpretation there should be allowances in the excavation and foundation budget to account for this. We refer to the appended "Important Information about Your Report" to further clarify. The results are as follows:

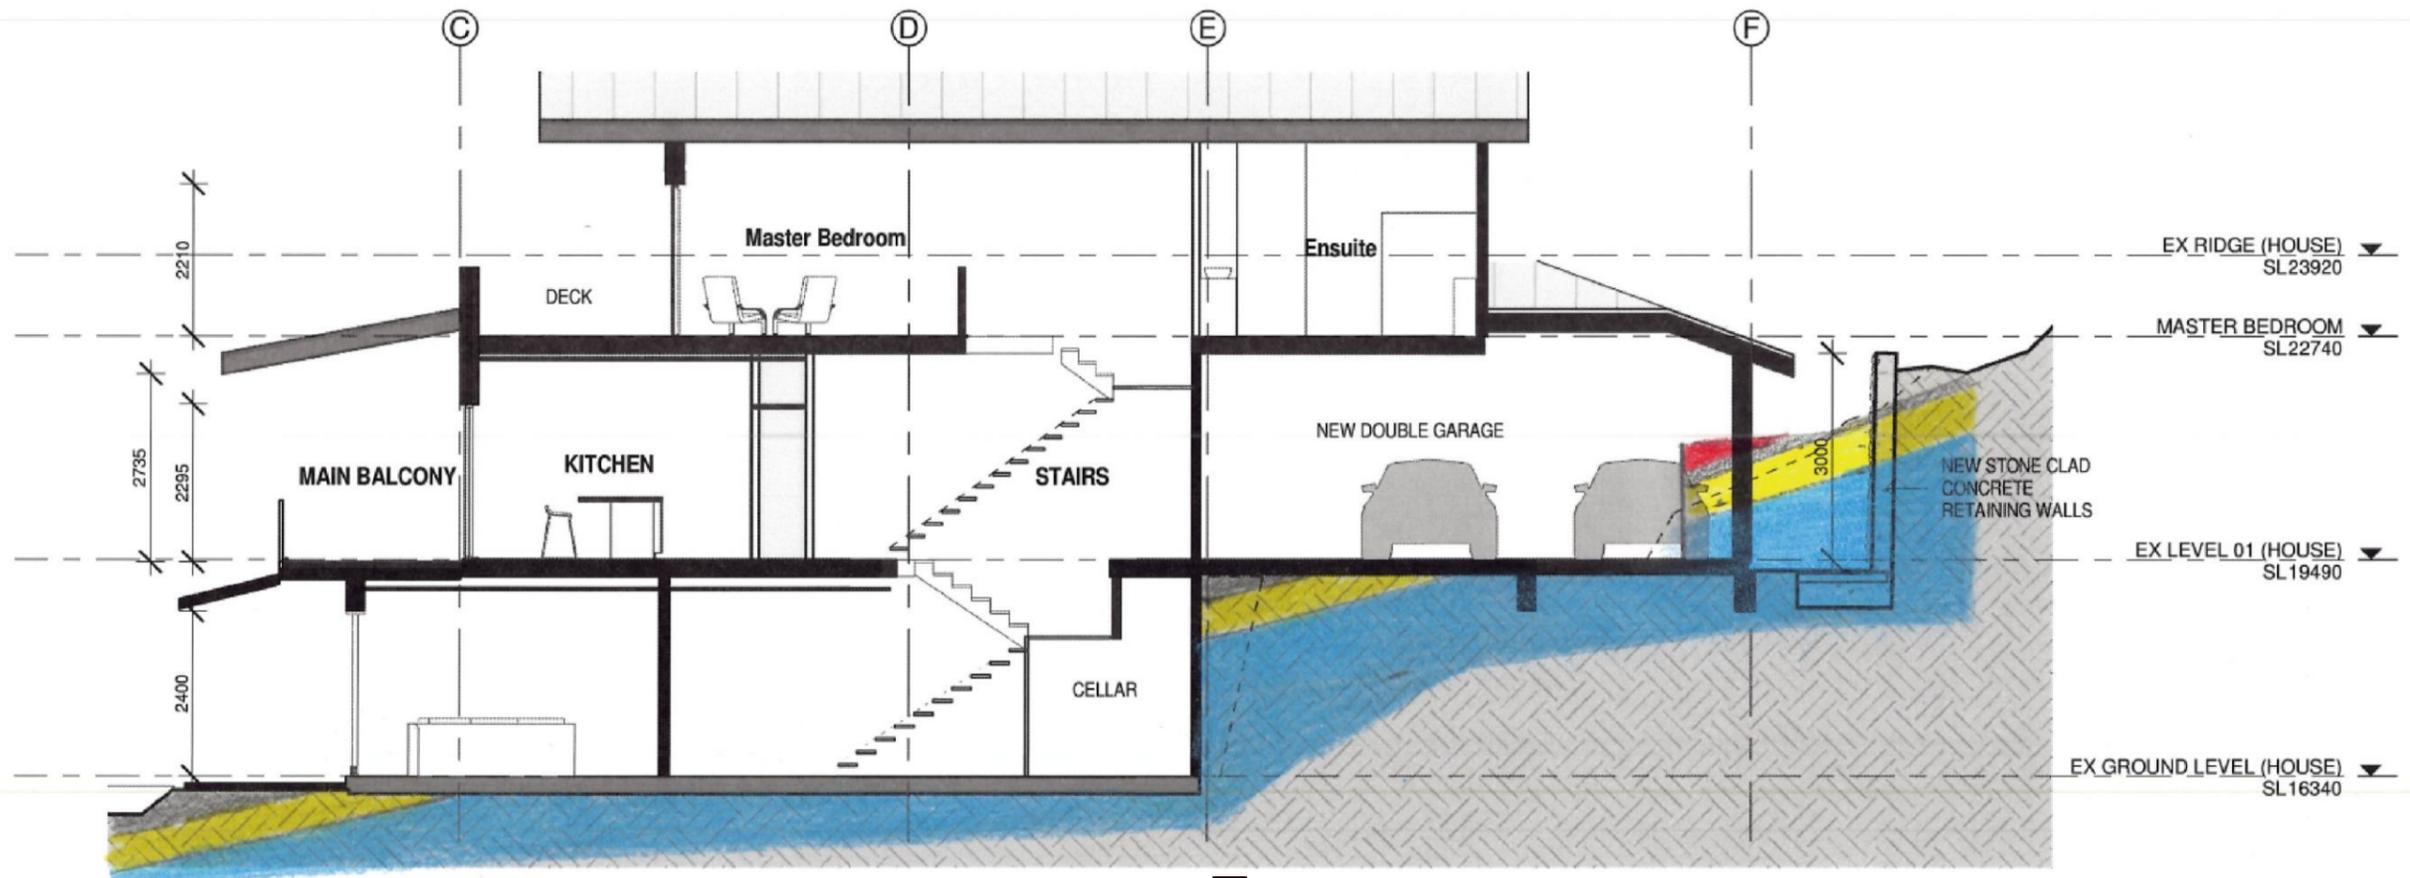
TYPE SECTION – Diagrammatical Interpretation of expected Ground Materials

The slope materials are colluvial at the near surface and residual at depth. In the test locations, the ground materials consist of a thin sandy topsoil over sandy clays. The clays merge into the weathered zone of the under lying rocks at depths of between 0.8m to 0.9m below the current surface. The weathered zone of the underlying rock is interpreted as Extremely Low to Low Strength Rock. It is to be noted that this material is a soft rock and can appear as a mottled stiff clay when it is cut up by excavation equipment. See Type Section attached for a diagrammatical representation of the expected ground materials.
