## **GEOTECHNICAL INVESTIGATION:**

### **New Lift at 16 Cabarita Road, Avalon**

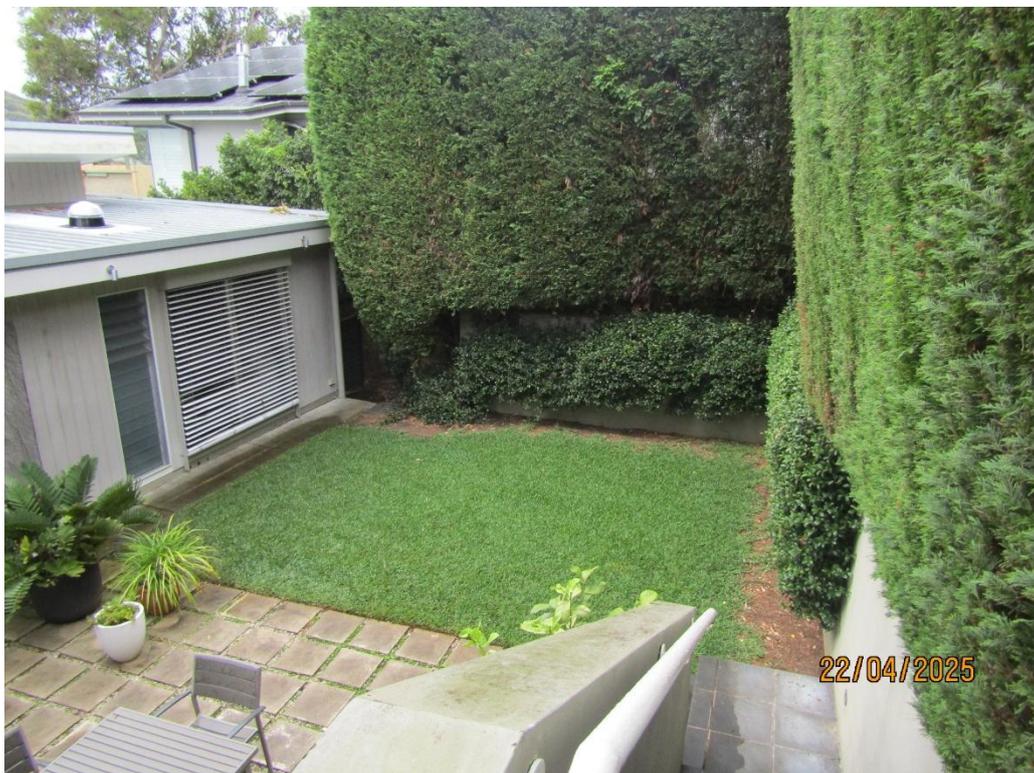
Photo 1

- 2.3** At the road frontage, a concrete driveway runs to a stable garage along the upper boundary of the property (Photo 1). On the downhill side of the garage, an excavation has been made into the slope for a level lawn above the house (Photo 2). The excavation is supported by rendered masonry retaining walls that appear well constructed (Photo 3). The one and two storey clad house displays no significant signs of movement in the external supporting walls (Photo 4). The slope between the downhill side of the house and the waterfront is terraced with a series of stable stack rock retaining walls reaching ~0.8m high (Photo 5). A cut at the waterfront is supported by a stable ~1.8m high sandstone block retaining wall

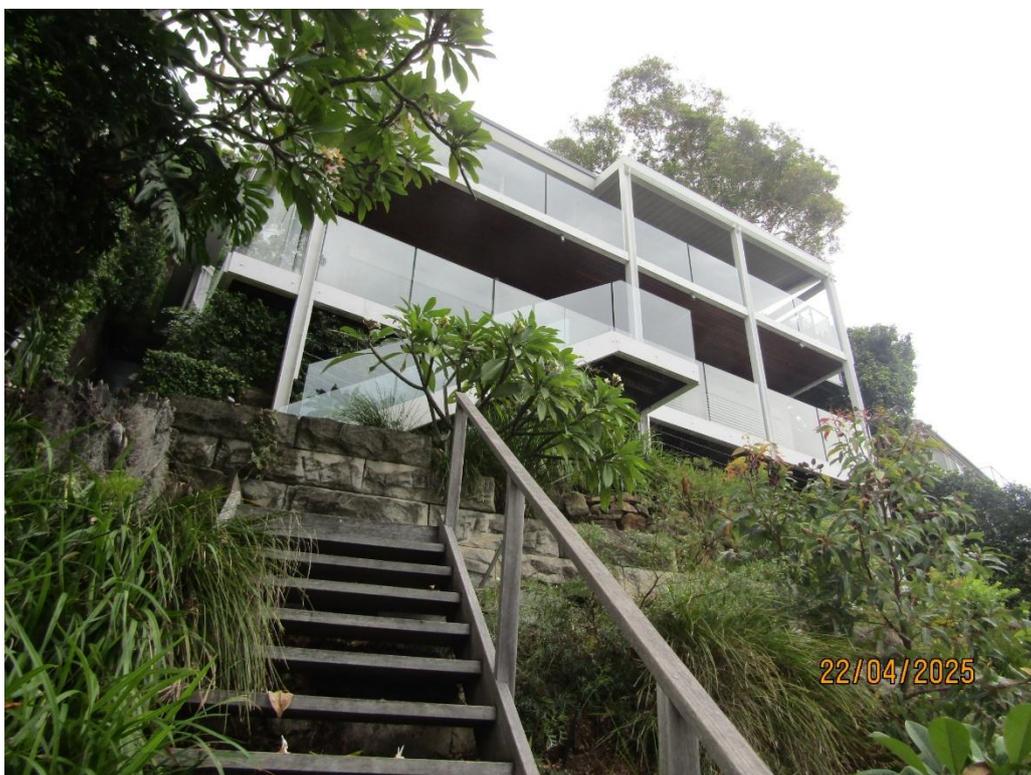
Photo 3

An opening will be cut through the masonry retaining wall immediately downslope of the garage (Photo 3). The boundaries of the wall to be removed are to be cut with saws before

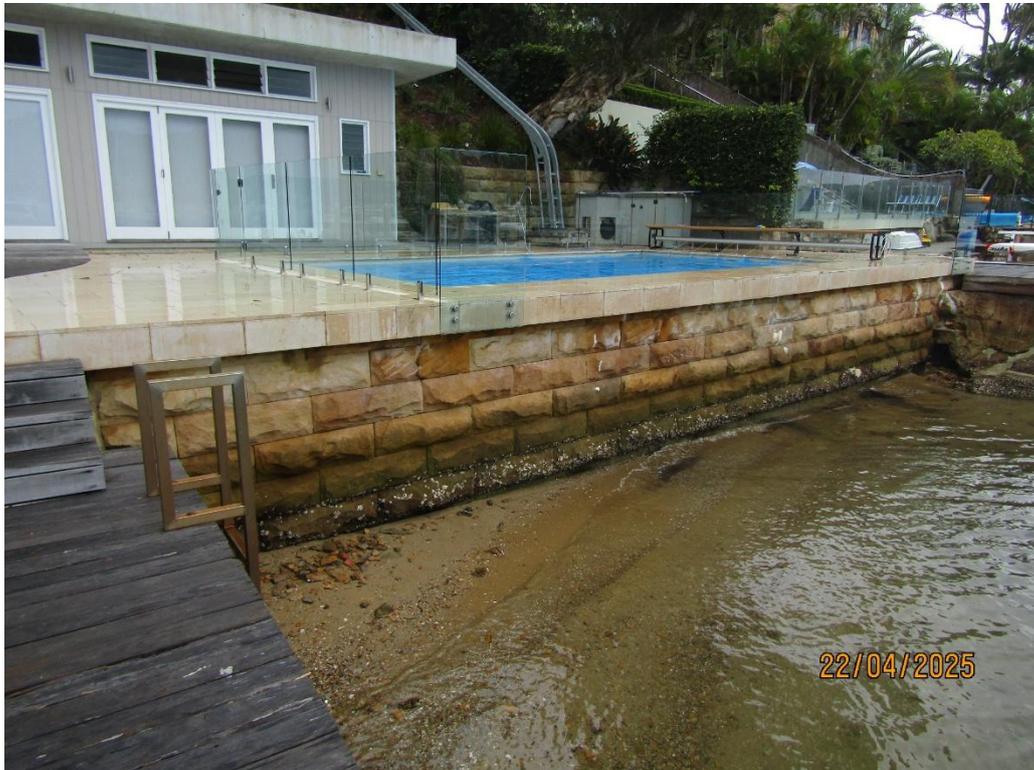
Photo 8

(Photo 6). A boatshed and pool at the waterfront are cut into the slope and appear stable (Photos 7 & 8). The fill around the pool is supported by a stable ~1.8m high sandstone block seawall (Photo 9). Below the property, a jetty extends into Pittwater (Photo 10).
