# Arboricultural Impact Assessment

8 Orara Road, Allambie Heights  
NSW, 2100  
3/-/DP622166  
Job No: 25122  
21/08/2025

**Temporal Tree Management Pty Ltd.**

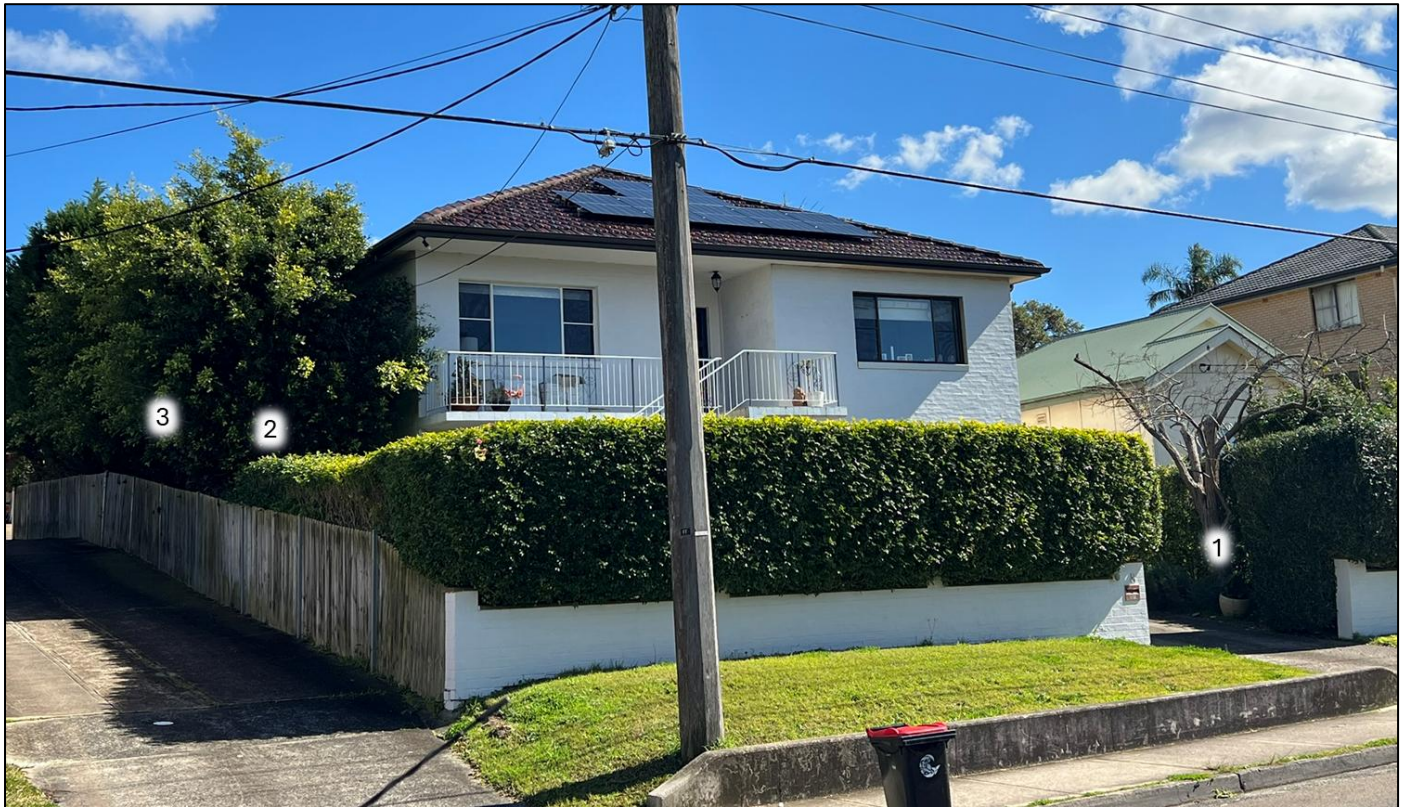
Figure 2. Trees 1, 2 and 3 are positioned within the south-eastern and south-western boundaries of the site.

- Fenced protection zones will not be suitable for Trees 2 and 3 due to the confined pathway area between their stems and the western dwelling wall.
- It is therefore recommended that stem protection measures are installed on Trees 2 and 3 in accordance with *Section 4.5.3 of AS4970 (2025)* (Figure 10 and Figure 11).

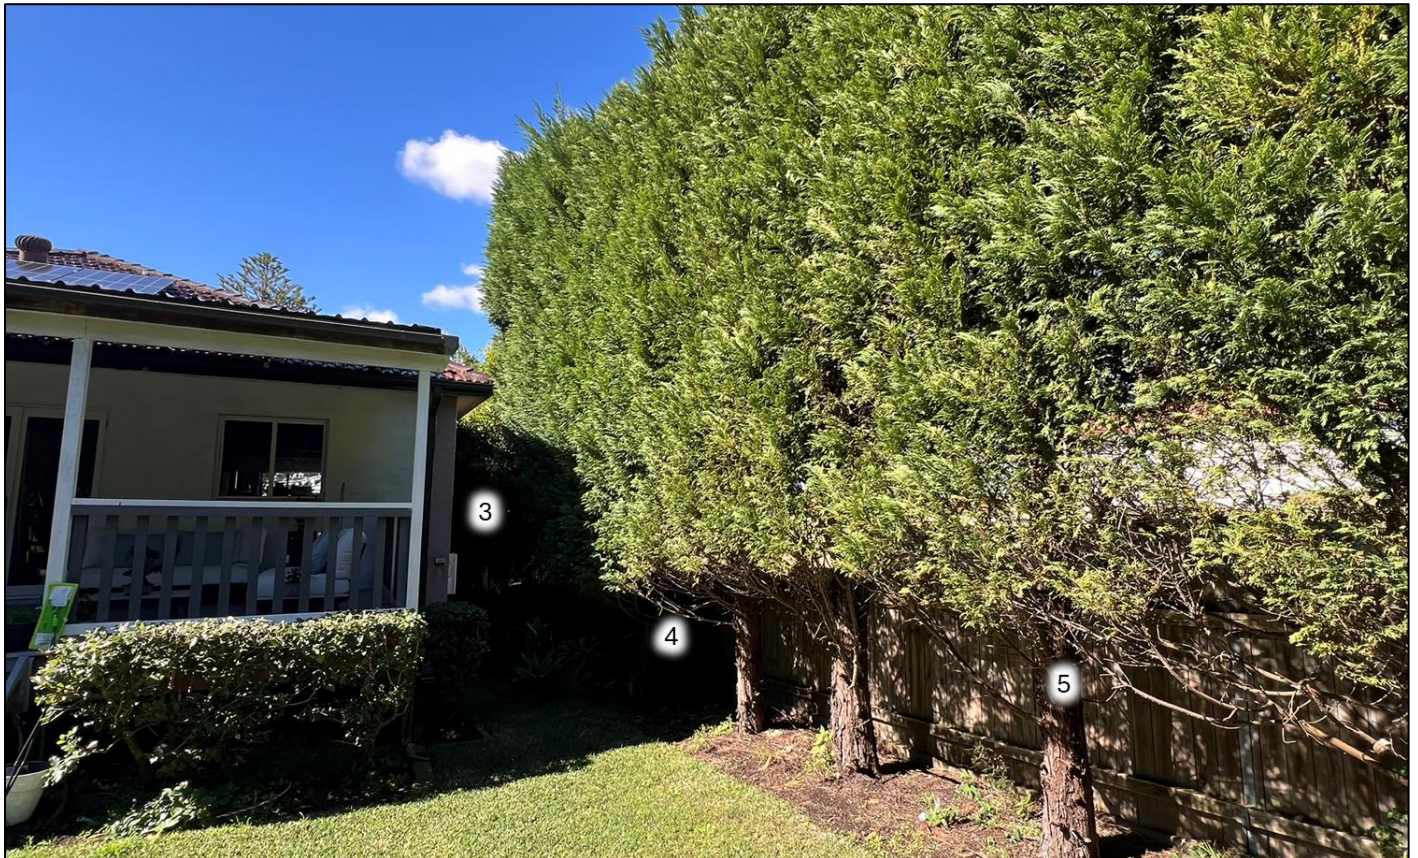
Figure 3. Trees 3-5 are positioned within the western boundary of the site.

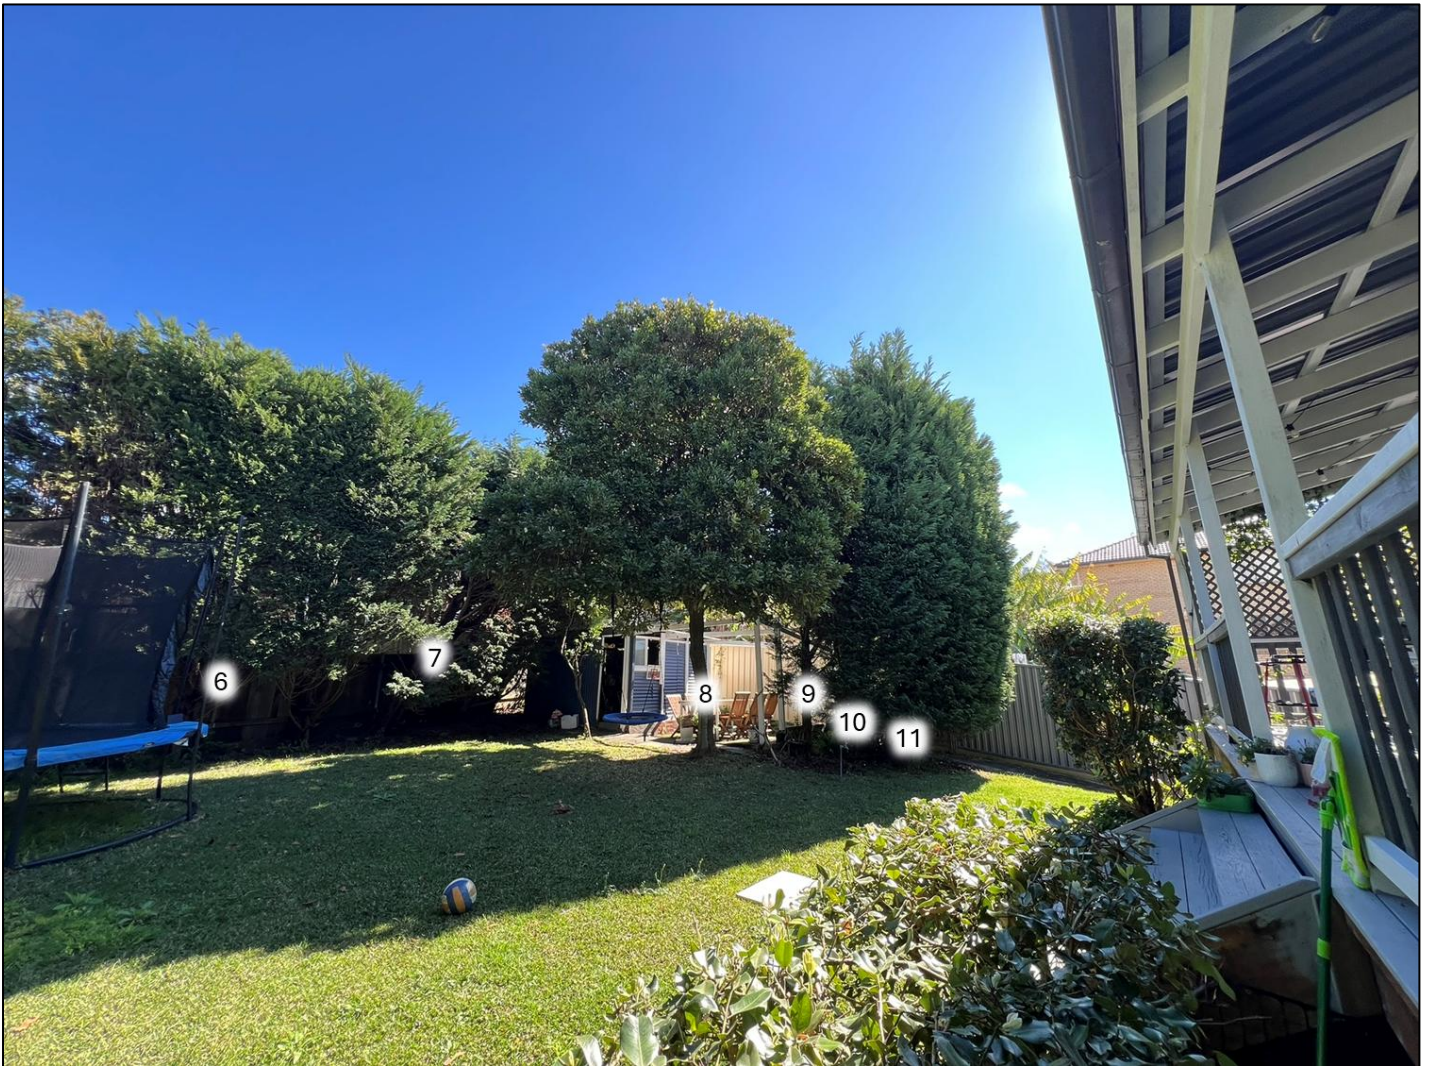
Figure 4. Trees 6-11 are positioned within the northern portion of the site.

Eight trees included in this assessment (Trees 4, 5, 6, 7, 8, 9, 10 and 11) will require removal to facilitate the proposed development. The stems of four specimens (Trees 8, 9, 10 and 11) are within the footprint of the proposed pool (Figure 7) (Table 3). Two trees (Trees 4 and 7) and two tree groups (Trees 5 and 6) will sustain Major or Moderate NRZ encroachments that will breach their SRZs. The viability of these four trees will be compromised by the encroachments they will sustain. Trees 4, 5, 6 and 7 are therefore also recommended for removal.

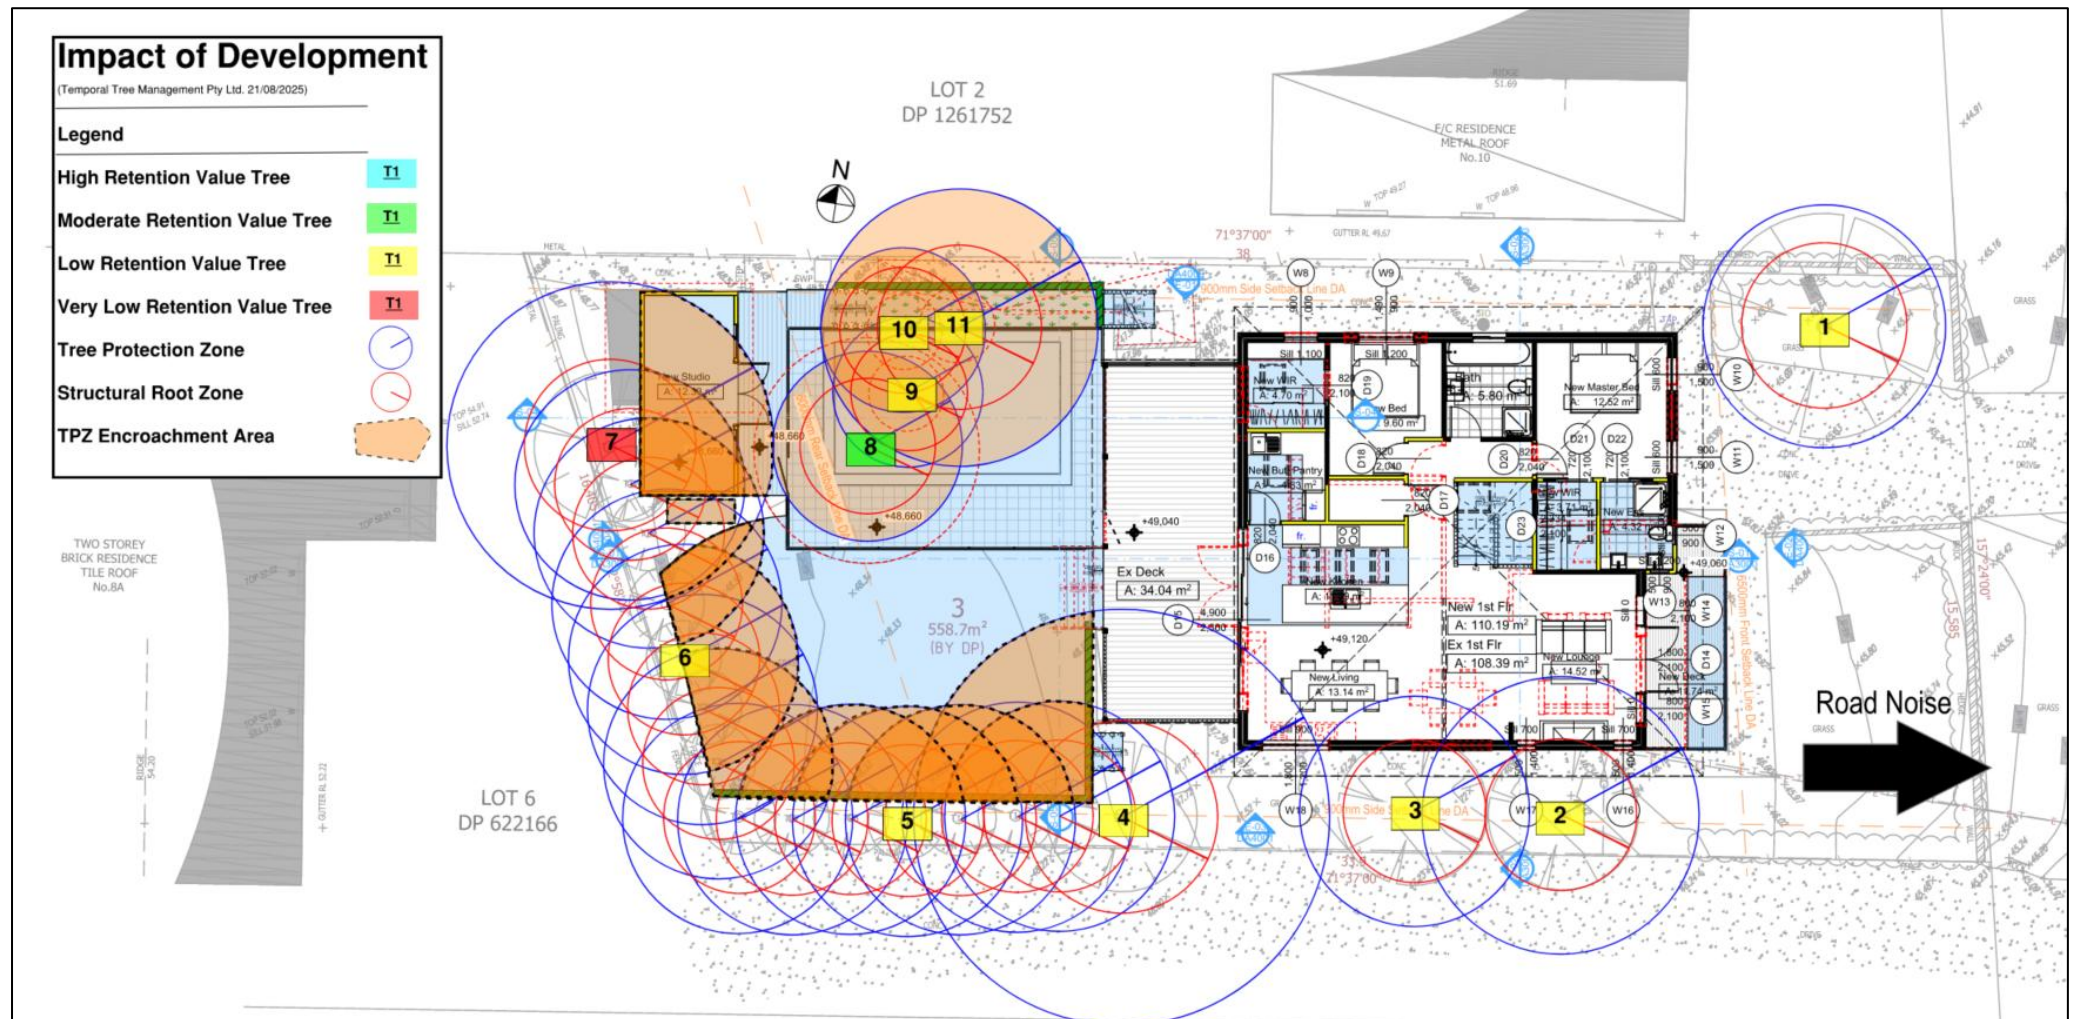
Eight trees included in this assessment (Trees 4, 5, 6, 7, 8, 9, 10 and 11) will require removal to facilitate the proposed development. The stems of four specimens (Trees 8, 9, 10 and 11) are within the footprint of the proposed pool (Figure 7) (Table 3). Two trees (Trees 4 and 7) and two tree groups (Trees 5 and 6) will sustain Major or Moderate NRZ encroachments that will breach their SRZs. The viability of these four trees will be compromised by the encroachments they will sustain. Trees 4, 5, 6 and 7 are therefore also recommended for removal. Trees 4, 5, 6, 7, 9, 10 and 11 are all specimens of a species (*Cupressocyparis leylandii*) that is listed in *Table 1 – Exempt Species of Part E – The Natural Environment, Chapter 1 – Preservation of Trees or Bushland Vegetation* of the Warringah Development Control Plan (WDCP 2011) (Northern Beaches Council 2025). Trees 4, 5, 6, 7, 9, 10 and 11 may therefore be removed without prior approval from the Northern Beaches Council. Tree 8 is protected under *Part E – The Natural Environment, Chapter 1 – Preservation of Trees or Bushland Vegetation* of the Warringah Development Control Plan (WDCP 2011) (Northern Beaches Council 2025). Consent for the removal of this tree must be issued by Northern Beaches Council prior to their removal.

Figure 7. Retention values, NRZs, SRZs and Encroachments for eleven trees positioned within the subject site. Site Plan, prepared by: *Rapid Plans* (Drawing No: DA1003, Rev: -, drawn: 14/07/2025). Annotated by Temporal Tree Management Pty Ltd. (21/08/2025).

It is recommended that Tree 8 is suitably replaced as part of the proposed Landscape Plan. It is recommended that a minimum of one specimen of a suitable indigenous or native tree species capable of growing to a mature height of no less than 8 metres is planted within the subject site in a position within the northern portion of the site that will ensure its ULE is entirely fulfilled. The replacement trees must come in a 75L pot and in compliance with the *Australian Standard for Tree Stock for Landscape Use (AS 2303 2015)*.
