8 Bower Street, Manly

Geotechnical Comments for Section 4.55

GEOTECHNICAL INVESTIGATION:

Alterations and Additions, New Pool, and New Outbuilding at **8 Bower Street, Manly**

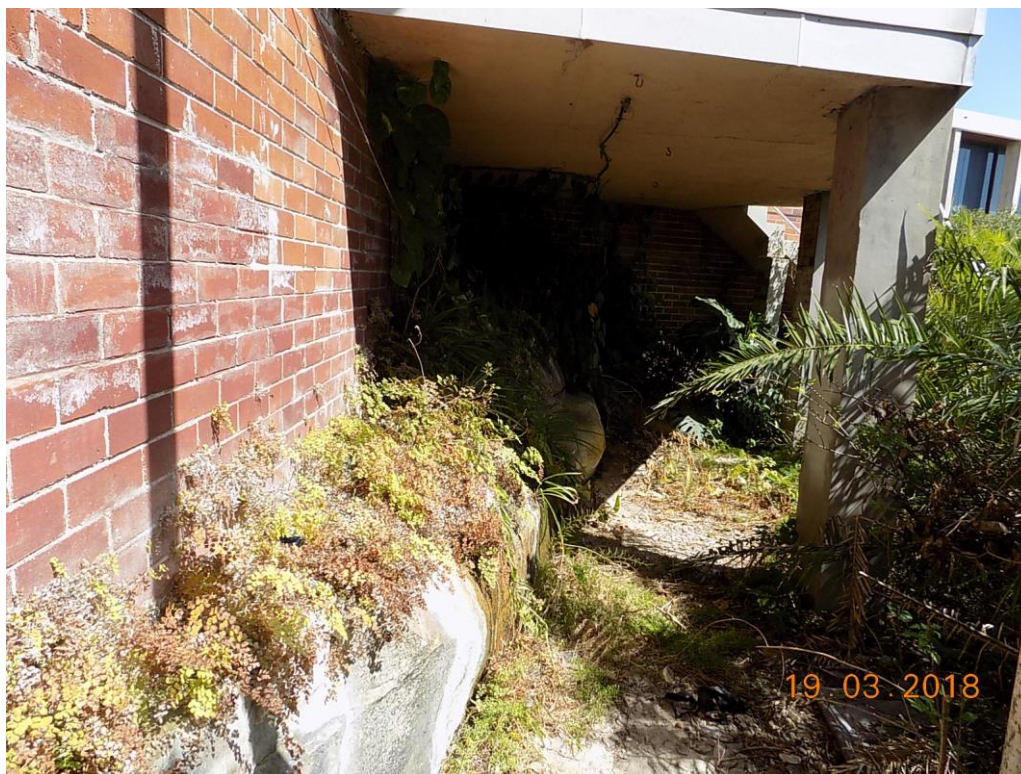
Photo 2

2.3 At the road frontage, a concrete driveway runs to a garage on the ground floor of the house (Photo 1). The part two-storey brick house is supported on brick walls and brick piers (Photo 2). No signs of movement were observed in its external supporting brick walls and the supporting brick piers stand vertical. Some of the supporting brick piers and portions of the supporting brick walls were observed to be supported directly on competent Medium Strength Sandstone (Photo 3). A fill has been placed on the downhill side of the house for a level patio area. The fill batter is lined with rocks and is considered stable (Photo 4). A gentle to moderately sloping lawn falls below the fill batter. Competent Medium Strength Sandstone outcrops through the upper portion of the lawn (Photo 5). A timber framed and clad outbuilding has been constructed near the lower boundary (Photo 6). The outbuilding will be demolished as part of the proposed works. A fill has been placed at the lower boundary. The fill is supported by a rough but stable stack rock retaining wall reaching $\sim 1.0\text{m}$ high that lines the lower boundary (Photo 7). A creek flows down the slope below the lower boundary (Photo 8). Medium Strength Sandstone outcrops through the creek bed.
