REPORT TO
**MANLY PROPERTY GROUP NO.2 PYT LTD ATF
MANLY UNIT TRUST NO.2**

ON
HAZARDOUS BUILDING MATERIALS SURVEY

FOR
PROPOSED DEMOLITION WORKS

AT
27 EAST ESPLANADE, MANLY, NSW

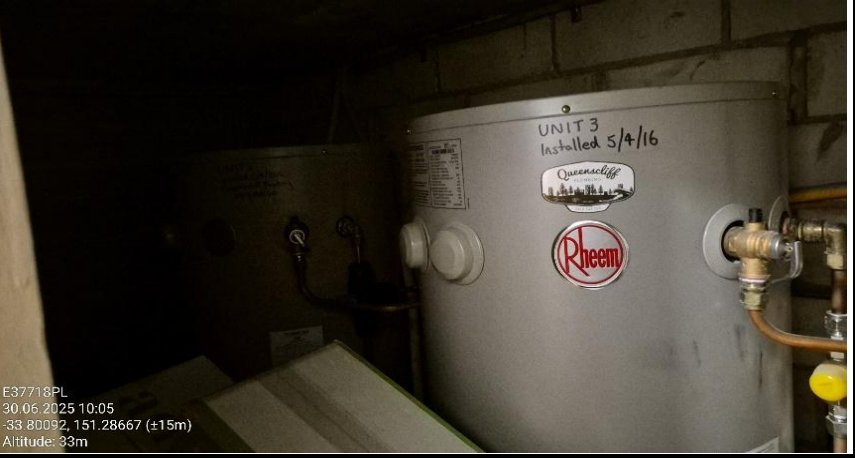
Building interior, Hallway, Cupboard under staircase, Hot water heaters	Internal Insulation	NA - Electrical Hazard	NA - Assumed to contain SMF	Generally Intact	-	2 Units	Remove prior to refurbishment / demolition by appropriately licensed hazardous materials contractor in accordance with the relevant standard/code of practice/guidelines.	Yes

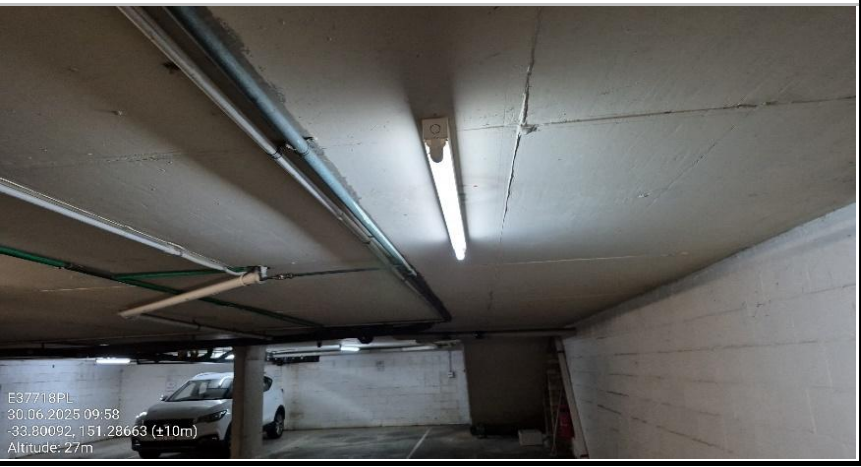
<div>E37718PL 30.06.2025 09:25 38.86100, 151.28546 (±24m) Altitude: 33m</div>
Building interior, Garage, Ceiling	Single tube Fluorescent Light fittings	NA - Electrical Hazard	Of an age indicative of housing PCB containing capacitors	Generally intact	NA	8 Units	Undertake detailed inspection following isolation of electricity supply, OR Handle in accordance with relevant standard/code of practice/guidelines.	No (access via ladder only)
