87 Alexandra Crescent, Bayview

Comments on Updates to Plans

GEOTECHNICAL INVESTIGATION:

Alterations and Additions at **87 Alexandra Crescent, Bayview.**

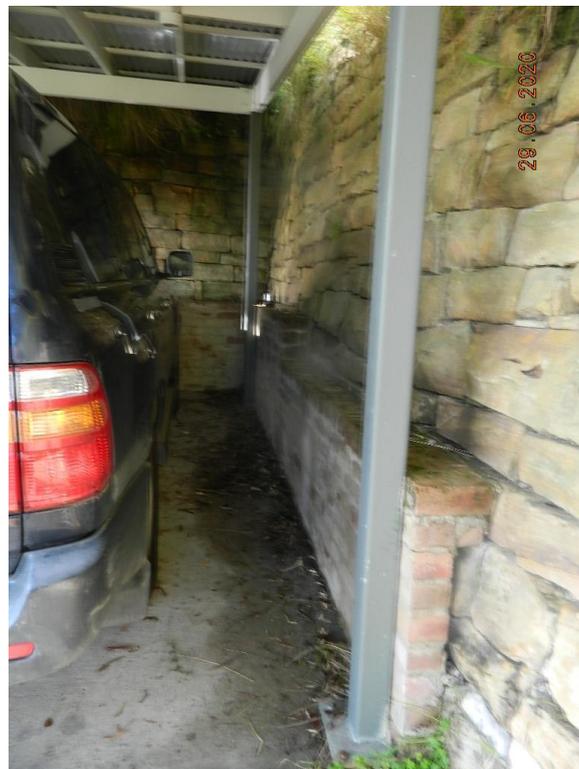
Photo 2

2.3 At the road frontage a concrete driveway runs to a carport cut into the slope (Photo 1). The cut is supported by sandstone block, brick and concrete block retaining walls up to ~3.4m high (Photos 1 to 3). The highest portion of the sandstone block wall is supported by a brick wall in front of the base of the retaining wall (Photo 2). The retaining walls are considered to be stable. Between the carport and the house is a steep and thickly vegetated slope (Photo 1). The part three storey rendered brick and weatherboard clad house is supported by brick walls and brick piers Photos (1 & 4). The supporting walls and piers stand vertical and show no significant signs of movement (Photo 5). Uphill of the house a cut in the slope provides a level platform for the house. The cut is supported by concrete block and sandstone flagging retaining walls up to ~2.7m high. (Photos 6 & 7). The W portion of the concrete block retaining wall is tilting at up to ~4° from vertical. See 'Section 16 Ongoing Maintenance'. A Medium Strength Sandstone bedrock cliff face up to ~7m outcrops above the cut for the house (Photo 8). A portion of the cliff face is undercut by up to ~4.4m (Photo 9). The undercut is considered stable. No geotechnical hazards were observed on the neighbouring properties that could impact on the subject property as seen from the street and subject property.

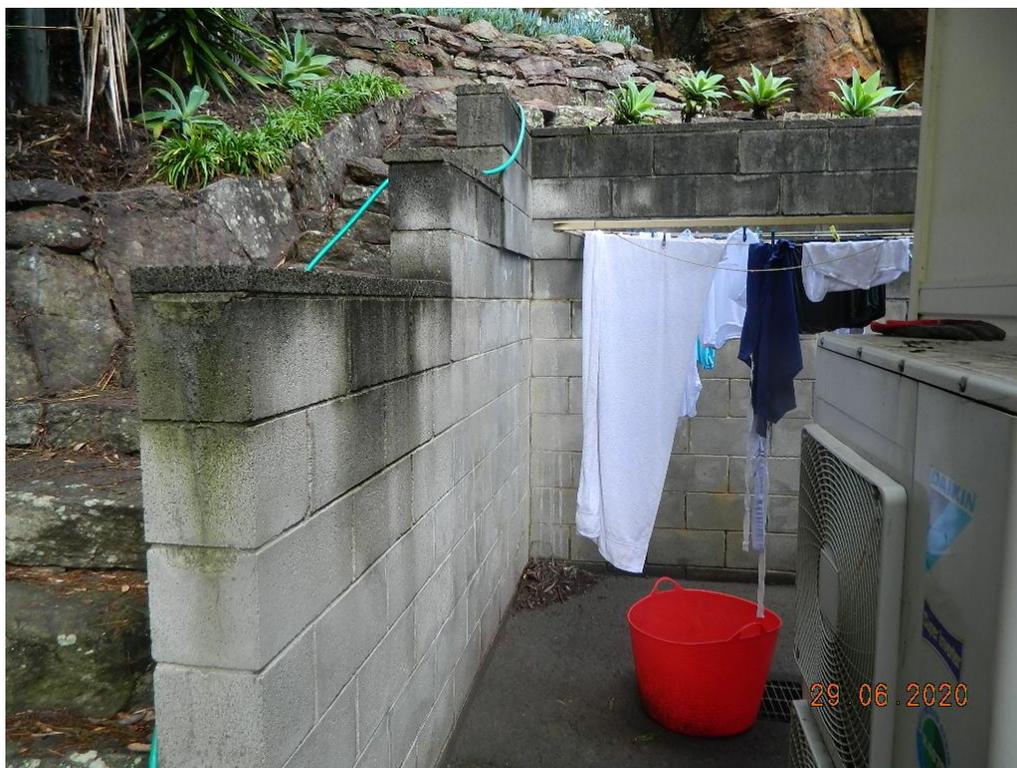
Photo 6

The concrete block retaining wall (Photo 6) is to be monitored by the owners on an annual basis or after heavy prolonged rainfall events, whichever occurs first. A photographic record of these inspections is to be kept. Should further movement occur the wall is to be remediated so it meets current engineering standards. We can carry out these inspections upon request.
