# Geotechnical Assessment

**Project:** Alterations & Additions  
38 Judith Street, Seaforth NSW

**Ref:** AG 25211  
29 May 2025

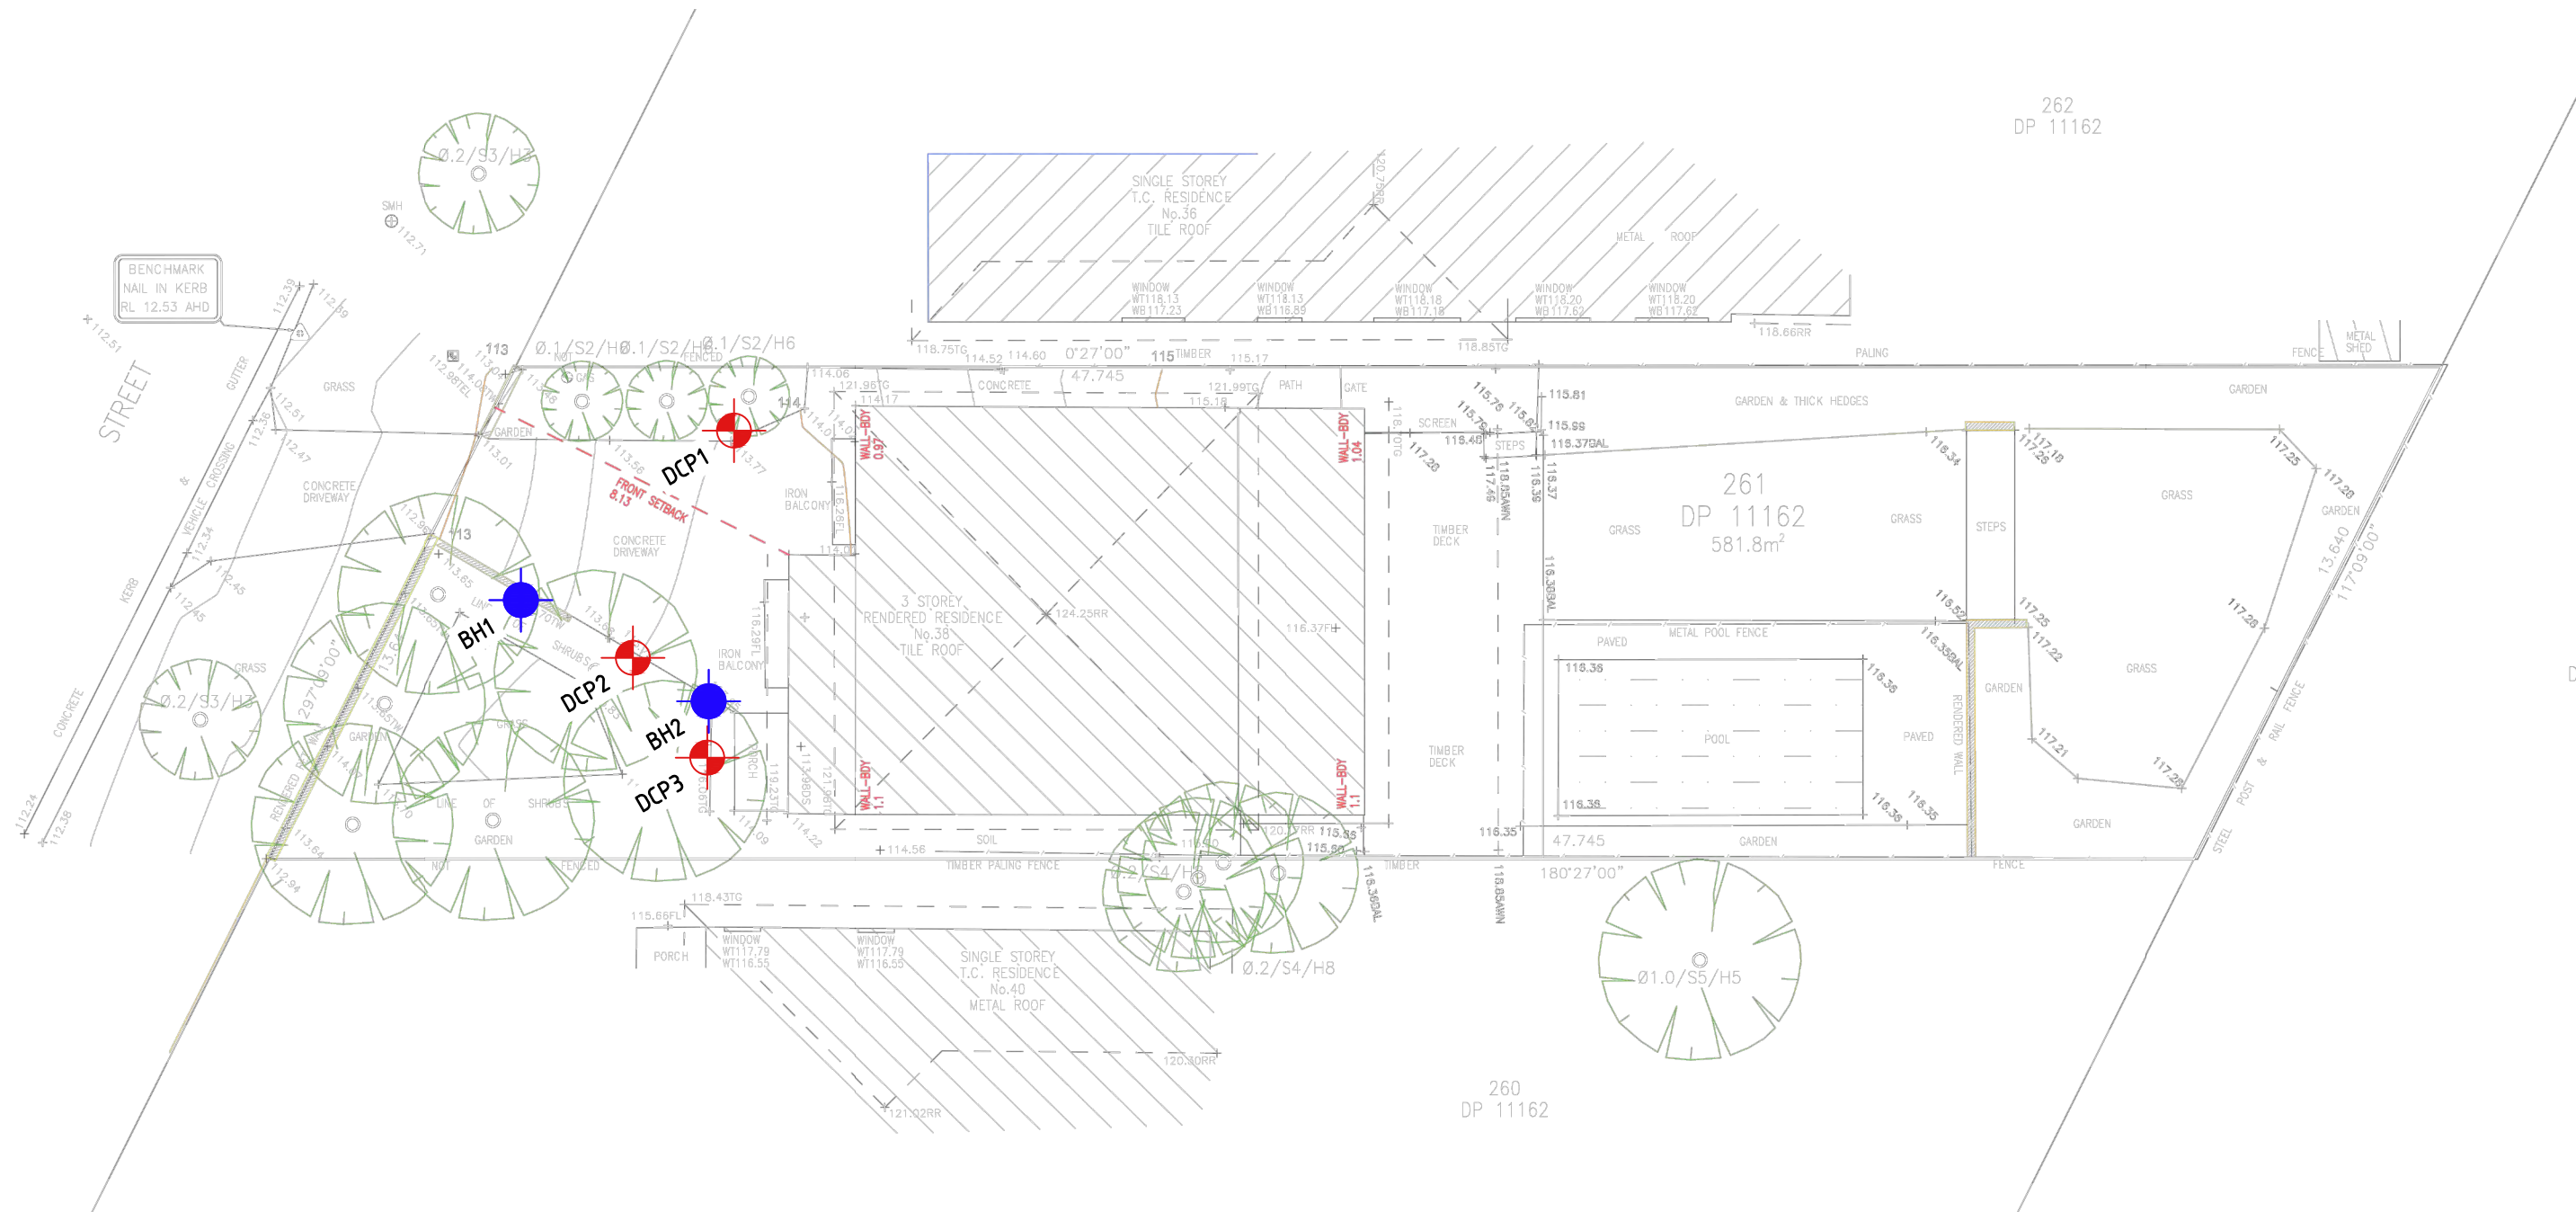
SITE PLAN/GROUND TEST LOCATIONS  
SCALE NTS

Test	Summary
DCP 1	Refusal @ 0.4m Bouncing on bedrock. Brown sand on moist tip.
DCP 2	Refusal @ 0.6m Bouncing on bedrock. Orange sand on moist tip.
DCP 3	Refusal @ 0.4m Bouncing on bedrock. Brown sand on moist tip.

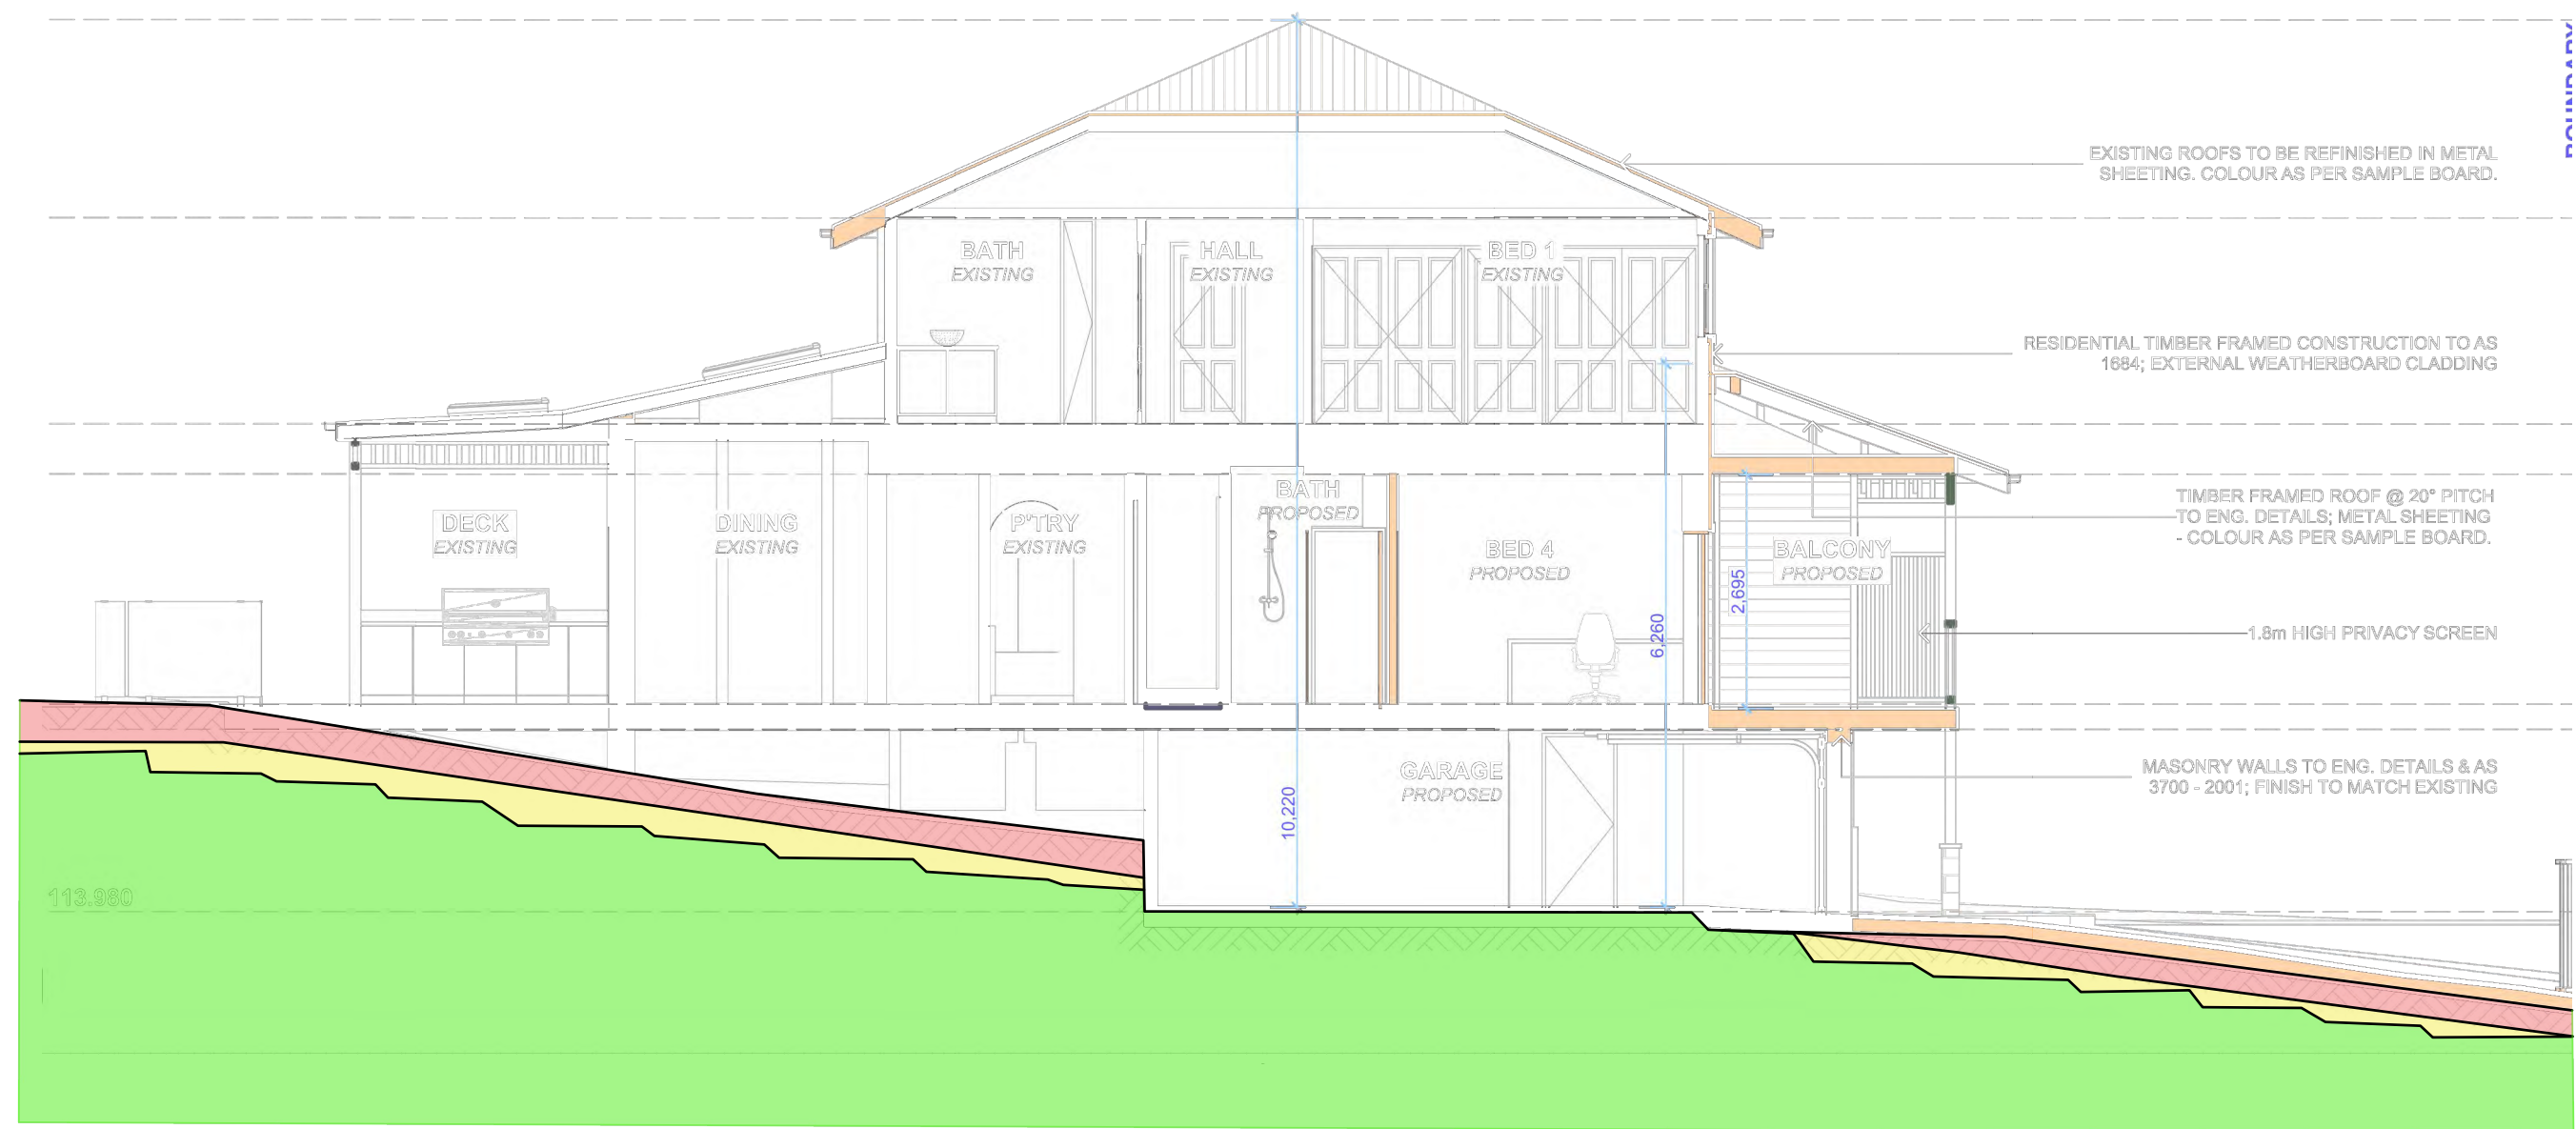
DRAWING NO:  
**AG 25211- S1**

Unit	Material	Comments
1	Topsoil / Fill	Sandy topsoil and fill material. Unit 1 is inferred to be uncontrolled and poorly compacted.
2	Sand	Medium to coarse grained sand of the natural profile, minor clay.
3	Sandstone	Medium strength or greater sandstone bedrock (Class III+*) expected to be found below the weathered crust (Class IV-V*).

INTERPRETED SUBSURFACE SECTION ONLY.  
ACTUAL GROUND CONDITIONS MAY VARY.
