948 Barrenjoey Road, Palm Beach

Comments on Updates to Plans

GEOTECHNICAL INVESTIGATION:

Minor Works at **948 Barrenjoey Road, Palm Beach**

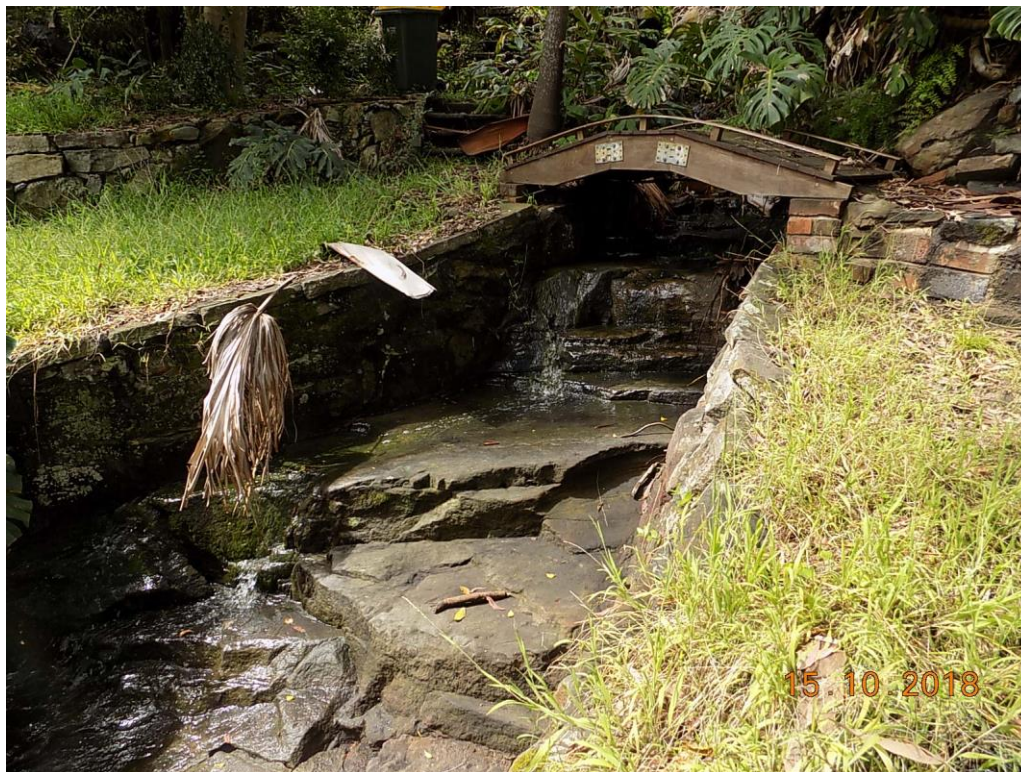
Photo 4

A ~3.0m cut has been made for an inclinometer on the S side of the property (Photo 4). It is supported by a continuation of mortared dimensioned sandstone retaining walls that terrace the slope front. The wall shows some cracking but is currently considered stable (Photo 14 & 15). See **Section 13** "Site Maintenance" for treatment of the cracking. Medium Strength Sandstone was observed outcropping in the lower portions of the wall at the S boundary and bedrock was also present in the creek bed that flows down the slope to the N of the property (Photo 5 & 6). The part two-storey rendered masonry and timber clad house is supported by rendered masonry walls and was undergoing renovations at the time of the inspection (Photo 7 & 8). No significant signs of movement or cracking was observed in the external supporting walls of the house. Two dimensioned sandstone block walls terrace the slope above the house (Photo 9 & 10). The lower wall reaches a maximum height of ~2.0m and levels the area for the lower ground floor. The upper wall reaches a maximum height of ~1.0m and levels an area for a deck attached to the ground floor. Both walls are slightly angled back into the slope and are considered stable. The slope above the house gradually increases to steep angles to the uphill boundary. It is densely vegetated (Photo 11). Large dislodged sandstone joint blocks that have historically fallen from the slope above were observed outcropping randomly on the slope (Photo 12 & 13). Most are obscured by the vegetation but those visible are partially embedded in the slope so have been in place for a long time and are considered stable.

The property is extensively terraced in mortared stone walls (Photos 2, 3, 4, 8 & 9). These types of walls require occasional maintenance to ensure ongoing stability in the future. As such, it is recommended that the owners inspect the walls on an annual basis or after extreme rainfall events, whichever occurs first. A photographic record of these inspections is to be kept. We can carry out these inspections upon request. Should cracking, bulging or tilting in the wall face be observed the wall is to be assessed for stability by a geotechnical consultant. The risk assessment in **Section 8** is conditional on these inspections being carried out.
