# Arboricultural Impact Assessment

8 Surfside Ave, Avalon Beach

# **Prepared by Alex Austin**

### August 2022 V5

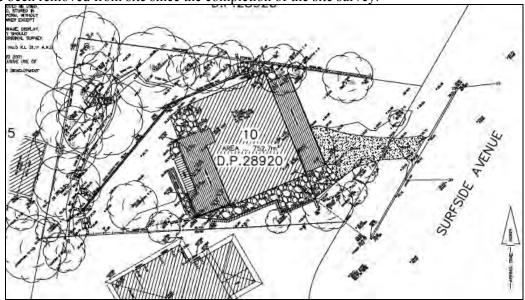
The exiting layout includes a two story house, driveway, retaining walls on southern and western side of site. Dense trees on southern and, western and northern boundaries of the site that provide considerable privacy. Five (5) weed/exempt trees numbered T6, 10, 22, 23 & 24 have been removed from site since the completion of the site survey.

Figure 12: The existing layout. (Source: Site Survey, By Adam Clerke Surveyors, dated 28/09/2021)

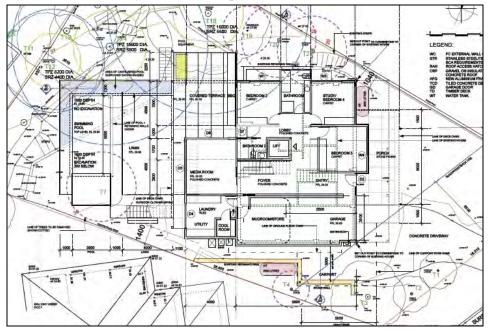
The proposed development works include demolition, tree removal, excavation and then construction of a new tow story residence and pool.

Figure 13: The proposed site plan. (Source: Proposed Plans by Atelier Halefeli Architects, revision A, dated 18/08/22)

Six (6) Trees numbered 4, 7, 16, 19, 20 & 21 are proposed for removal and should be removed at the beginning of the project (STCA). The trees nominated for retention must not be damaged during the tree removal works.

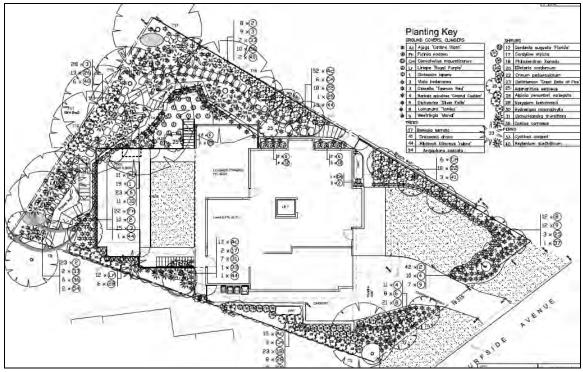
**Figure 23**: The proposed landscape plan. (Source: Landscape Plans, by Wallman Partners dated 17/08/22)

11 new trees are to be planted onsite to offset the loss of canopy form the proposed tree removals and to improve the quality of the landscape.

The 11 new trees are shown the Landscape Plans. The new plantings include One (1) *Banksia serrarta* (Old Man Banksia) and Two (2) *Angophora costata* (Sydney Red Gum).
