Report Title: Geotechnical Report 31 Marine Parade, Avalon Beach
Report Date: 9/6/21

GEOTECHNICAL INVESTIGATION:

New House and Garage at **31 Marine Parade, Avalon Beach**

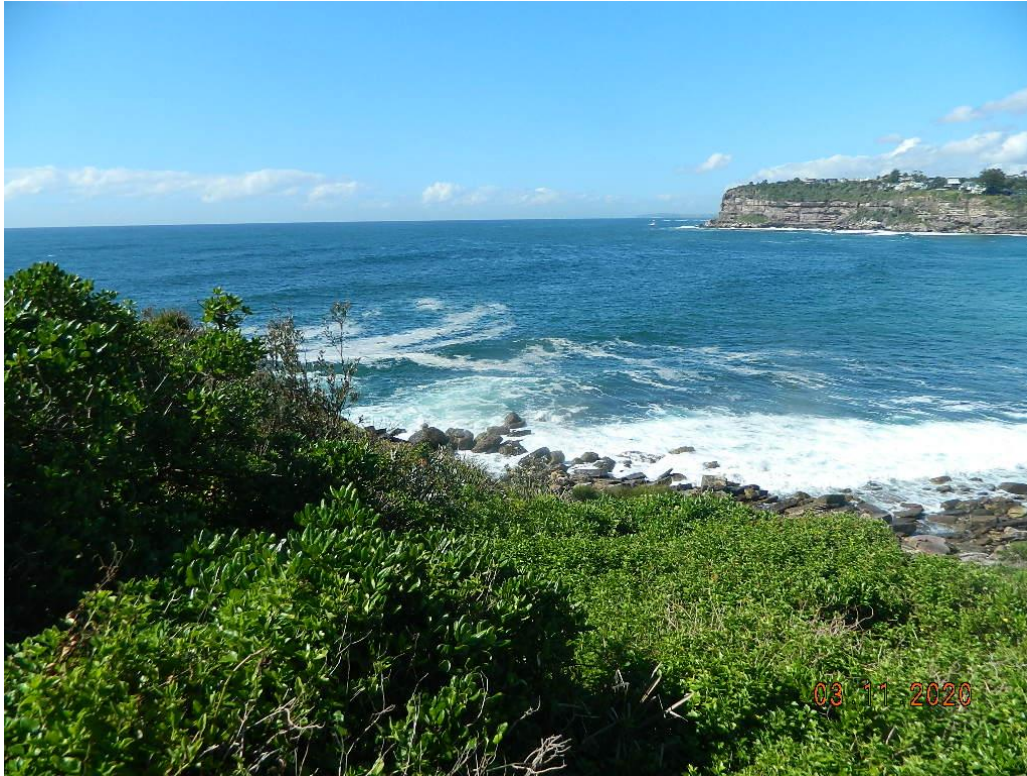
Photo 9

the downhill side of the house (Photo 7). A stable brick retaining wall up to ~2.0m high along the W common boundary supports a cut on the W neighbouring property (Photo 8). The steep coastal bluff that falls to the waterfront is densely vegetated (Photos 9 & 10). A cliff face consisting of various sedimentary layers including laminate, shale and sandstone marks the beachfront. The cliff face shows some evidence of recent rock falls but these are limited in extent by the structure of the rock and are considered part of the normal ongoing weathering process.
