WARRINGAH COUNCIL HAZARDOUS BUILDING MATERIALS SURVEY

NORTH MANLY BOWLING CLUB KENTWELL ROAD, MANLY VALE NSW 2093

REFERENCE No. S8654-BUI00137

NOVEMBER 2015

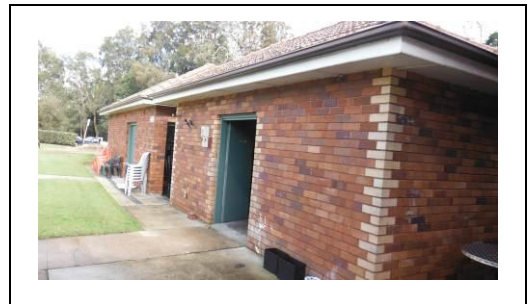
Workshop Building

The building is a single level attached structure with a tiled roof, brick walls and concrete floors.

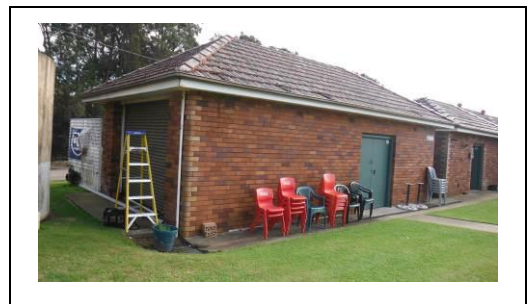
Amenities\Store Building

The building is a single level attached structure with a tiled roof, brick walls and concrete floors.
