Arboriculture Assessment & Hazard Management Statement

January 2020

Site: Lot 33 in DP 12186
37 Parkes Street
MANLY VALE, NSW

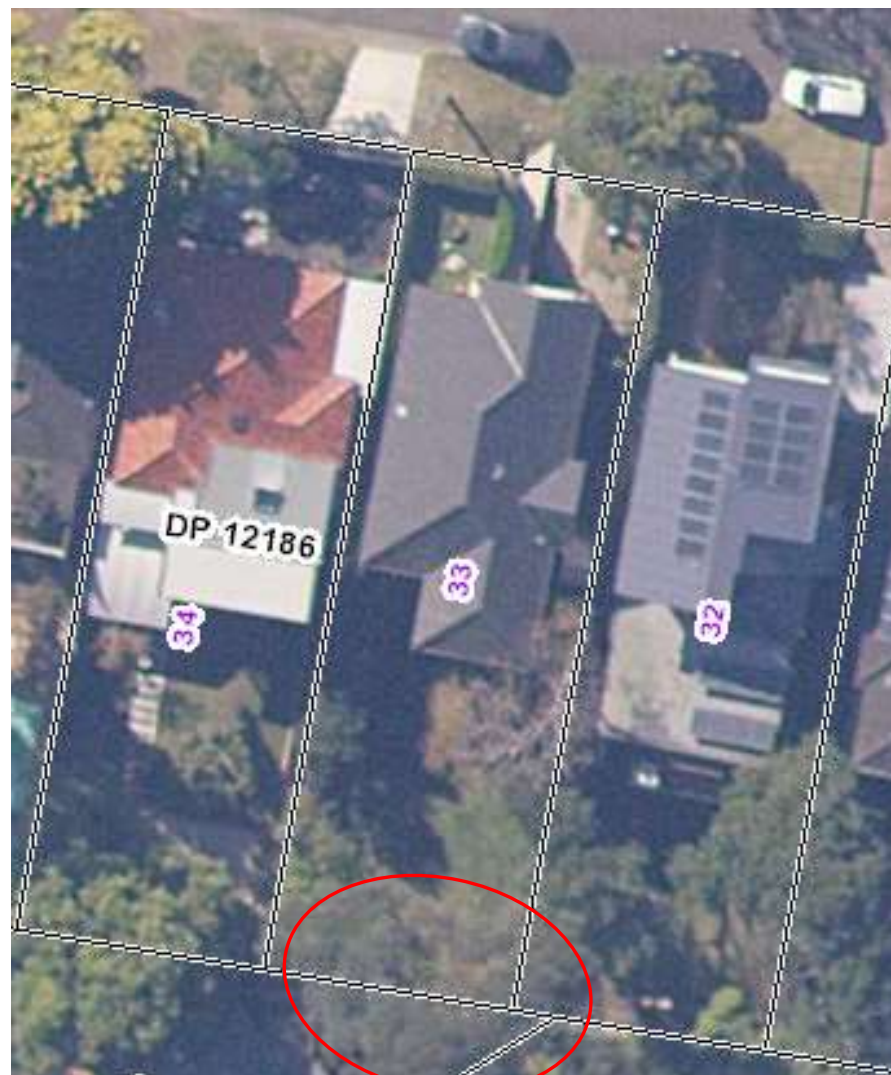
Figure 6: Aerial Map of 22 October 2019, (courtesy of Nearmap) confirms discussed tree location.

The discussed tree has been assessed & classified to be an unacceptable 'risk' on the basis of many recent years 'live branch' failure incidents of a significant diameter. Eight (8) sites have been identified by VTA stage 1 & stage 2 criteria.

It is unusual for a tree that has so many 'live branch' failure incidents to be as orientated in any single direction as observed at this site. Most 'live branch' failure incidents face the north. The reason for this is not known. The tree appears to be more exposed to winds from a Northerly direction. It is possible a tree from within one of the adjoining to the subject site common boundary properties has had a large tree removed that has exposed the discussed tree.

With the tree without challenge providing both private & communal 'landscape amenity' it must be replaced by a suitable tree in a location whereby its present contribution to local area 'tree canopy density' can be replicated over time.

- *Refrain from any unnecessary backyard occupation, especially during storm events or days.*
- *Apply to the NBC for immediate removal & replacement in this coming Autumn with a suitable new tree species.*
