GEOTECHNICAL INVESTIGATION REPORT

ALTERATIONS AND ADDITIONS TO A DWELLING
21A GREYCLIFFE STREET, SEAFORTH NSW

PREPARED FOR GREG RITCHIE
REPORT ID: G25023QUE-R01F

Date: 7th April 2025

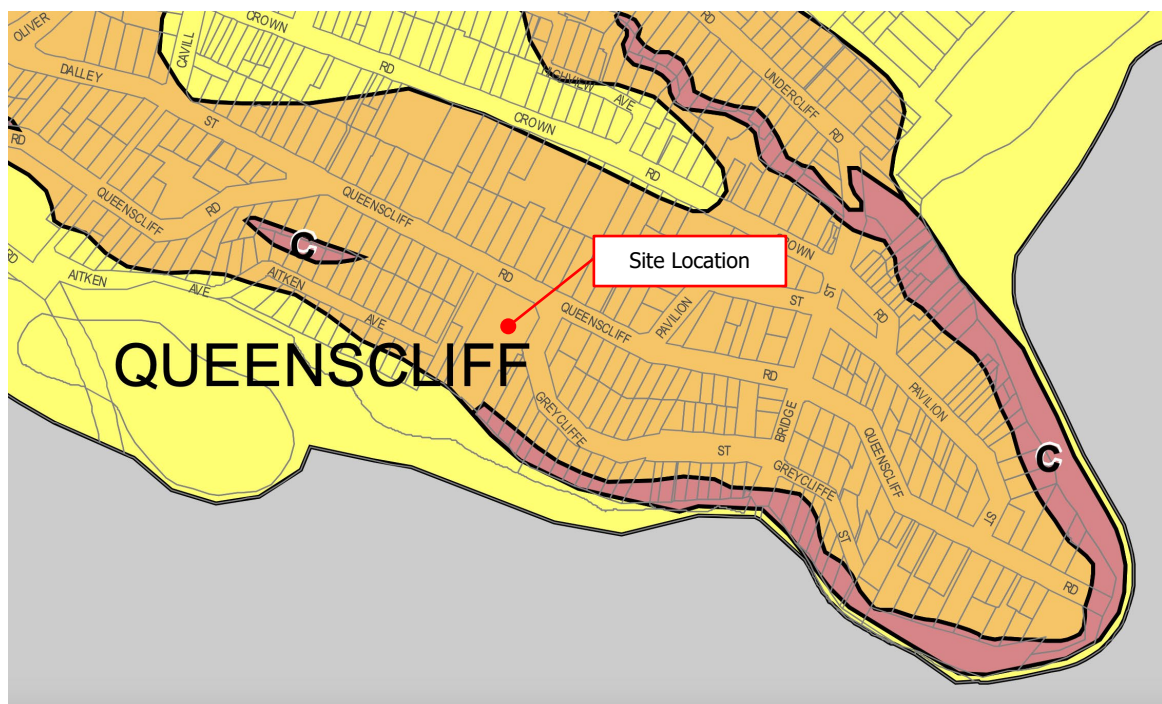
The Northern Beaches Council, Warringah LEP 2011-Landslide Risk Map (see below) shows that the site is within 'Area B (Flanking Slopes from 5 to 25 Degrees)'.

Landslip Risk Map Covering the site.

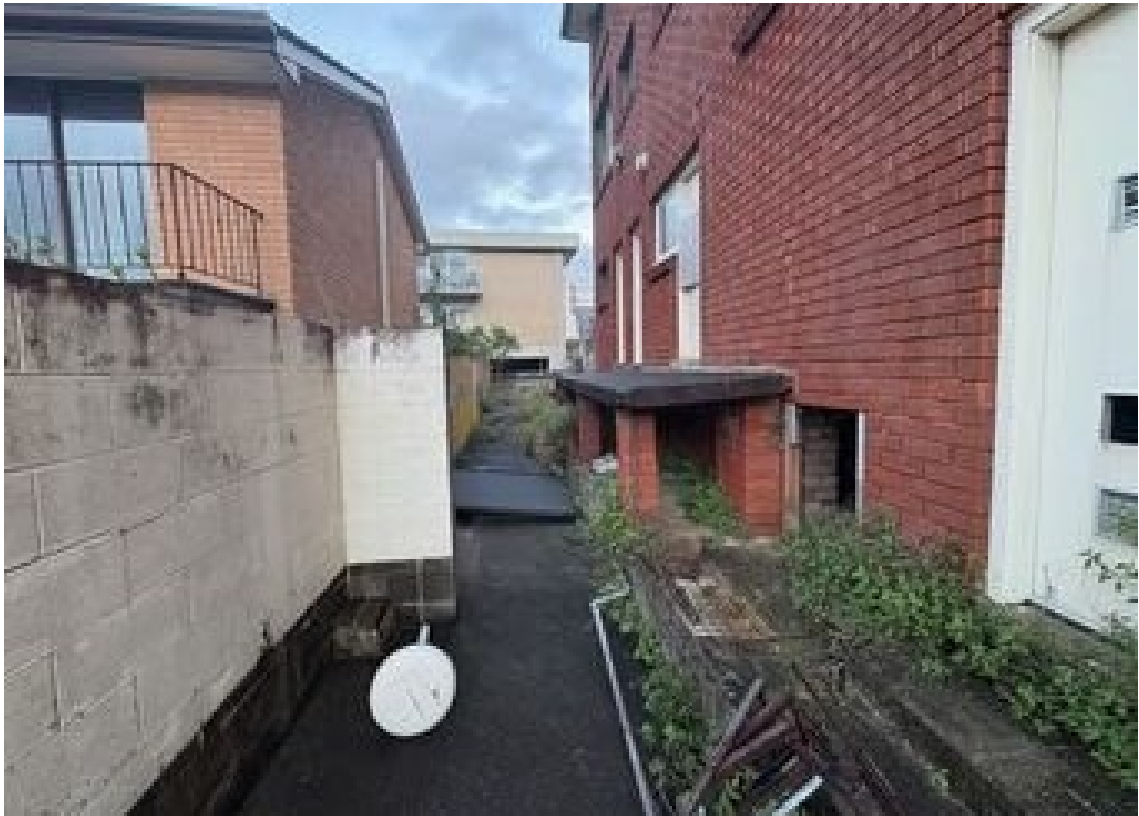
Plate 7: Boundary with 68a Queenscliff Road viewed to west.

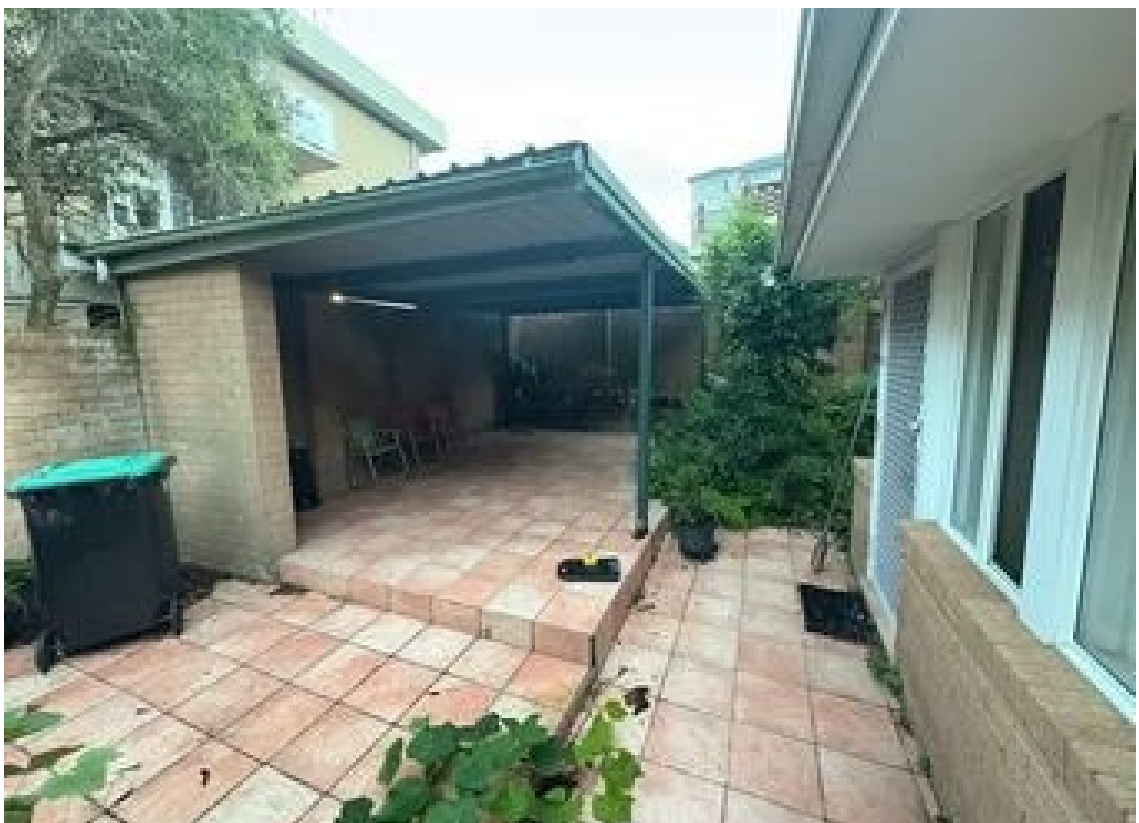
The rear yard has a small garden area along the rear northern boundary, a fibro shed in the southwest corner and an enclosed outdoor area in the northwest corner. The remaining paths and open areas were covered in tiles, **Plates 8 and 9**. The front yard comprised an open garden area, with a concrete driveway and concreted pathways down both sides of the dwelling, **Plate 1**.

Plate 8: Rear yard viewed to the north.

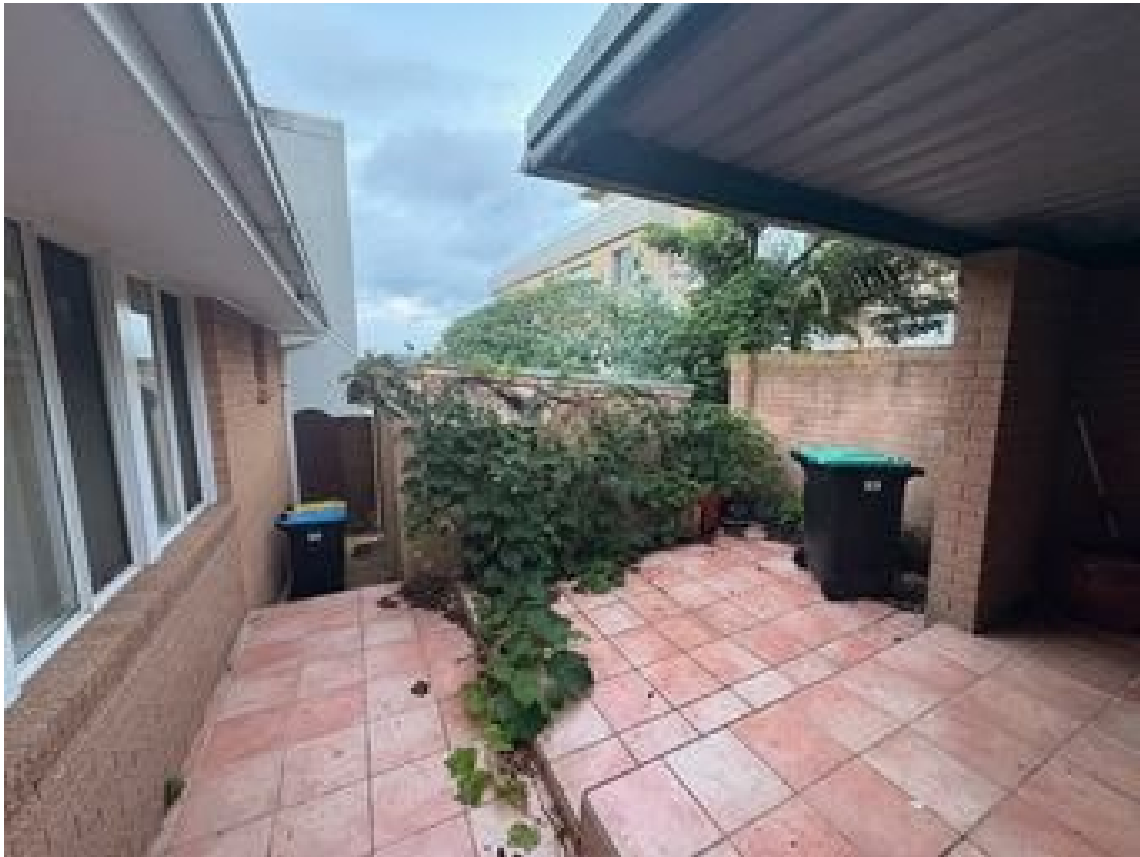
Plate 9: Rear yard viewed to the south.

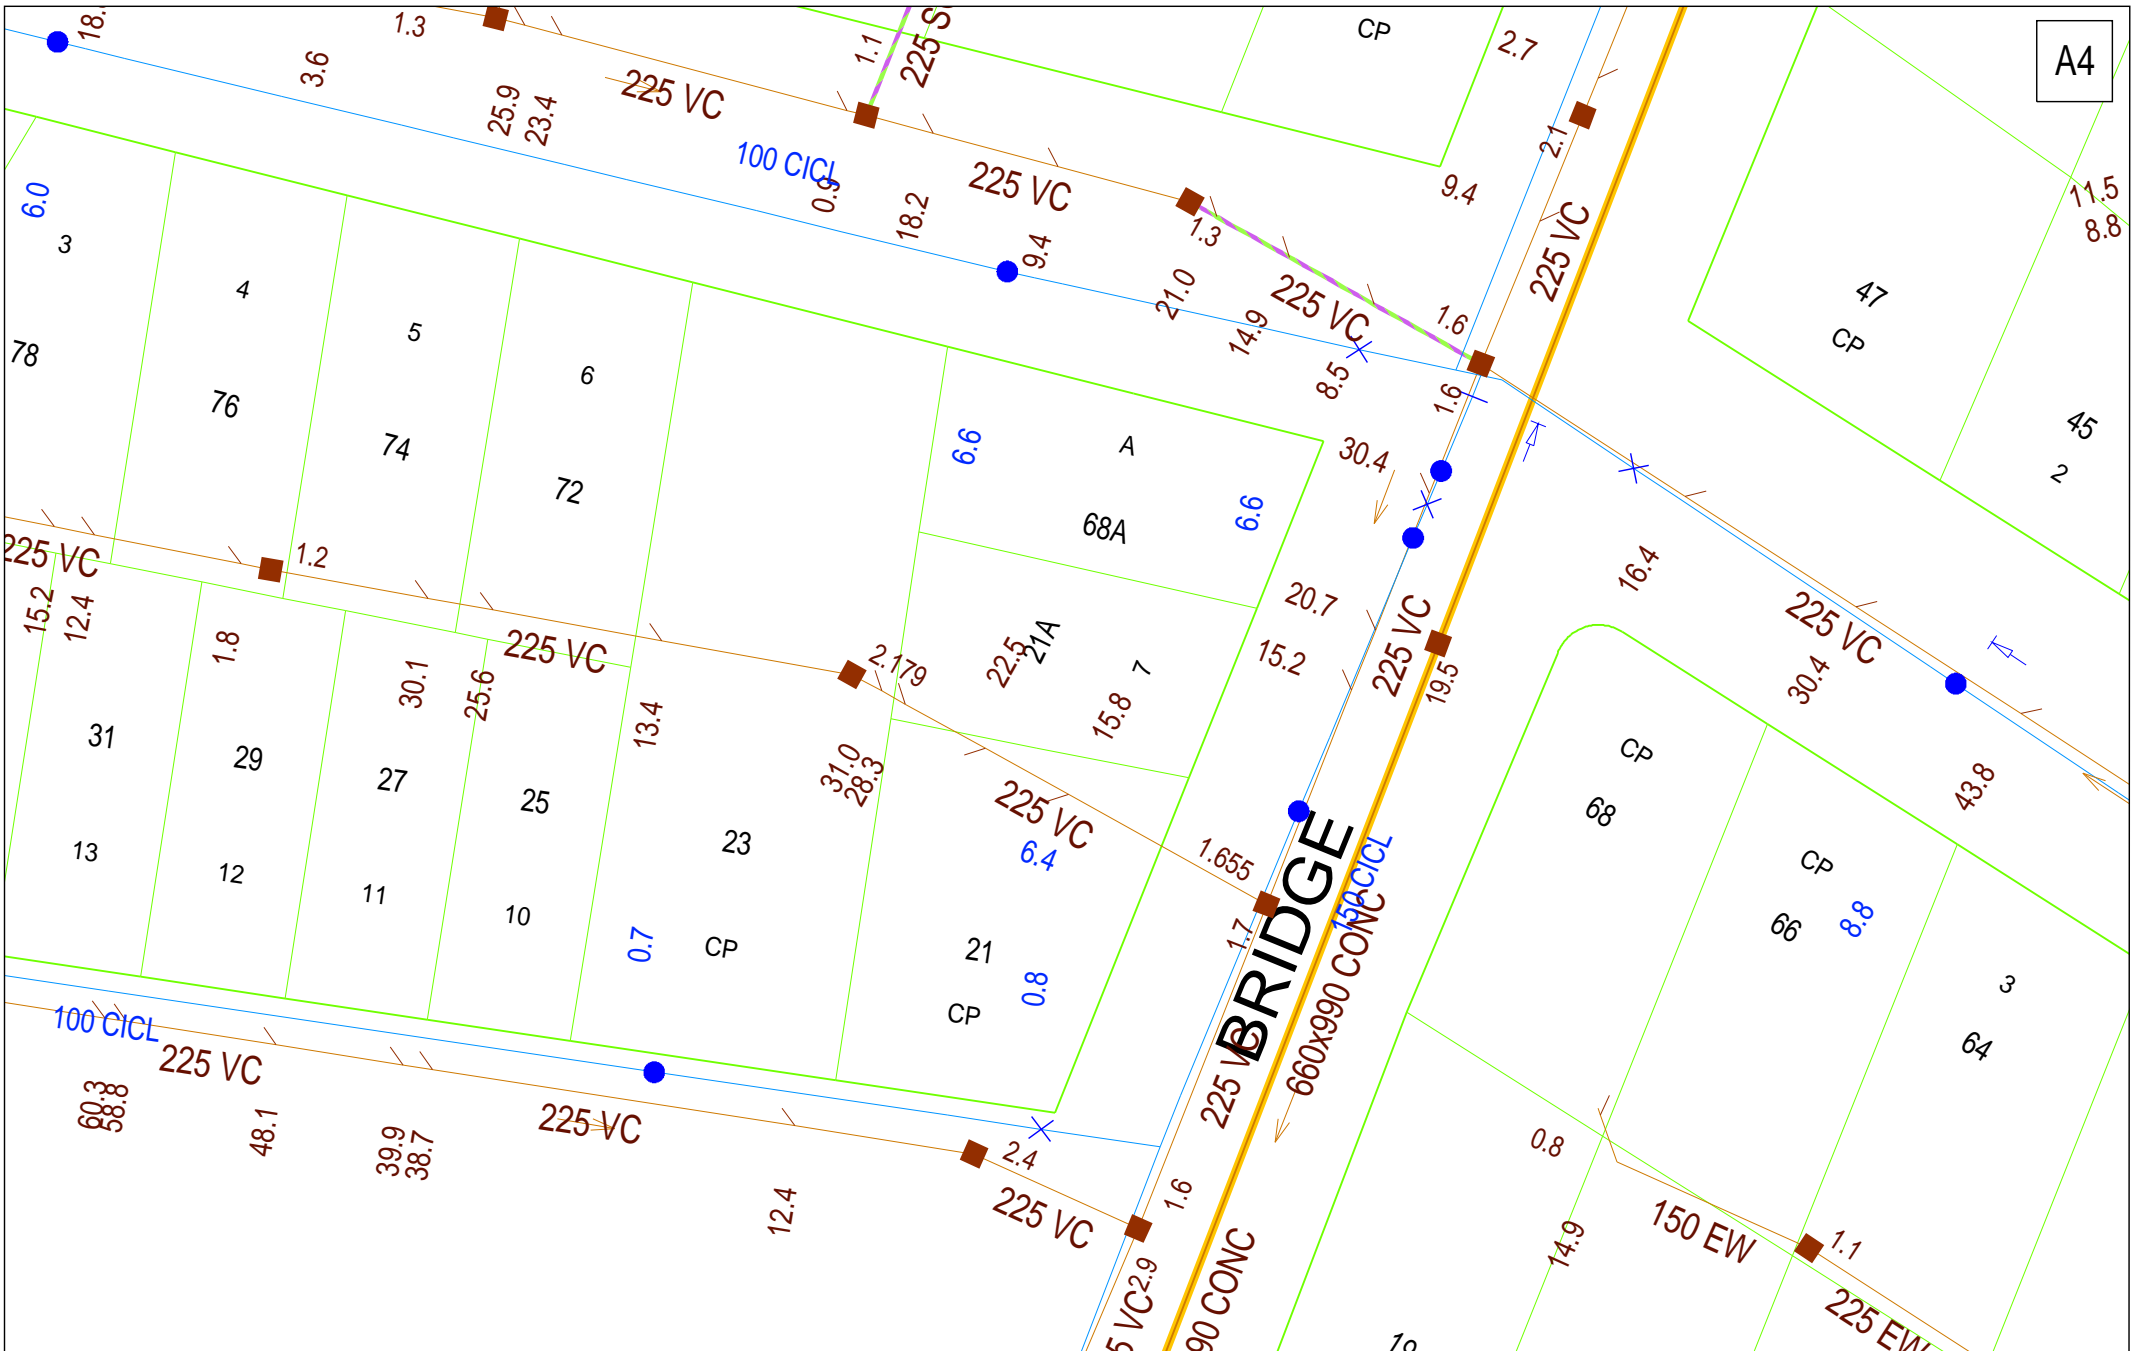
Sydney Water Sewer Plan (1 Sheet)

Finally, it is noted that a Sydney Water Sewer Line comprising a 225 VC pipeline crosses the southwest corner of the site. An adjacent man cover shows the invert depth of the pipe is approximately 2 metres below ground surface. A copy of the Sydney Water BYDA plan is provided for reference in **Appendix B**.
