# Jack Hodgson Consultants Pty Limited

MR 30957  
26<sup>th</sup> July, 2017  
Page 1

## GEOTECHNICAL ASSESSMENT REPORT FOR PROPOSED ALTERATIONS AND ADDITIONS AT 9 LOLITA AVENUE FORESTVILLE

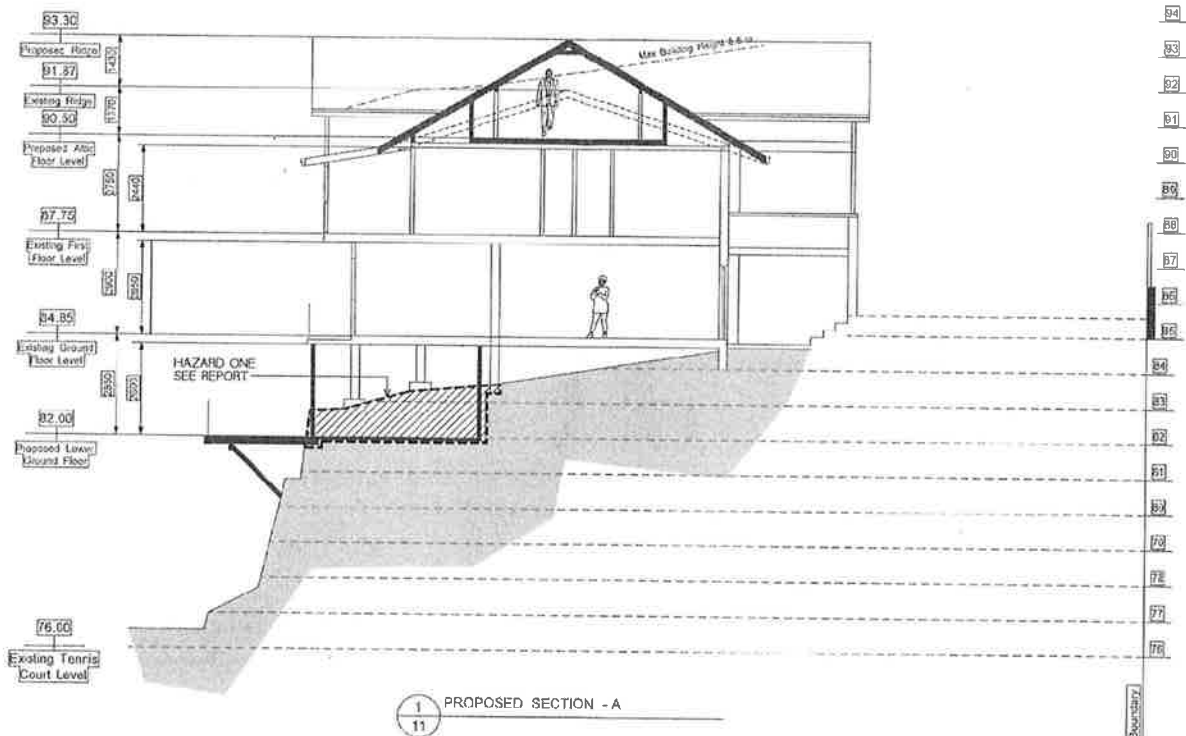
## SITE PLAN - HAZARD LOCATIONS

HAZARDS	Hazard One
TYPE	The excavations required for the proposed development are considered a potential hazard.
LIKELIHOOD	'Unlikely ( $10^{-4}$ )
CONSEQUENCES TO PROPERTY	'Minor' (5%)
RISK TO PROPERTY	'Low ( $5 \times 10^{-6}$ )
RISK TO LIFE	$8.7 \times 10^{-7}$ /annum
COMMENTS	This level of risk is 'ACCEPTABLE' provided the conditions in Section 10 are followed.
