Tree Management Strategies

Arboricultural Impact Assessment

BROOKVALE OVAL
23-10-19

Leigh Brennan
Tree Management Strategies

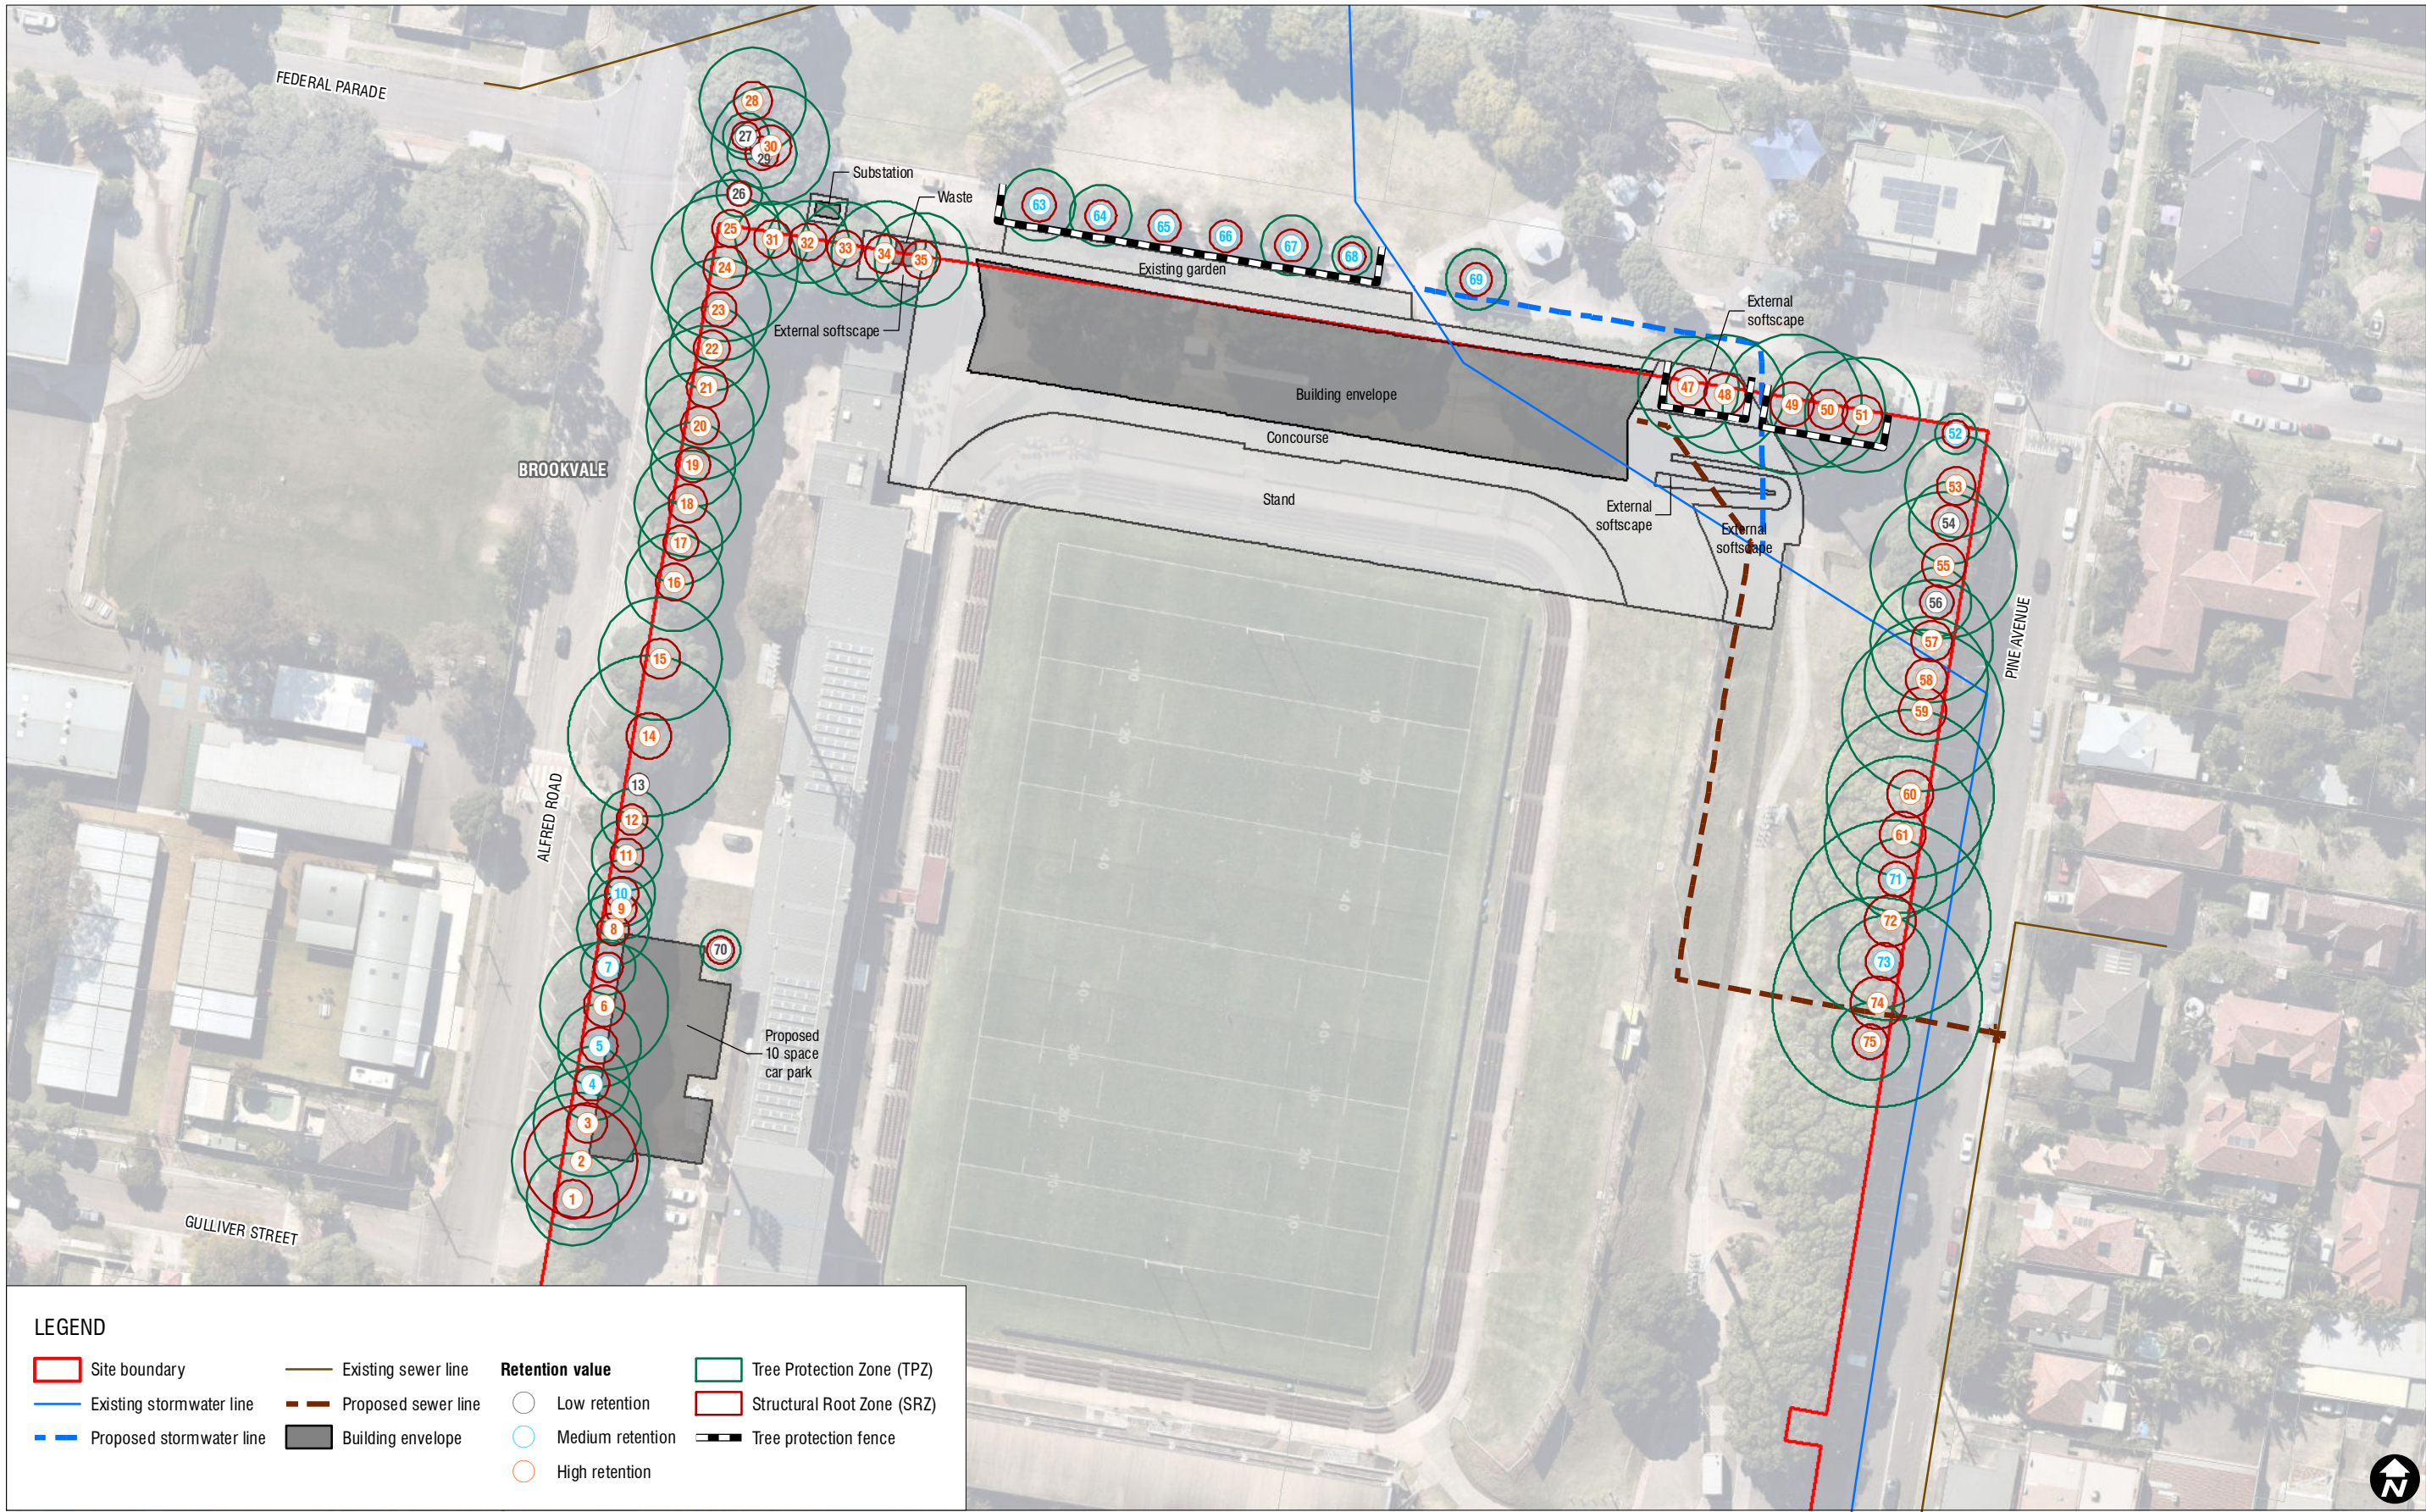
Note:
 - Building envelope design based on HASSELL drawing GA Plan - Concourse Level 00 Rev J.
 - Potential increased incursion to trees 34 and 35 due to concrete paving.
 - Trees 47 to 49 impacted by retaining wall and paving.
