Report Title: Geotechnical Report 47 The Serpentine, Bilgola

Report Date: 1/4/19

GEOTECHNICAL INVESTIGATION:

New Pool at **47 The Serpentine, Bilgola**

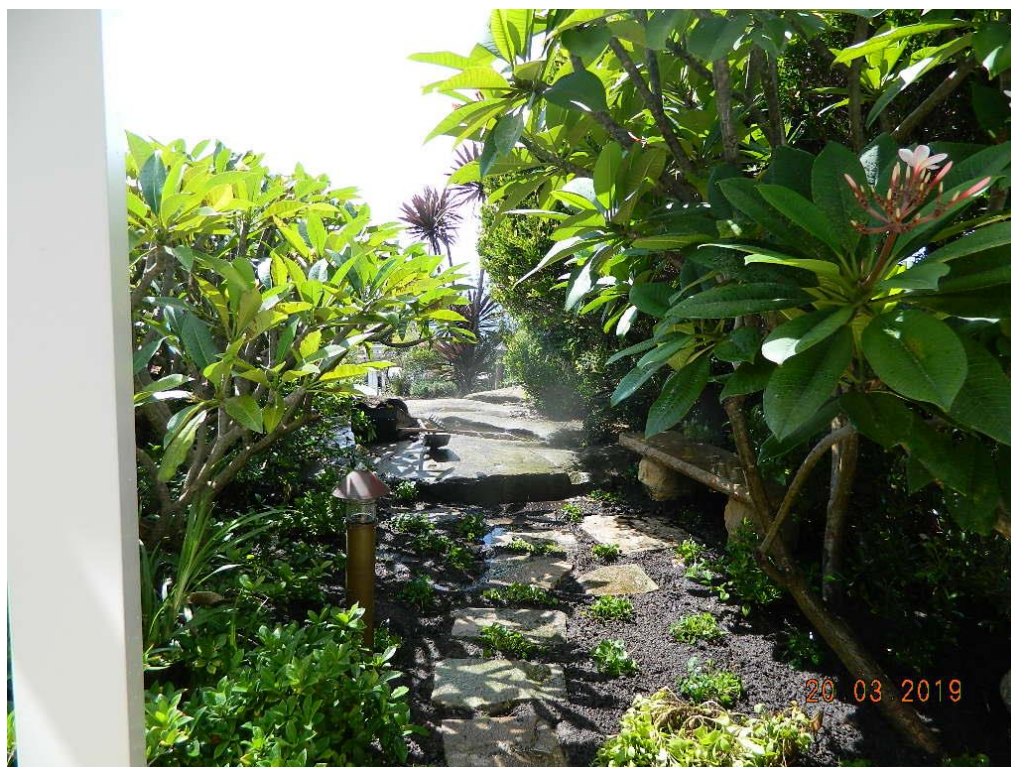
Photo 3

- 2.3** At the NE road frontage a concrete driveway runs to a garage on the NE side of the property (Photos 1 & 2). An excavation has been made for the garage and driveway. Stable concrete retaining walls reaching a maximum height of ~2.5m support the cut for the driveway (Photo 3). Medium Strength Sandstone was observed outcropping at the road frontage and in the garden on the SE side of the garage and driveway (Photo 4). The part three-storey, concrete block, brick, sandstone flagging and timber clad and framed house is supported on concrete block and brick walls, and brick and timber piers (Photo 5). No significant signs of movement or cracking were observed in the external supporting walls of the house and the brick piers stand

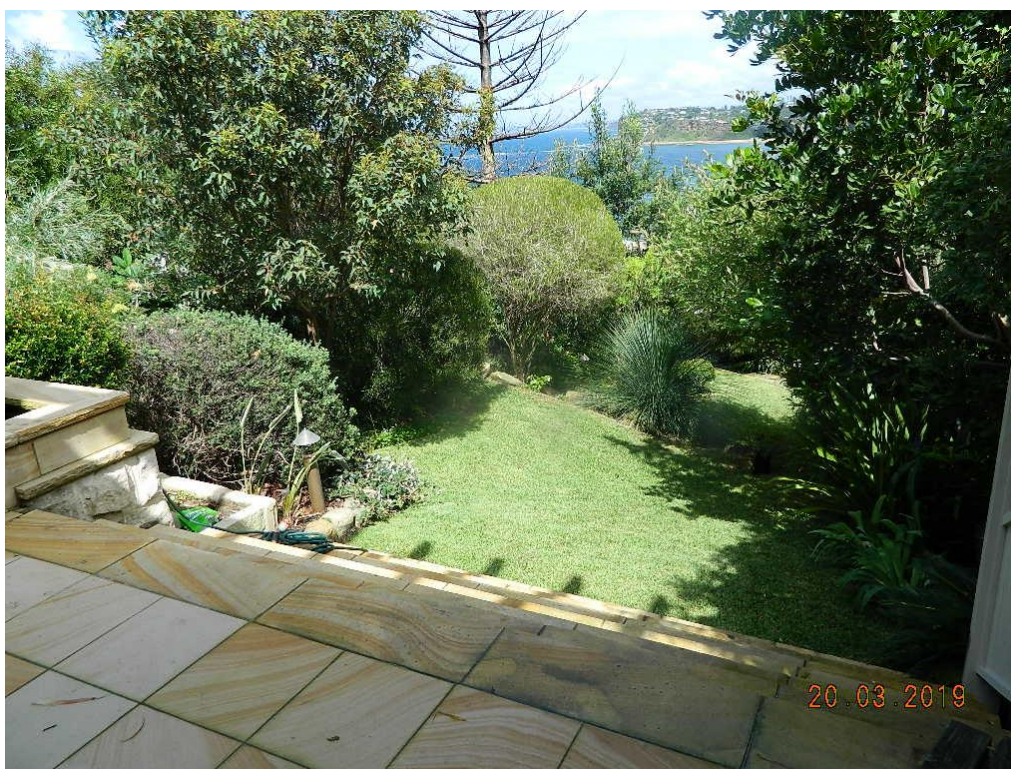
Photo 7

vertical (Photo 6). An excavation has been made on the NW side of the house along the boundary for the lower ground floor of the subject house. The cut is supported by a stable concrete wall reaching a maximum height of ~1.0m (Photo 7). The slope below the house is landscaped with a series of stable terraced gardens and intermittent open grassy areas that extend to the road frontage along the SW boundary (Photos 8 & 9). The terraces are constructed of large, stacked sandstone boulders. No significant signs of movement were observed on the property. No geotechnical hazards that could impact on the subject property were observed on the neighbouring properties as seen from the subject property and the road.
