## **56 CRESCENT ROAD**

**NEWPORT, NSW**

# **ARBORICULTURAL ASSESSMENT & DEVELOPMENT IMPACT REPORT**

*Report Ref No- RTC-19618*

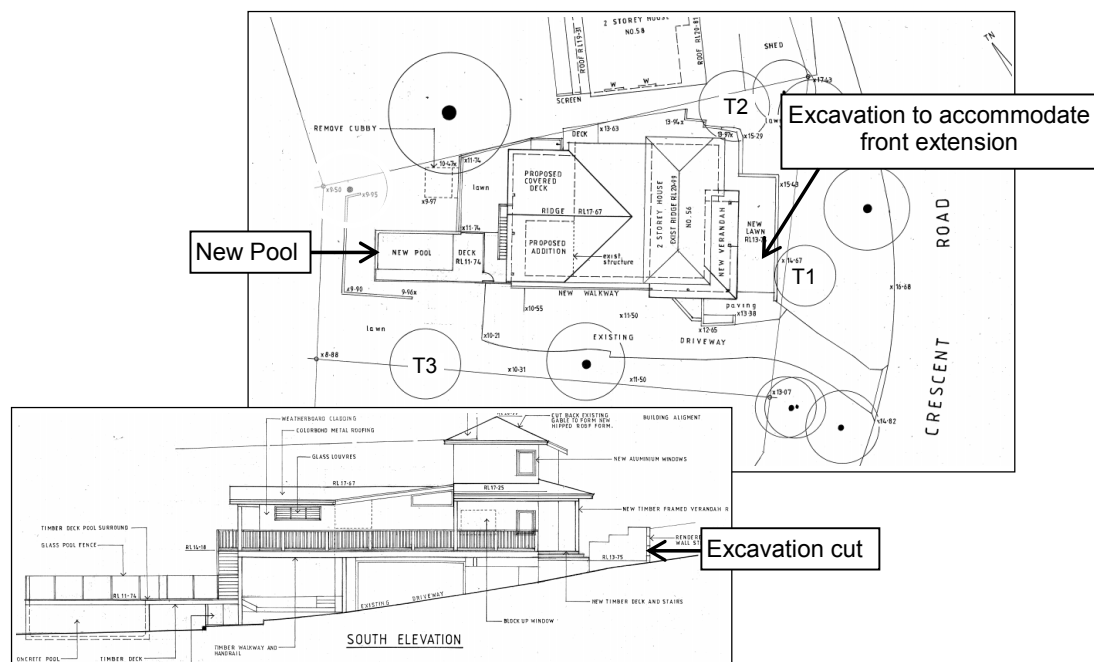
Figure 1, showing proposed development footprint

- 1.2.1 The development proposal consist of additions and alterations to the existing dwelling with excavation to accommodate a new retaining wall cut and rear yard swimming pool.

1.3.1 Tree 1. Proposed works adjacent the tree consist of excavating a cut face to accommodate a new entry access area, verandah and timber decking. Works are located just outside of the 2.4m SRZ with the overall encroachment within the TPZ considered a Medium level (<20%) of encroachment within the tree protection zone (TPZ). The level of impact is considered manageable as the TPZ is not radial due to the existing cut within the notional TPZ and recent loss of an adjacent tree which has reduced soil moisture competition. To ensure the tree is adequately managed the following recommendations are provided as a guide for the minimising of impacts during work activities:

- 1.3.2 Tree 2. Proposed works adjacent the tree consist of excavating a cut face to accommodate a block retaining wall at near 5.2m from the tree. The encroachment within the 5.4m TPZ is considered negligible to low impact (<10%) with the following recommendations provided to ensure the tree is adequately protected during work activities.

- 1.3.3 Tree 3. Proposed works adjacent the tree consist of excavation to accommodate the new swimming pool with the line of cut located outside of the 7.2m tree protection zone. That which may affect underlying tree roots is constant traffic and disturbance during construction activities. In order to adequately protect the tree the following general recommendations are provided:

5. Given the cut location adjacent the SRZ and soil loss, the TPZ radius is recommended to be mulched with native leaf mulch and routinely watered to retain soil moisture content and reduce stress during development activities.

1. Prior to works occurring tree protection fencing is recommended to be installed at a 3.5m radius from the tree, primarily protecting the 2.7m SRZ. Should the tree protection fencing restrict development activities alternate tree protection methodology may be applied under the guidance and certification of the appointed project arborist. Alternate protection may include timber beam trunk and ground protection, with designated vehicle tracks during earthworks.

2. The SRZ is to be considered a development access and work exclusion zone.
- 1.3.4 Remaining trees located along the driveway access handle are protected by default having a hard surface driveway over tree protection areas. Timber beam trunk protection is recommended to be installed to avoid potential vehicle impacts that may occurring during earthworks and general construction activities.
