GEOTECHNICAL REPORT

PROPOSED NEW DWELLING

18 HILLCREST AVENUE, MONA VALE NSW

Project No.: 2022-039.2 November 2024

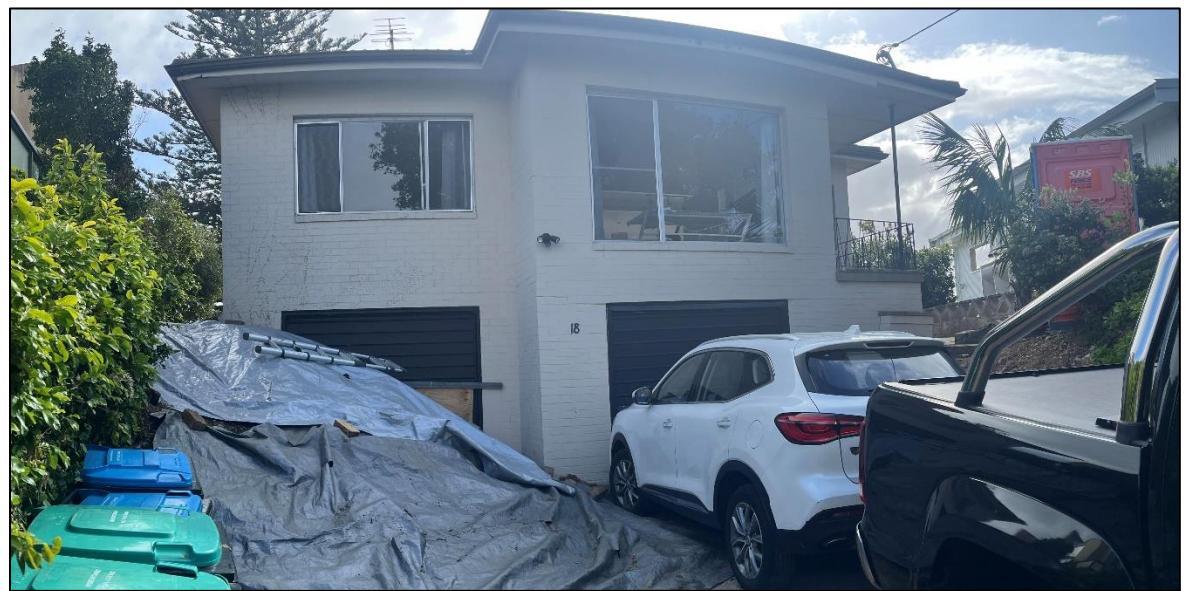
Photograph 2: View of the front of the site looking north

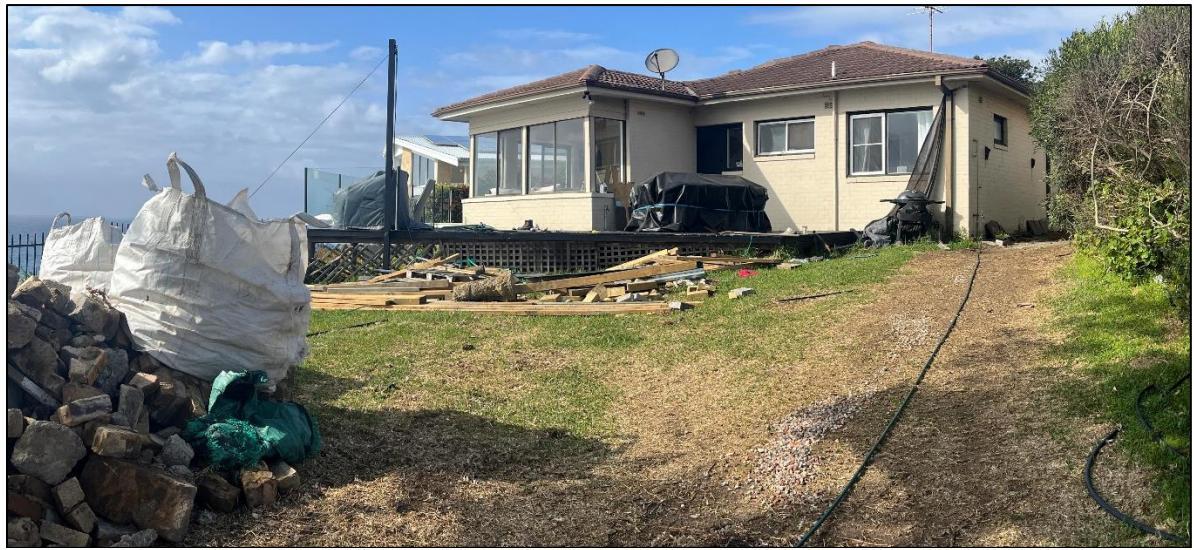
Photograph 3: View of the site looking south from the rear garden

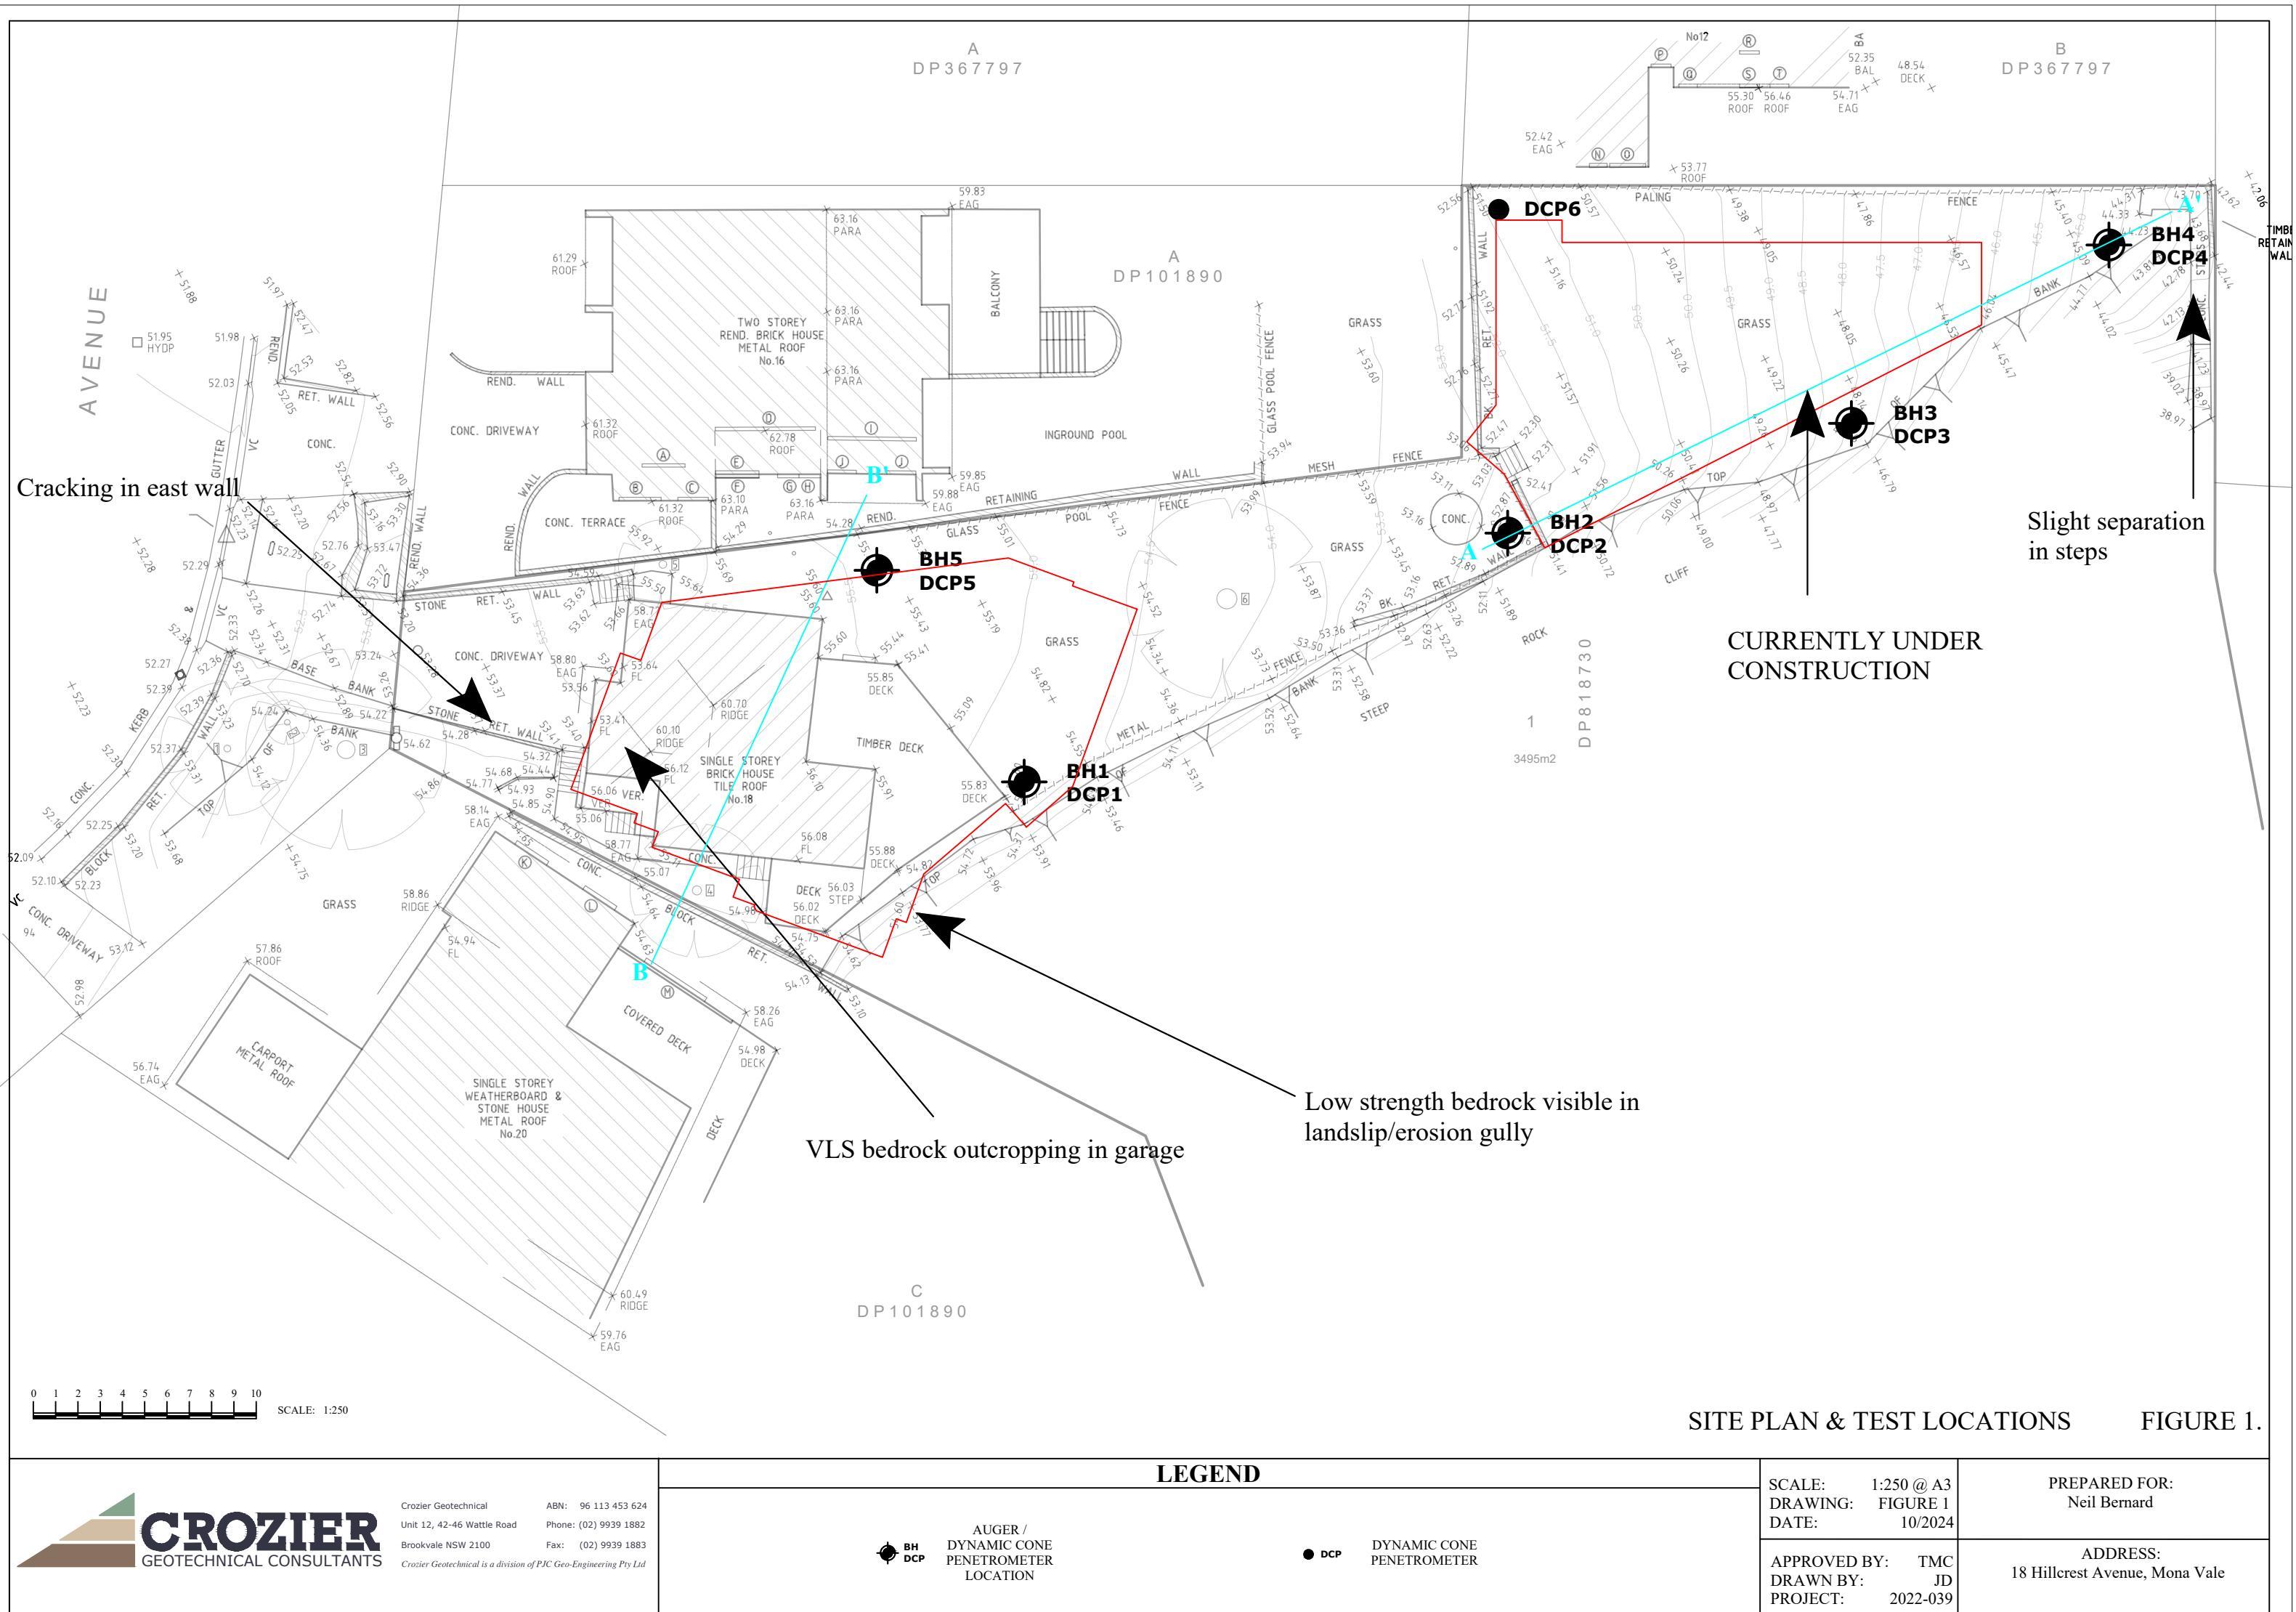
SCALE: 1:250 @ A3 DRAWING: FIGURE 1 DATE: 10/2024	PREPARED FOR: Neil Bernard
APPROVED BY: TMC DRAWN BY: JD PROJECT: 2022-039	ADDRESS: 18 Hillcrest Avenue, Mona Vale

Explanatory notes are included in Appendix: 1. Mapping information and test locations are shown on Figure: 1, and a geological section is provided as Figure: 2 along with detailed Borehole log sheets and Dynamic Penetrometer Test Sheet in Appendix: 2.

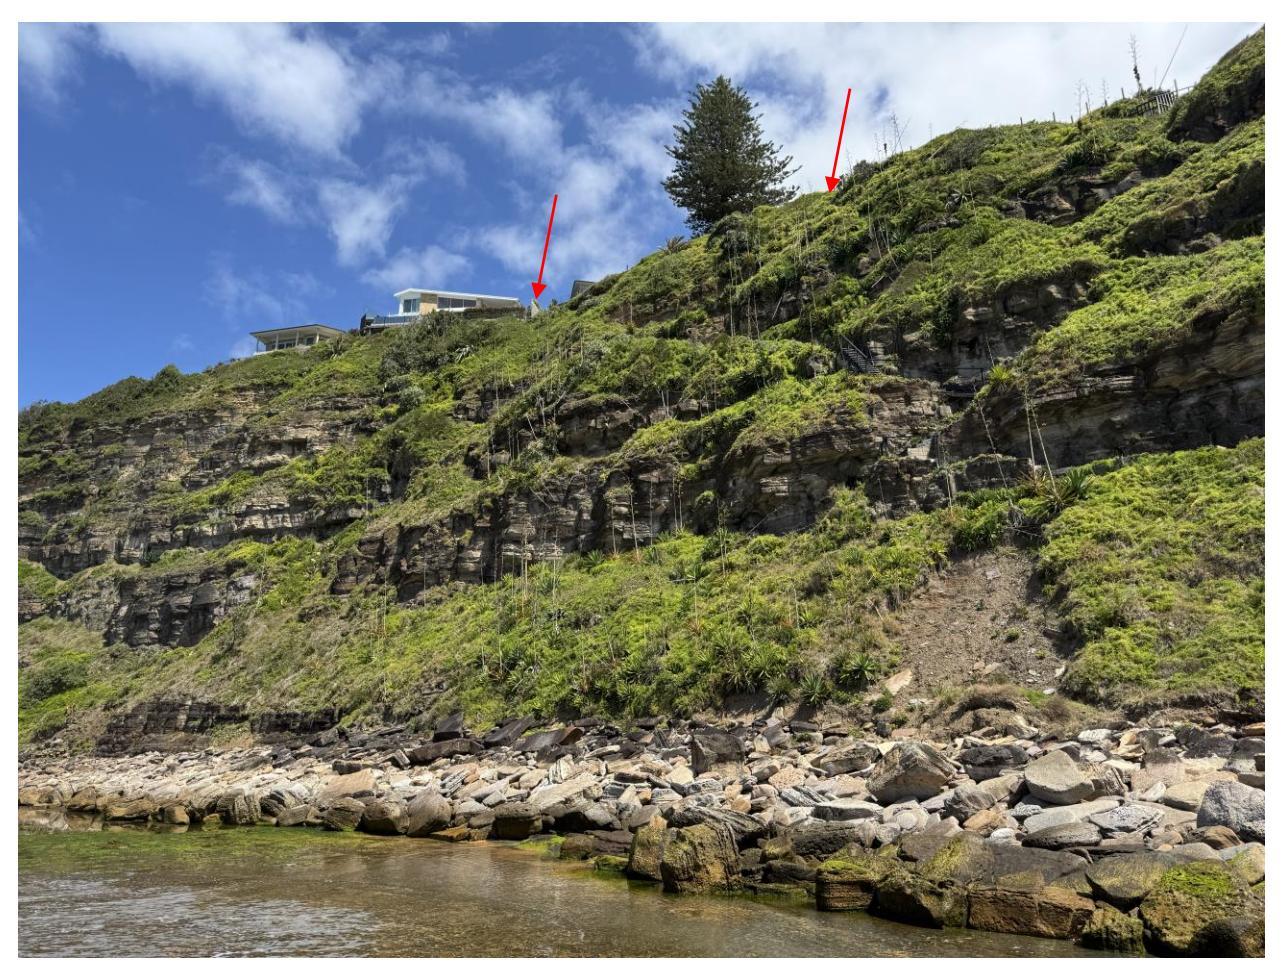
Figure 3: View of cliff face at site (extent at top of cliff approximately between arrows) on 3 October 2024, facing SW

⁶ Overhangs are currently evident in the cliff face, as visible in Figure 3.

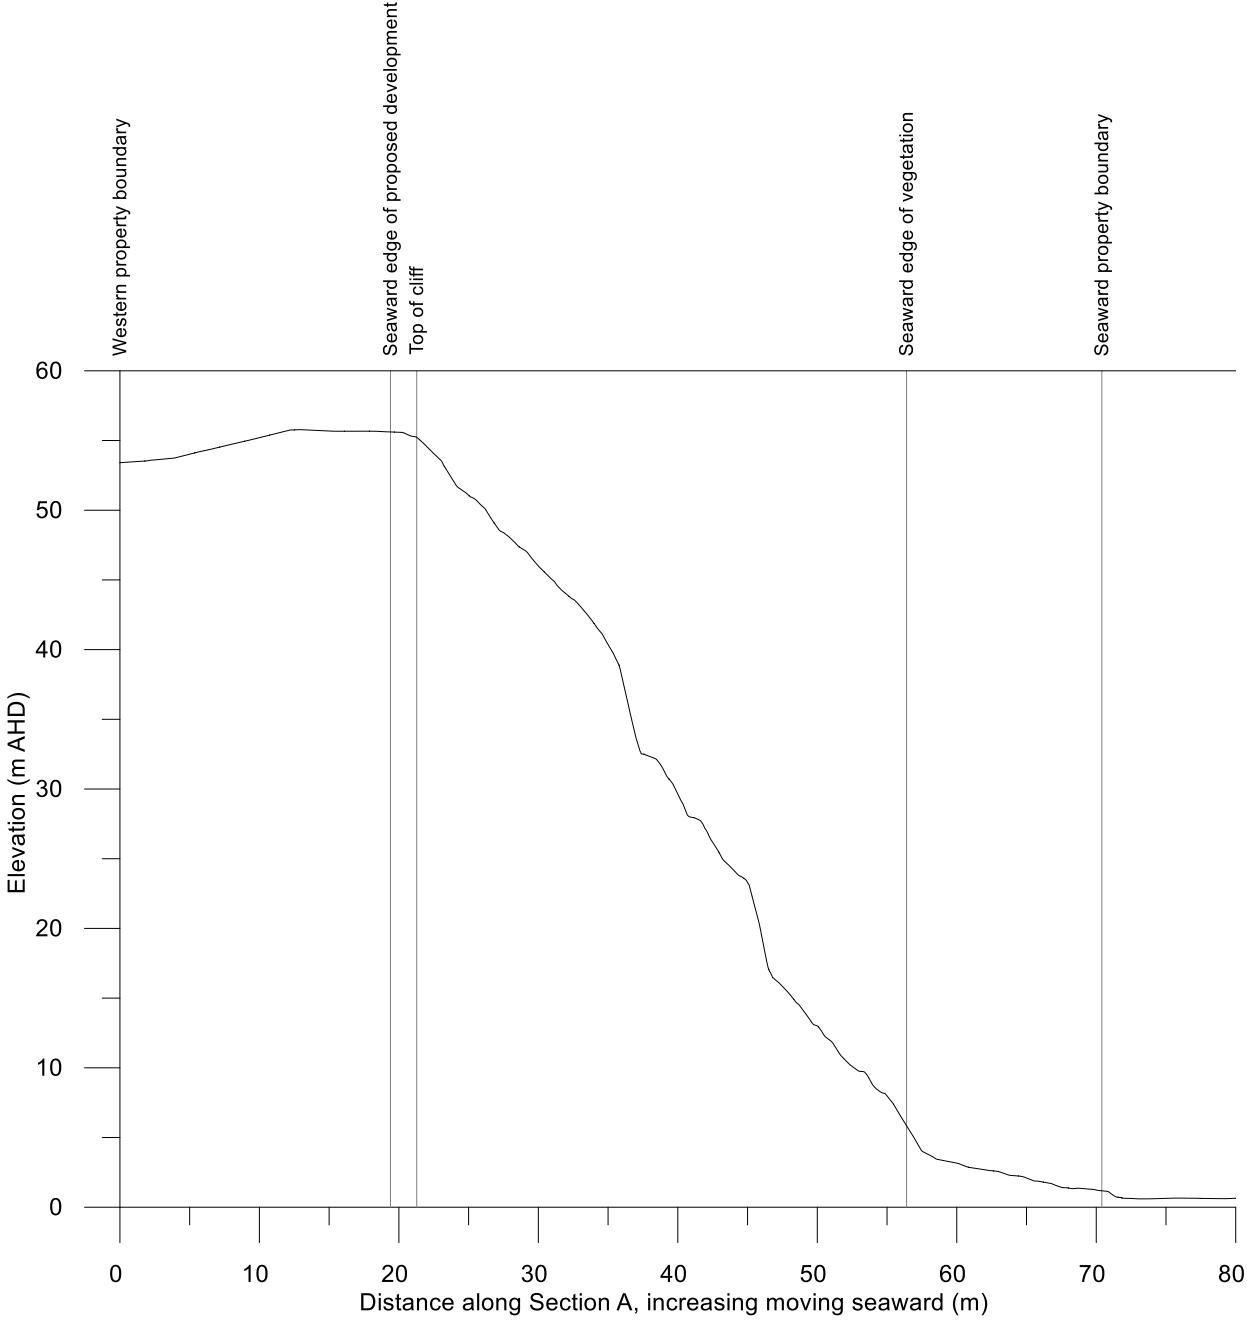
Figure 4: Section A through site, including cliff face and rock platform

Ground elevations along Section A approximately vary from about 55.5m AHD over most of the development area, 55.2m AHD at the top of the cliff, 3.5m AHD at the toe of the cliff, and 1.2m AHD at the seaward property boundary. The average slope from the top to the toe of the cliff is 1:0.7 (vertical:horizontal, V:H) or 54°, with steeper sections around the central portion
