Preliminary Assessment

Proposed Additions and Alterations

32 Ettalong Street, Wheeler Heights NSW 2097

Project No.: JASC0727-GEO AA
23 March 2022

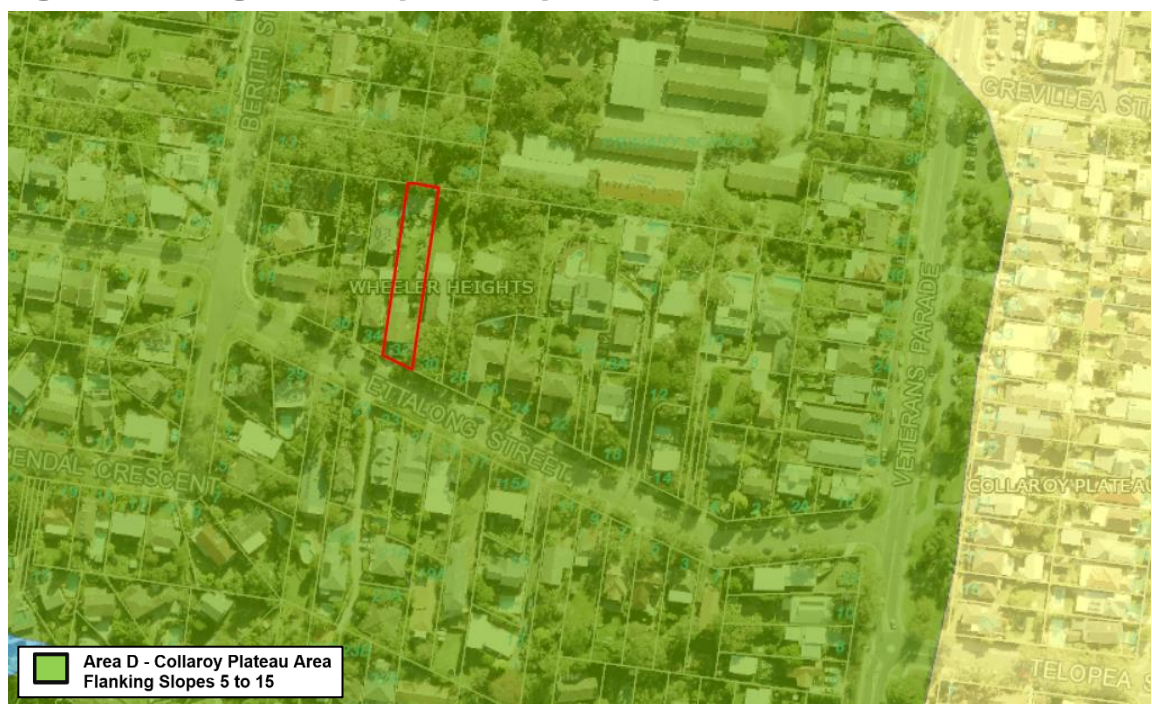
Figure 1 Warringah Landslip Risk Map Excerpt

The proposed site is classified as Landslip Risk Classification D and a map excerpt of the Warringah Landslip Risk Map is provided in **Figure 1** below.
