## **REPORT ON GEOTECHNICAL SITE INVESTIGATION**

### **PROPOSED DEVELOPMENT**

**2A ALLEN AVENUE, BILGOLA BEACH, NSW**

**Project No.: 2021-086**

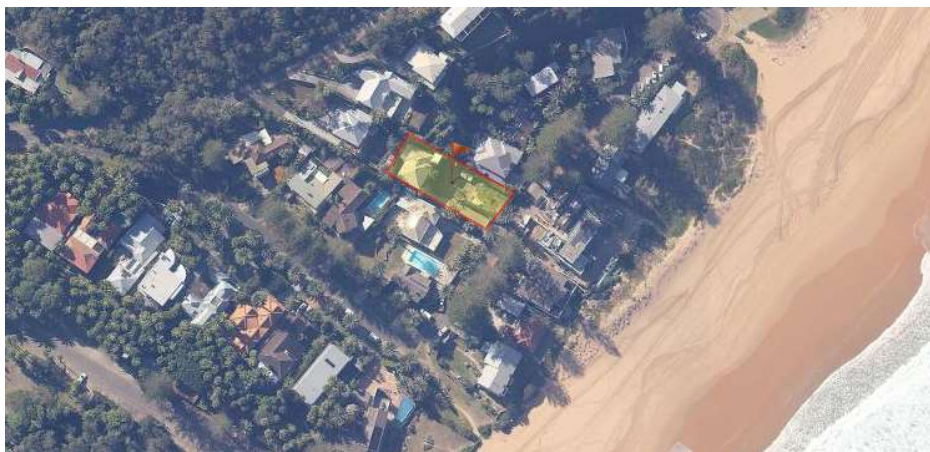
*Photograph-1: Aerial photo of site and surrounds*

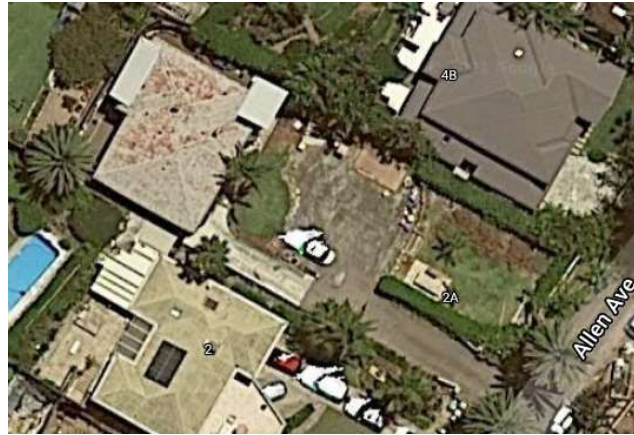
Based on available google maps satellite view it appears that the centre of the site previously contained a concrete surface with a platform adjacent to the north boundary, whilst the eastern side contained a grass lawn (Photograph-11).

*Photograph-11: Previous site plan. Extract from available Google Maps satellite view.*
